Revitalization of the Carthusian Monastery at Žiče

EC project within the programme CULTURE 2000

Agreement No.:
2005-0817/001-001 CLT-CA31
Period: 2005-2006
<http://zicka.zag.si>

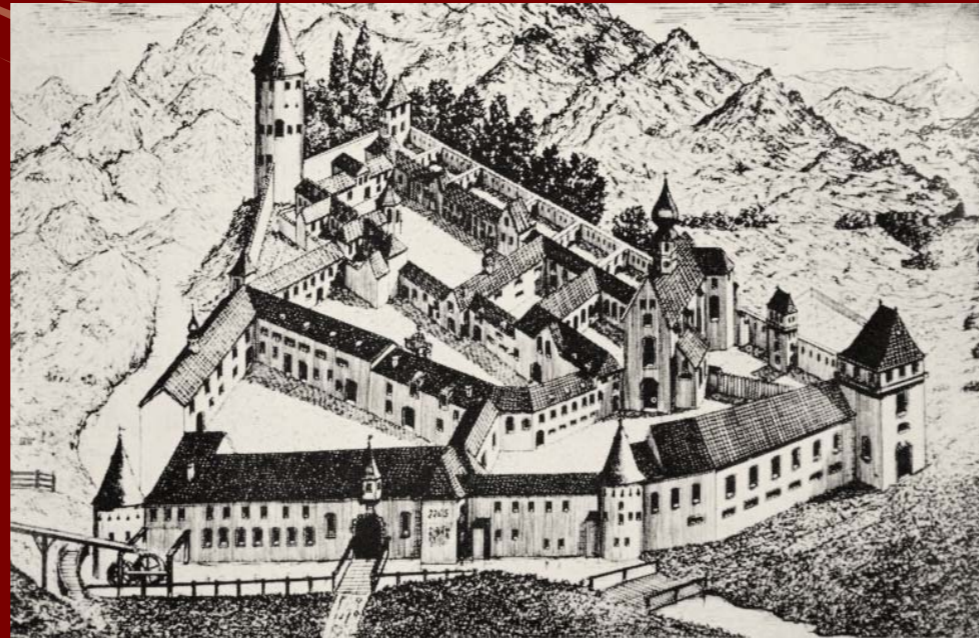
Graphic representation of the ecclesia major of the Carthusian monastery at Žiče, dating from the 18th century

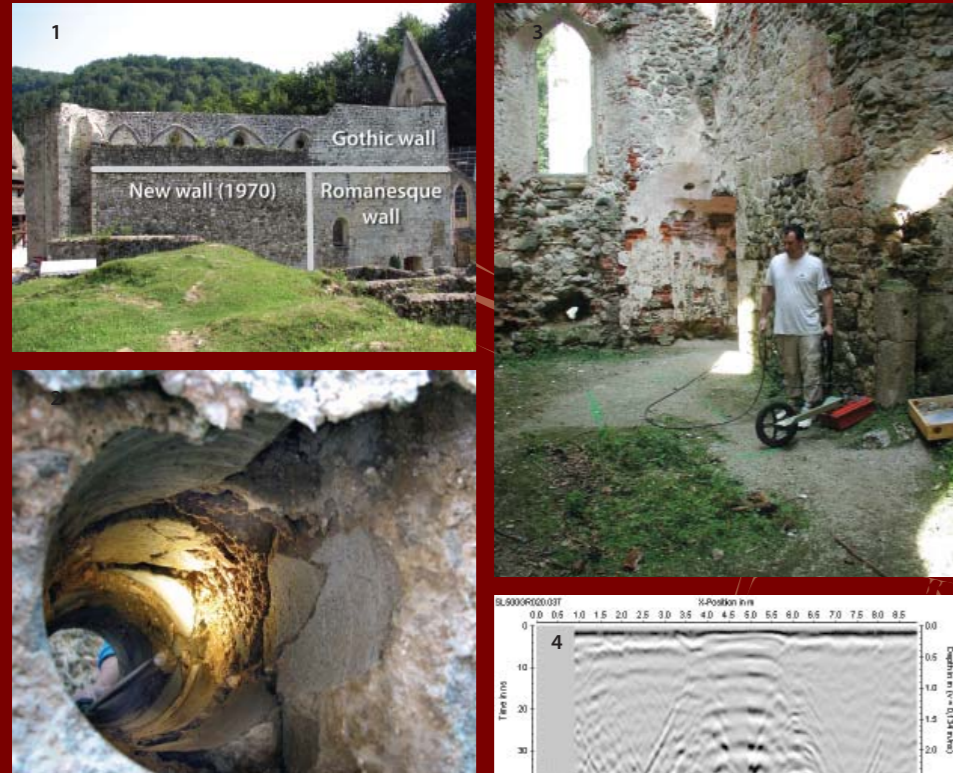
Field and laboratory research established that the wall structures originated in different historical periods. Non-destructive georadar and thermal methods were used to identify hidden columns, arches and voids inside the walls, and for ground investigations.

1. Different types of masonry at north wall, 2. Boroscopy investigation, 3. Non-destructive assessment of ground of the Otokar Chapel, 4. Radar traces of grave in the Otokar Chapel

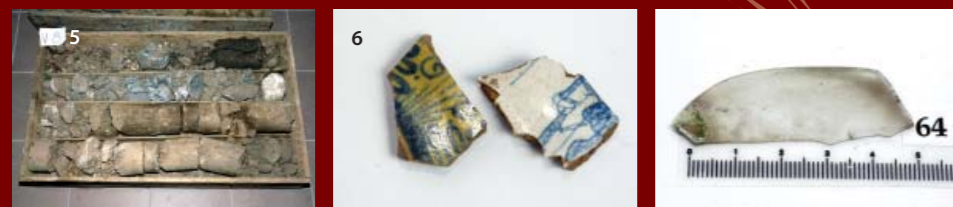
Drilling core 8, located next to the east wall of the presbytery, is exceptional for the depth of archaeological deposits: a layer of mortar was found at a depth of 330 cm - the deeper clay layers do not show any traces of human activity.

Fragments of gothic glass and modern age ceramics have been classified as rare findings in the existing archaeological research of the Žiće monastery.

5. The core of the archaeological borehole, 6. The pieces of new-age ceramics and glass from Gothic period

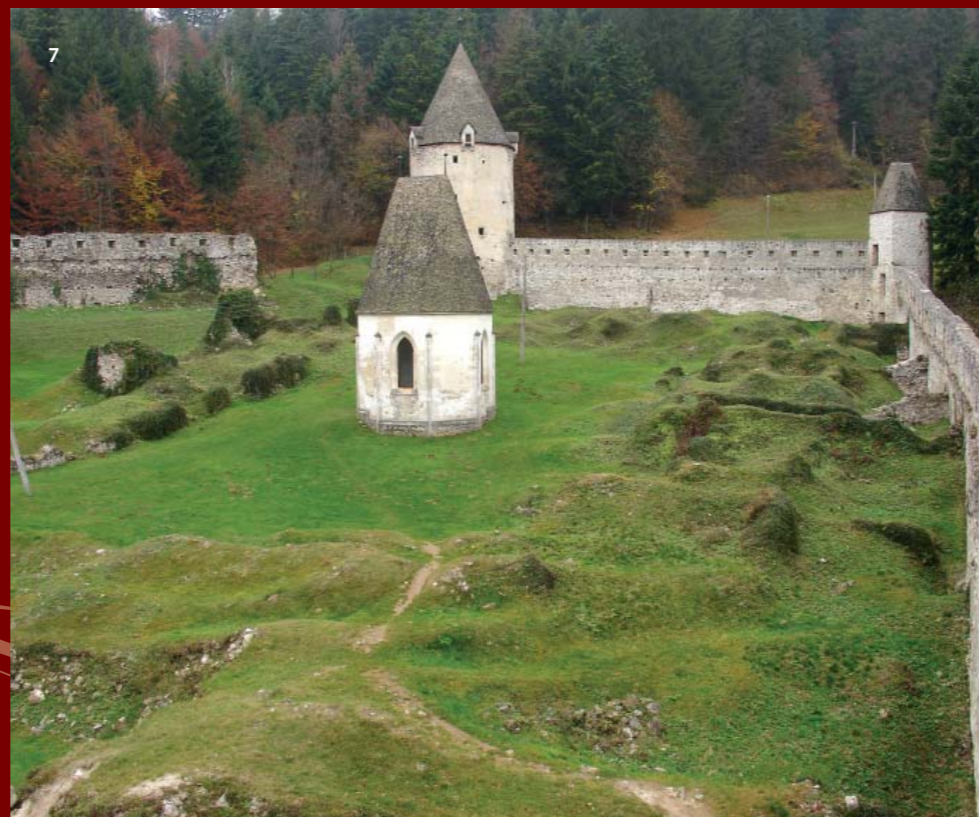
7. Research into archaeology inside the Carthusian Monastery

It is very likely that the mortar belongs to the remains of the church nave or to the reconstruction of the northern side chapel.

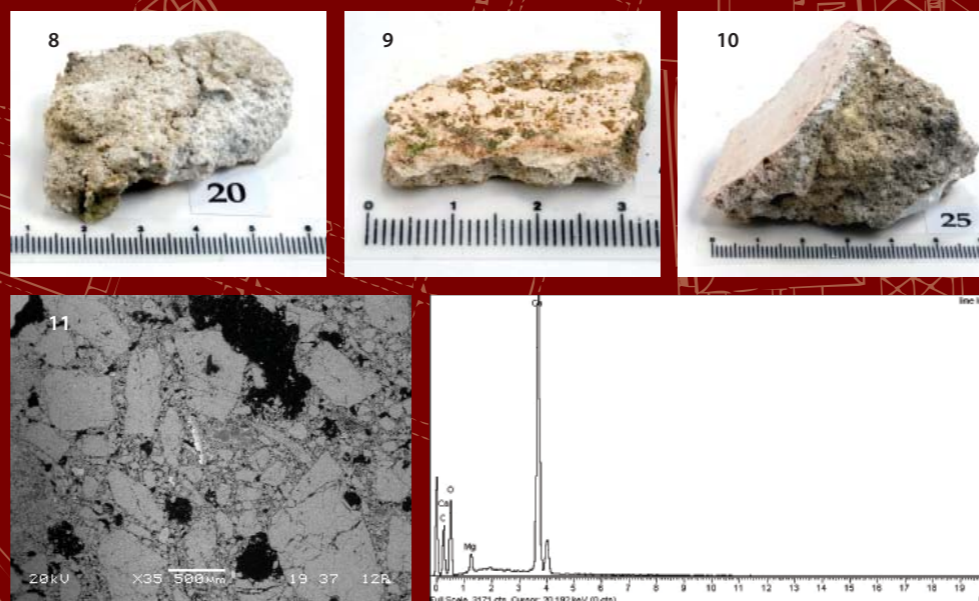
The main goal of the research into mortars was to determine their age on the basis of their composition. The noted differences in the composition of the mortars suggest that the building development of the Church of St. John the Baptist dates back to the Romanesque, Gothic, and Baroque periods.

8. Pointing mortar from the Romanesque period, 9. One-layered plaster with smooth finishing layer from the Gothic period, 10. Double-layered plaster with finishing layer from the Baroque period, 11. Sample back-scattered image of mortar (left) with Ca-rich binder (right) from the Gothic period

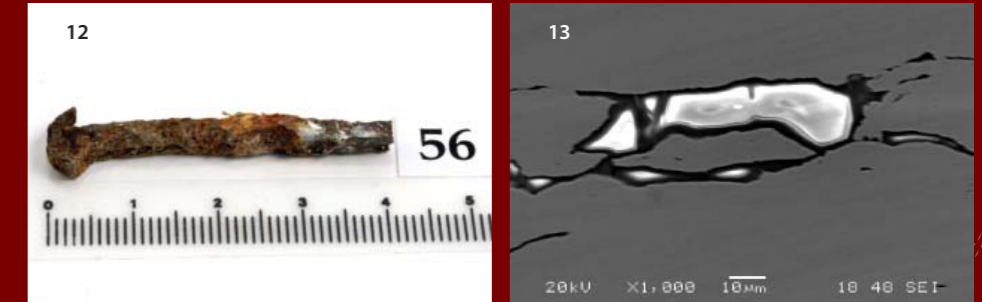
The inspected specimens of nails are made of non-homogeneous composite materials, consisting of different oxides of silicon, calcium, aluminium, magnesium, and iron.

The metal products are of good quality, and even after 700 years they are not significantly corroded.

12. Handmade nail from Gothic period, 13. Back-scattered image of the non-metallic inclusions in the ferrite matrix

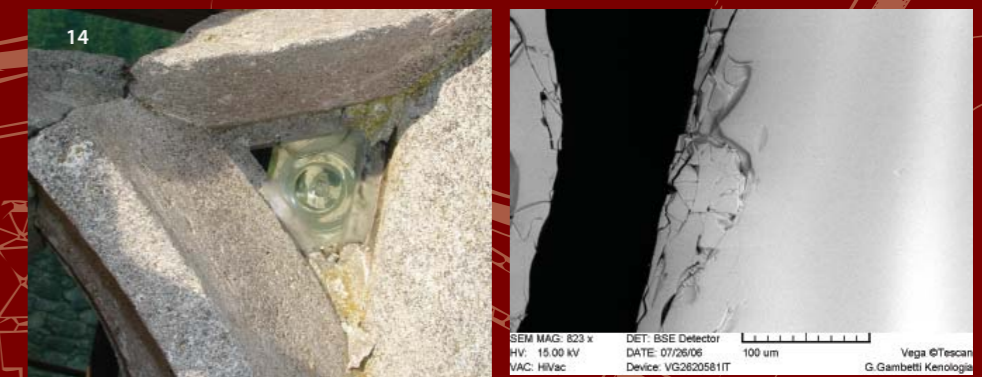
The chemical composition of the inspected glass fragments is homogenous: they consist of different oxides of Si, Al, Mn, Mg, Ca, Na, K, P, S, Cu, Fe, Ti and Pb. Comparative analyses of glass fragments from the Central European territories suggest that the Žiće glass dates back to the Gothic period.

14. A piece of original window glass (left) and SEM image of the glass cross-section (right) from the Gothic period

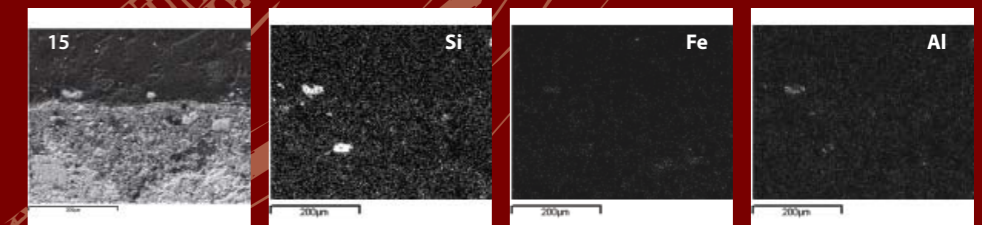
The Carthusian architecture is modestly painted, so the number of identified pigments was small. Red soil, as well as pigments of copper, lead, titanium, chromium and nickel, were identified, of which the red soil and lead pigments are historical.

15. EDS mapping analysis of most common red soil pigment
