The European Heritage Days Cultural Routes 1999 Guide to Monuments

# Contents

## Cultural Routes – The Cultural Trail Begins Right Here

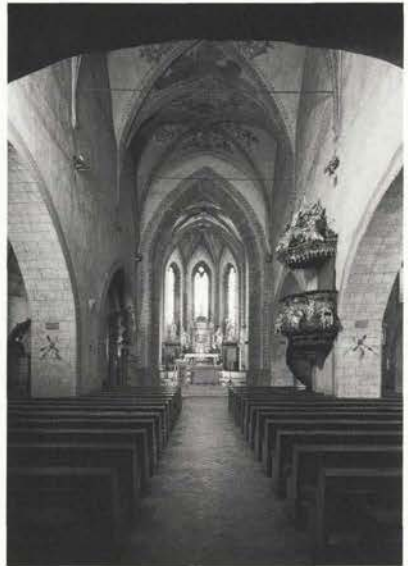
View of the main nave and the presbytery of the abbey church of St. Daniel. "The triumphal arch is still the only missing accent of the church interior. The decision for its reconstruction was a risky one..."

ing Mary's death, assumption and coronation, the work of the Istrian Colour Master, in the third section. The frescoes were renovated and the missing masonry elements reconstructed and shaded in terracotta. The presbytery was thus revived in its original harmony, and was soon joined by the nave of the same colour; the triumphal arch is still the only missing accent of the church interior. The decision for its reconstruction was a risky one, since it would present the first intervention of that kind in Slovenia; yet the church would have remained incom-

plete without it. Appropriate plans were drawn up, and the church has finally obtained the reconstructed arch, including the painted border decoration with the acanthus motif restored on the basis of preserved fragments. The attempt to restore the original Gothic atmosphere of the place was successful, and all the executed works were recorded in detail.

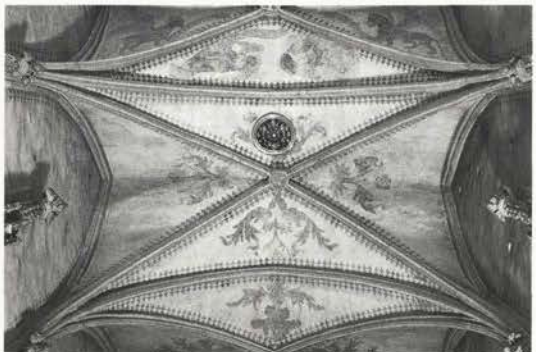
View of the renovated Gothic chapel of St. Mary. "Through the restoration of the architectural elements and fine presentation of the features an exceptional place from the period of chivalric Gothic has been obtained..."

The renovated chapel of St. Mary now displays a special charm of the abbey church. It had been used as a lumber-room since the previous century. A substantial part of its stone-cut decoration had disappeared during the Baroque period, and its furnishings were modest. Once the lumber had been removed and the walls surveyed, further walled-in, partly destroyed al-

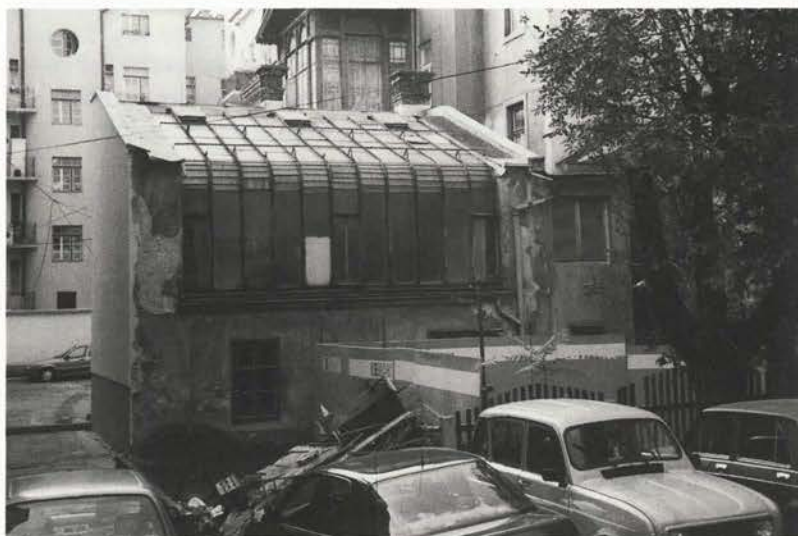
The Pelikan studio before the renovation. "In such a sorry state the studio was finally subject to a complex renovation in 1997 and has since then obtained the new function of a museum..."

By the end of the thirties Pelikan had moved his workshop to the ground floor of his residence and abandoned the studio. Decades without maintenance had caused its rapid deterioration. Dried out putty had given way, glass panes had cracked, iron beams had rusted, the parquet flooring had moulded, and windows and doors had rotted. In such a sorry state the studio was finally subject to a complex renovation in 1997 and has since then obtained the new function of a museum.

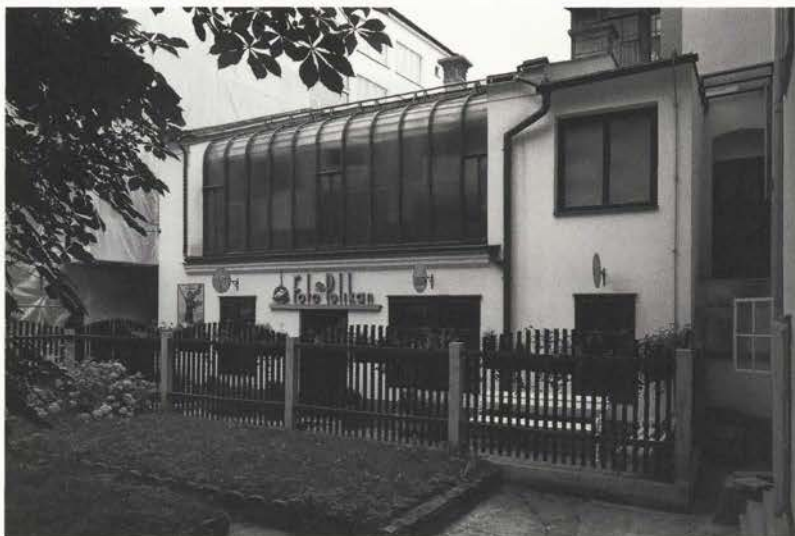
The Pelikan studio after the renovation. “...the key issue was the glazing of the studio. The dilemma was whether to insist on single-layer glazing, thus ensuring the authenticity of the historic building...”

with delicate exhibits various factors had to be considered: current technical and building regulations, the expertise of contractors for this particular technical monument, and also the limited supply of “historic” materials on the Slovene market. The studio was in a very poor state, particularly the wooden parts which had to be replaced. Thus the studio has acquired new floors, windows, doors, and a new entrance, all of them copies of original parts with most of the original metal fittings. Unfortunately, it turned out that the original iron construction

would not be strong enough on account of rust. Its reconstruction was a great challenge since each metal bearer had to be manufactured and curved out of a single piece and then put in place. The reconstruction of condensation gutters presented similar problems, yet the key issue was the glazing of the studio. The dilemma was whether to insist on single-layer glazing thus ensuring the authenticity of the historic building, yet simultaneously exposing the heritage of Pelikan to further deterioration caused by condensed water as a characteristic feature of the old method of glazing – or to accept modern thermal glazing without condensed water, yet with a decisive transformation of the historic appearance of the studio. The solution had to be a compromise: the studio has retained single glazing and “acquired” air-conditioning. The least conspicuous solution out of many available systems was selected. The reconstruction of authentic glazing was determined by the choice of appropriate glass: it had to be strong enough with the originally formed gutters.

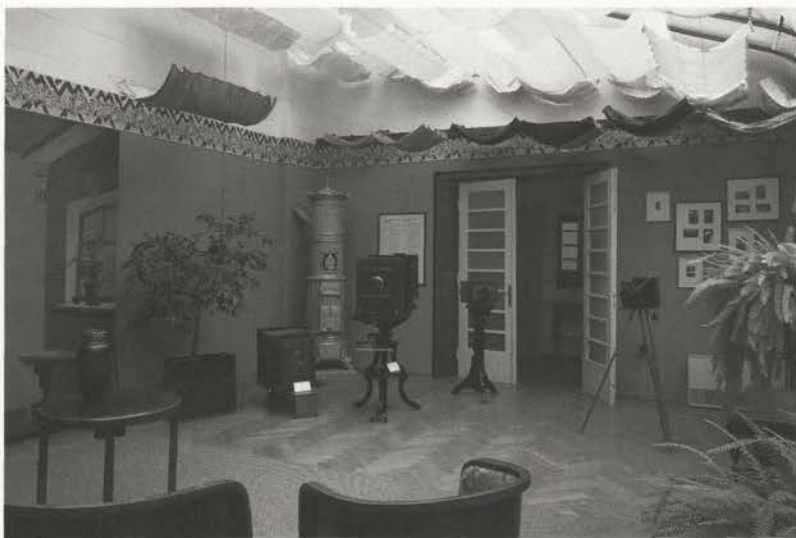
View of the Pelikan Studio. "Lenz had actually constructed a stone-built ground floor with three workshops and placed a glazed steel structure on it, also called the glass studio."

The studio was constructed in 1899 in the garden of his new house in Neugasse 1 in Celje by the local photographer Johann Martin Lenz. The plan drawn by the local builder W. Higersperger presented a one-storeyed glazed building, with a floor plan of 8 x 5m and 4.2m in height, yet Lenz had actually constructed a stone-built ground floor with three workshops and placed a glazed steel structure on it, also called the glass studio. The glazed part was probably manufactured by the Griedl company from Vienna. Thus the studio of Lenz was a modern building, built in accordance with contemporary technical regulations and intended for artistic portrait photography. The glazed part faced the north to capture softer light. The steel construction consisted of strong beams that traversed the walls directly, without disturbing the roof beams. The glass was strong enough to withstand the weight of the snow. It had a gutter structure and gave a blue reflection. The studio was well aired and heated with a cast iron stove. Drain pipes were provided for draining water condensed on the steel construction, and they were connected with roof gutters; the light and

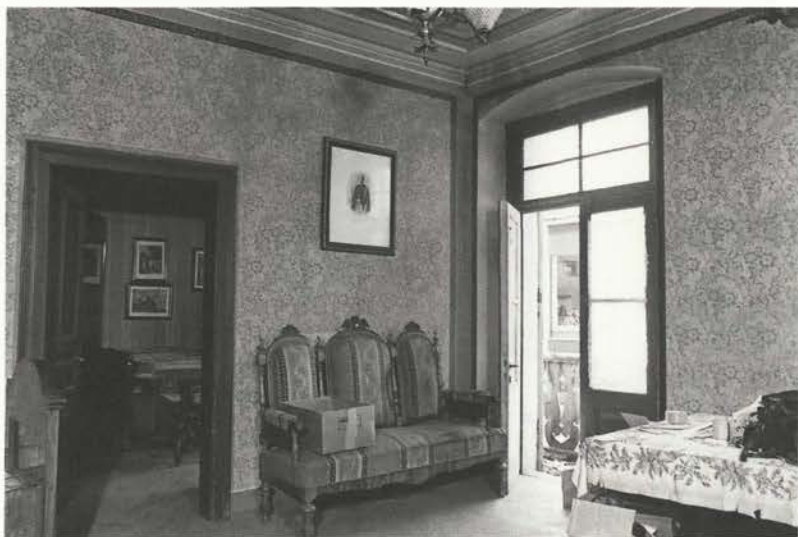
Interior of the house before the restoration. "...the whole first floor had to be renovated, including the pavements, wall painting and all the fittings and furnishings..."

The basic principle of the restoration was the preservation of this architectural monument in the image of the last style before Modernism. Strict rules for all interventions in the exterior of the house were set, including the rooms of the upper part: the whole first floor had to be renovated, including the pavements, wall painting and all fittings and furnishings, while more creative freedom was allowed in the renovation of the ground floor.

All the building works were relatively complex, since the house with modest foundations and built of stone and brick had to be protected against earthquakes by strengthening the foundations and injecting the walls. The walls were dehumidified with the construction of an air channel next to the foundation.

All plasterwork on the ground floor was removed and also all pavements, windows, doors and the roofing joinery with tiles. On account of the deteriorated supports the wooden veranda was also removed and replaced with a copy, as were the doors and windows, the banister of the balcony and the plasterwork. The most severe problem was posed by the preservation of painted ceilings on the first floor: all the rotten and wormridden parts were removed and the rest protected by insecticides. The construction of the ceilings was anchored in a new ferro-concrete slab with ventilation through slots on the facade.

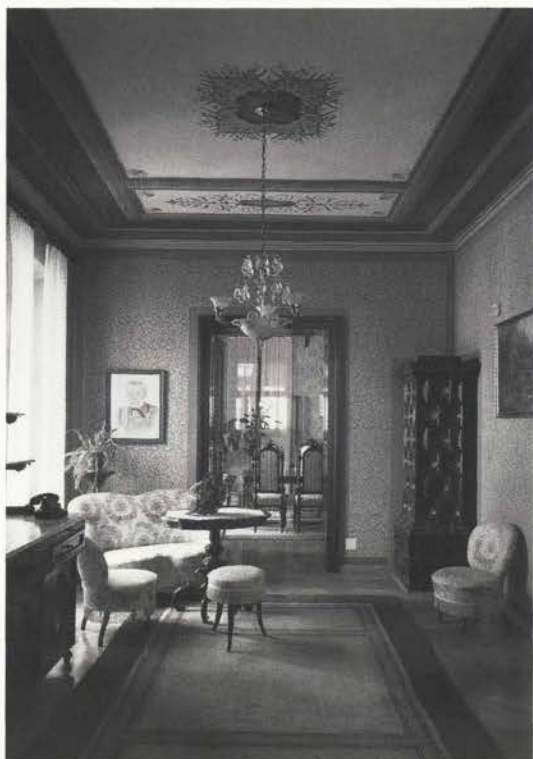
View of the renovated drawing room. "Through this room the route leads to Hribar's former study, now the session room..."

The second phase of the restoration comprised the reconstruction of the painted walls on the first floor. Fireplaces were

partly moved and are no longer usable. Numerous items of furniture were cleaned, repaired and freshly varnished. For the altered function of the session room additional copies of existing chairs were made. Unfortunately, it was not possible to replace all the original holiday furnishings of the house which were cheap, yet had created a more intimate atmosphere of the place. Thus the striped shutters and Bosnian carpets are missing, since they were beyond repair. Books, china and other more valuable articles had been removed by Hribar's heirs before the renovation. The restoration of the plastered in electrical wiring proved too demanding for the contractors.

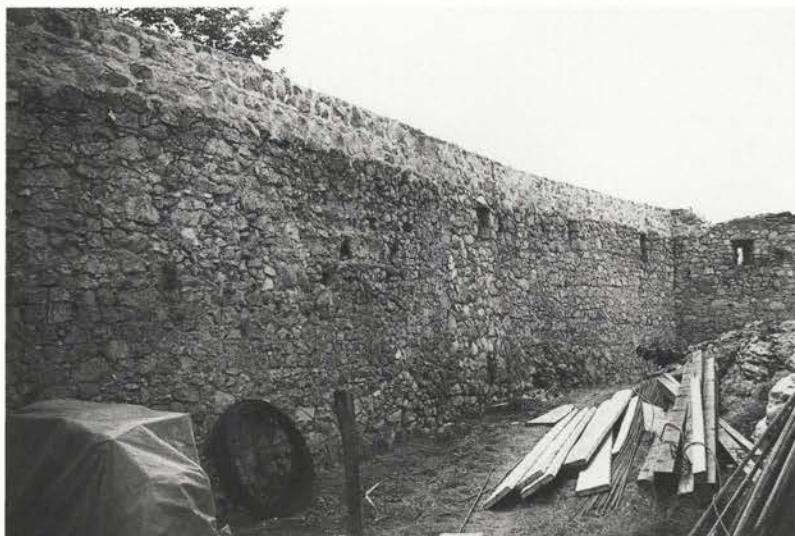
Stronghold walls before the reconstruction of the wooden defence parapet. "On account of scarce financial resources the efforts to prevent the best preserved stronghold complex in Slovenia from deterioration have been limited to the most necessary cleaning and maintenance works for years."

On account of scarce financial resources the efforts to prevent the best preserved stronghold complex in Slovenia from deterioration have been limited only to the most necessary cleaning and maintenance works for years. They were directed first by the architect Špelka Valentinčič Jurkovič and afterwards by Dušan Kramberger, the initiator of photogrammetric measurements undertaken in 1994.

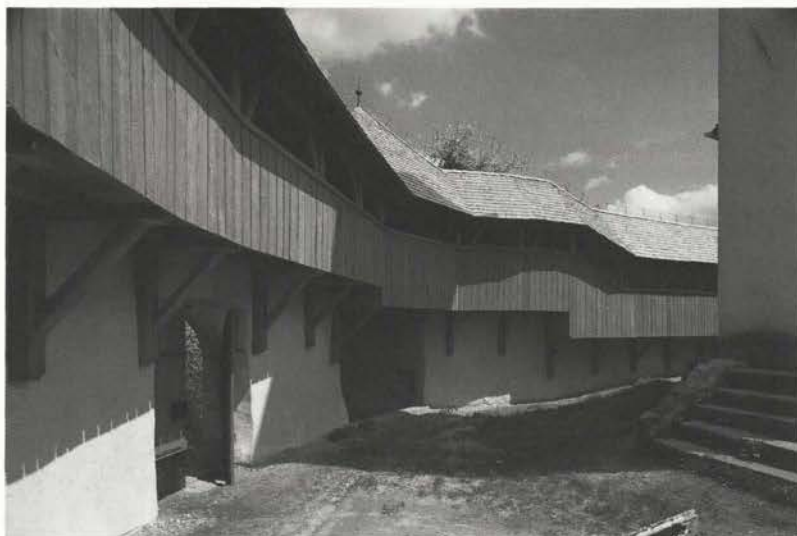
Reconstructed wooden defence parapet. "For the reconstruction of wooden elements the remnants were compared with the preserved or already renovated strongholds in Carinthia and both the rebuilt strongholds in Slovenia..."

An exact copy of the existing state of the complex was made on the basis of photogrammetric measurements. The knowledge of the original appearance of the stronghold by means of preserved architectural elements was completed by archaeological research, through which new stone-built foundations of three rectangular granaries of approximately the same size were discovered in the eastern part, apart from the original walkway within the stronghold walls. The paving has been preserved in the end granary in the south.

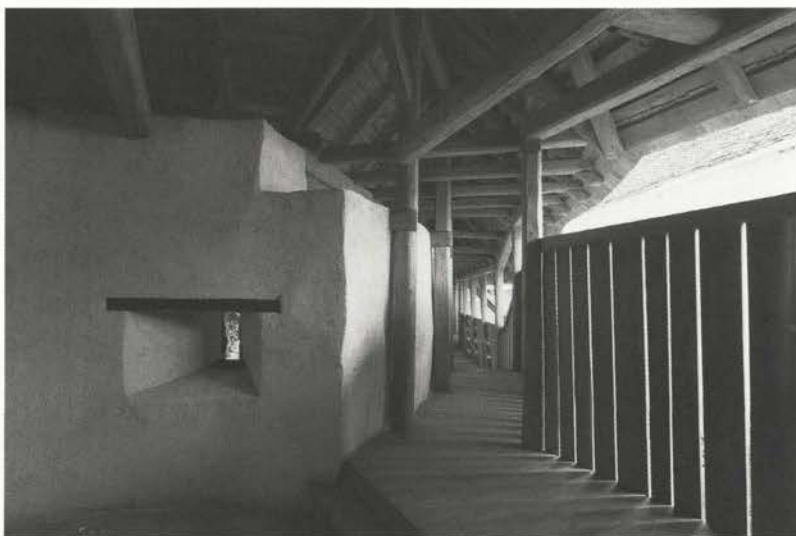
View along the wooden defence parapet. "The starting-point for the preservation and reconstruction of the entire walls was the well-preserved embrasures on different levels..."

different levels. Two basic types of wooden defence parapet were established on the basis of architectural elements: the lower one along the set of embrasures on the first floor of the eastern and southern walls, and the upper one above the embrasures positioned on different levels of the northern and western walls. The entire wall was heightened on the basis of analogies and valid proportions. The walls above the higher part without embrasures were completed by a wooden projection on cantilevers with embrasures. The existing parapets of other preserved strongholds served as examples for the reconstruction. The parapets were protected from the inside by means of high panelling and are now accessible from wooden leaders. The foundations of the granaries were restored and presented on the ground level. The end granary in the south was covered with a roof extended from the roofing of the defence parapet.

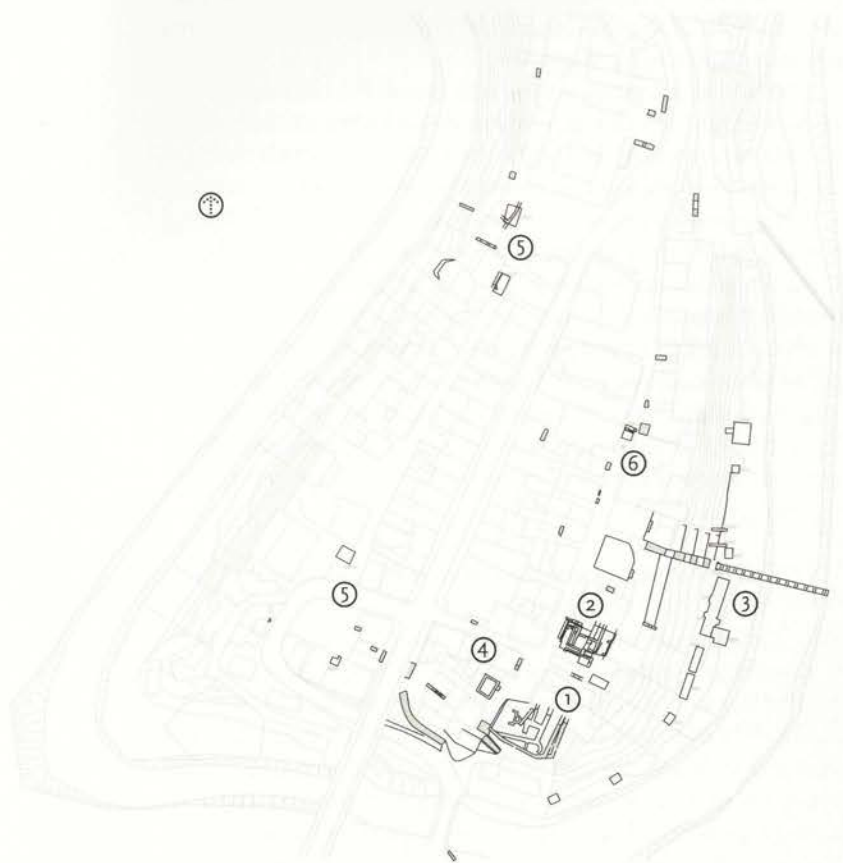
▲ Archaeological sites: 1 the church of the Holy Spirit, 2 the Pastoral Centre, 3 bank of the river Lahinja, 4 Špelič house, 5 Na Utrdbah Street, 6 Miran Jarc Street (Scale: 3mm = 10m)

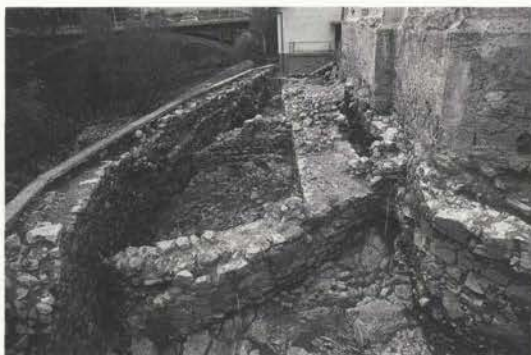
Archaeological excavations on the prominence of the church of the Holy Spirit. "The town prominence was resettled during late Antiquity, when a dense settlement was established at the end of the 4th or beginning of the 5th century..."

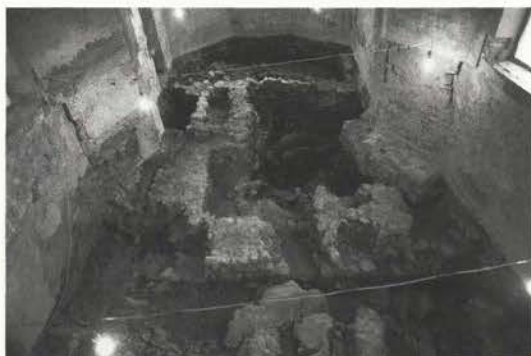
Protective excavations in the church of the Holy Spirit. "At that time a late Gothic church was built at the Holy Spirit site, which was first recorded in 1487 at the location of a former house..."

The excavation site of the church of the Holy Spirit yielded the best data of this settlement. It contained fortification walls built of stone and mortar with a round tower in the south-eastern corner. The pavement in the tower was of clay and sand and a fireplace was located to the east of the entrance. Fortification walls built of stone and mortar were found in the eastern part of the Pastoral Centre site. They were located in a south-north direction and had disappeared beneath the present rectory. A rectangular tower leaned on the eastern, external side of the fortification walls. The surface of the most recent building material in it had apparently functioned as a pavement, although no traces of a settlement layer or a fireplace were found.

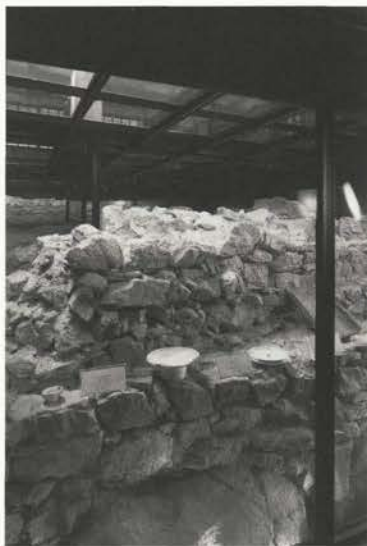
Presentation of archaeological finds in the Pastoral Centre. "The former cellar from the late 15th century was turned into a gallery for visitors on the original level in front of the late Antiquity walls to the west where a small selection of late Antiquity artefacts made of ceramics and stone is exhibited..."

The Pastoral Centre was selected as the ideal place for the presentation. It contained coherent remnants of buildings from late Antiquity, as well as mediaeval and late mediaeval periods in a relatively small area. The remnants were cleaned and strengthened. The necessary interventions were minimal since no direct public access to them is available. They are displayed beneath the ground floor of the building, which partly consists of glass slabs with special heating so as to ensure proper maintenance of exhibited remnants and to prevent the deterioration of their visibility on account of humidity. The remnants not directly exhibited were indicated in the structure of the floor on the ground floor. The former cellar from the late 15th century was turned into a gallery for visitors on the original level in front of the late Antiquity walls to the west, where a small selection of late Antiquity artefacts made of ceramics and stone is exhibited. The town wall from the late 15th century on the eastern side of the cellar was protected by glass walls. Thus an exhibition room was created for smaller finds from late Antiquity burial grounds and for the ceramics from the late mediaeval phase of the Pastoral Centre site itself. The information board with an explanation of the presentation and its position within the broader context of Črnomelj is located at the southern end of the cellar gallery. The presentation has observed modern principles for the presentation of archaeological finds in urban surroundings.

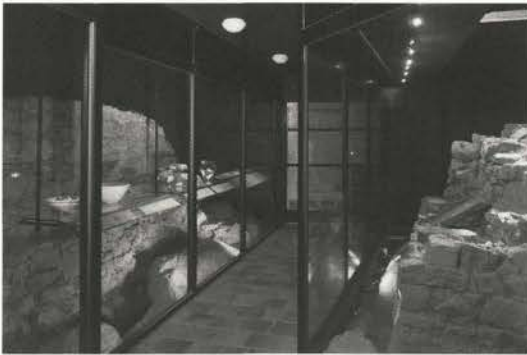
Presentation of archaeological finds in the Pastoral Centre. "The Pastoral Centre was selected as the ideal place for the presentation..."

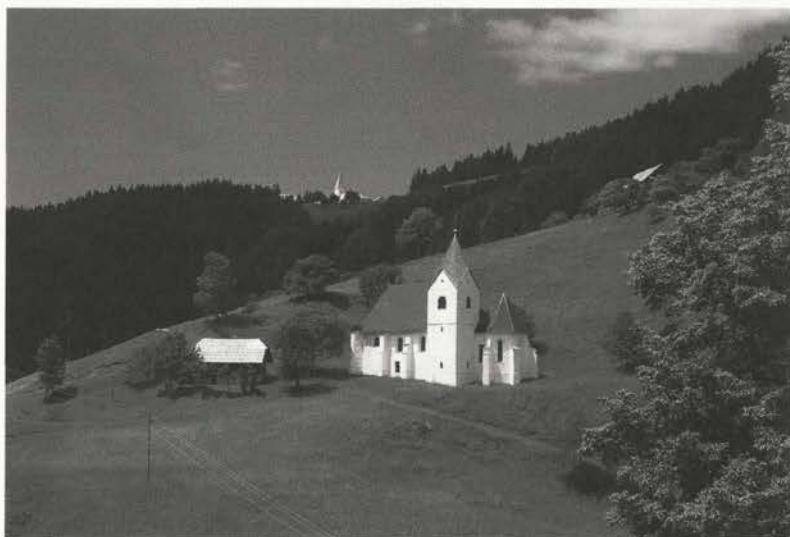
- ▲ View of the renovated church of the Holy Spirit. “There is a thick-set bell-tower at the juncture of the nave and the presbytery on the southern side...”
- ◀ Wooden painted ceiling before the renovation. “On account of moisture permeation, microorganisms and other physical damage the wood had severely rotted...”

During her writing of the book *Painted Wooden Ceilings in Slovenia* Dr. Nataša Golob had established, as early as 1984, that the ceiling was greatly endangered on account of the instability of the church architecture and partial decay caused by the damaged roof. In September 1992 the church was stabilized and the rifts between the ceiling boards had no longer increased, yet on account of moisture permeation, microorganisms and other physical damage the wood had severely rotted, putrefied and become brittle and breakable. The adhesive had disintegrated, the layer of colours had faded or been completely washed out. In the south nave the ceiling had slanted by 20-30cm, while the ceiling in the north nave completely rotted due to soaking.

inspection Dr. Nataša Golob proposed the procedure of the restoration, namely the removal of all the boards of the ceiling and choir and their subsequent cleaning, impregnation, restoration of the ornamented painting and final replacement. Yet the beginning of the restoration clearly showed the impossibility of restoring the original state of the ceiling through conservation only. Therefore the decision to perform the reconstruction of the entire ceiling was taken, with the exception of the choir banister and the ceiling above the choir.

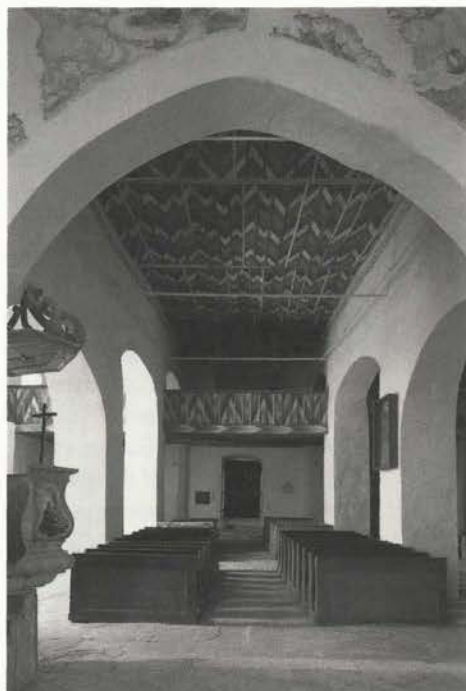
View of the main nave with the reconstructed wooden ceiling. "The ceiling is, according to its superficies, the largest painted wooden ceiling in Slovenia..."

With the exception of the painted ceiling there were no conservational dilemmas in the restoration, since through the centuries the church had not experienced substantial transformations that would have radically altered its primary form of a three-nave basilica. Therefore only the key restorational issues in the renovation of the painted wooden ceiling will be presented here.

The original paint was best preserved under the covering boards, therefore the reconstruction followed the model of the colours there and the copy of the ceiling at a scale of 1:1. That was the only possible method of copying the original with all its faults committed by the original artisans. The signed and dated cross-boards located between the second and third sections in all three naves were impregnated, strengthened, and finally replaced as documents of their time.

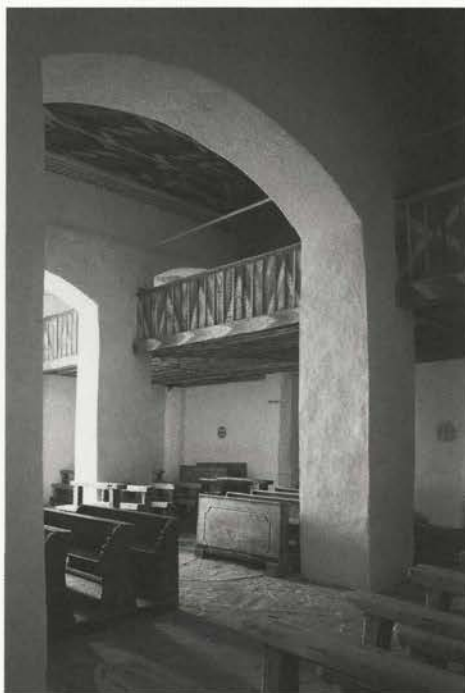
View of the renovated wooden choir. "Therefore the decision to perform the reconstruction of the entire ceiling was taken, with the exception of the choir banister and the ceiling above the choir..."

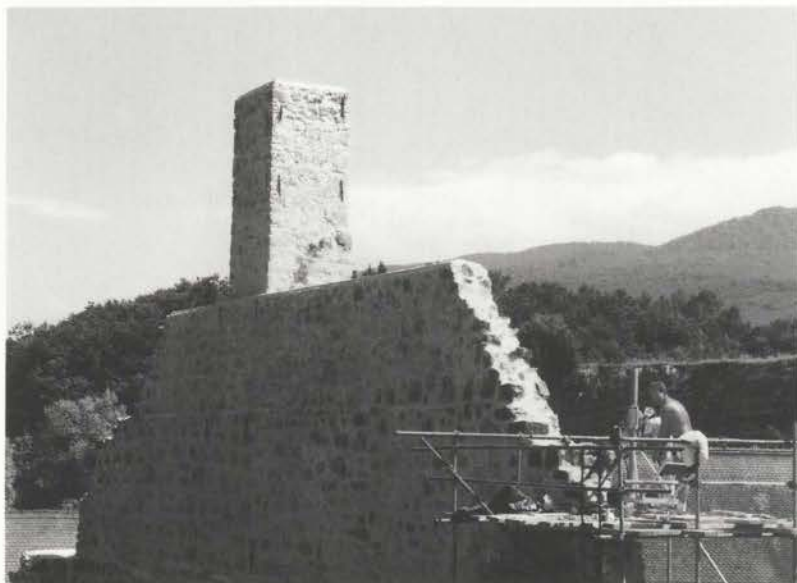
Renovation of the north wall. "In 1994 the second phase of the renovation of the former ironworks took place..."

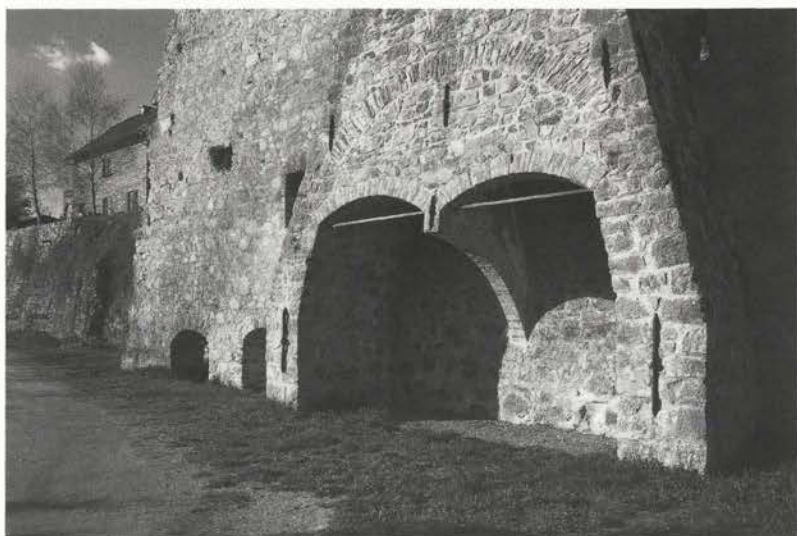
Renovated remnants of the chimney stack of the furnace. "The decision was taken to renovate two brick arches with primarily structural functions on the lower part of the wall..."

Badly damaged arches above the windows and doors were

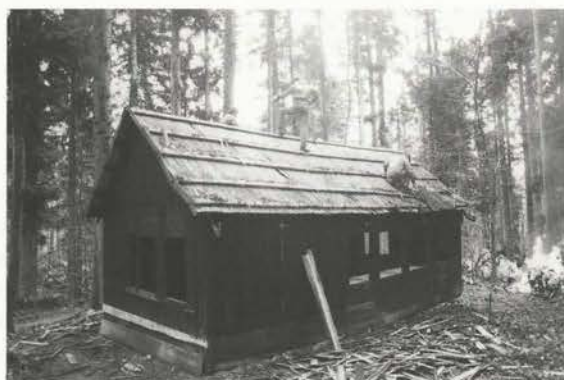
Hut No. 16 during the renovation. "The decision was reached to make a three-layered shingle roof which was more resistant than a double-layered one..."

The first renovated building in that period was No. 16, called the hut of “propagandists”. The building itself was not in a critical condition, yet the decision for its restoration was reached on account of its selection for the presentation of Base 20 as a museum. First the architectural topography of the building was performed and the interior and exterior were photographed. The work could only be planned in general terms since the exact conditions of the building and the damage could only be established during renovation. The replace-

ment of the roof as a whole was planned since the hut was one of the buildings with a double roof. Several years ago the shingle roofs in Base 20 were protected in such a way that additional boards were hammered on the existing covering and a new layer of shingles placed on top of it. Such roofs offered ideal conditions for microorganisms and sheltered small rodents. After the removal of the covering it turned out that the roof construction was in good condition and its replacement was not necessary. The construction was only cleaned and protected with wood preservatives. Subsequently battens were placed on the construction and new shingles on top of them. The decision was reached to make a three-layered shingle roof which was more resistant than a double-layered one. The treatment of the external walls of the building took place simultaneously. The external panelling was cautiously removed and the decayed parts of the supporting structure were replaced by new ones. Old, still well preserved panelling boards were re-used where possible. Windows and doors were removed and repaired, and one window frame was replaced by a new one manufactured by the carpenter according to the original. Inside the hut all the boards of the old museum presentation of Base 20 were removed. The walls and floor were cleaned and

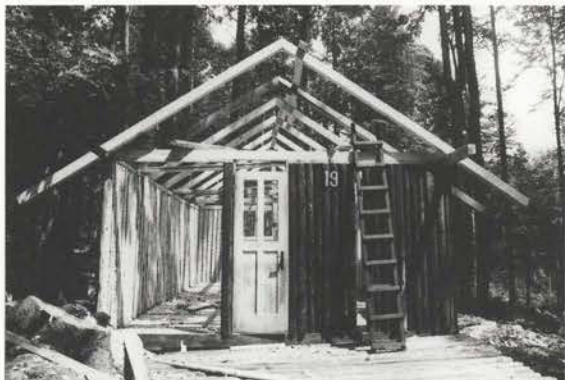
Hut No. 19 during the renovation. "In January 1995 a tree uprooted by strong wind leaned on the hut..."

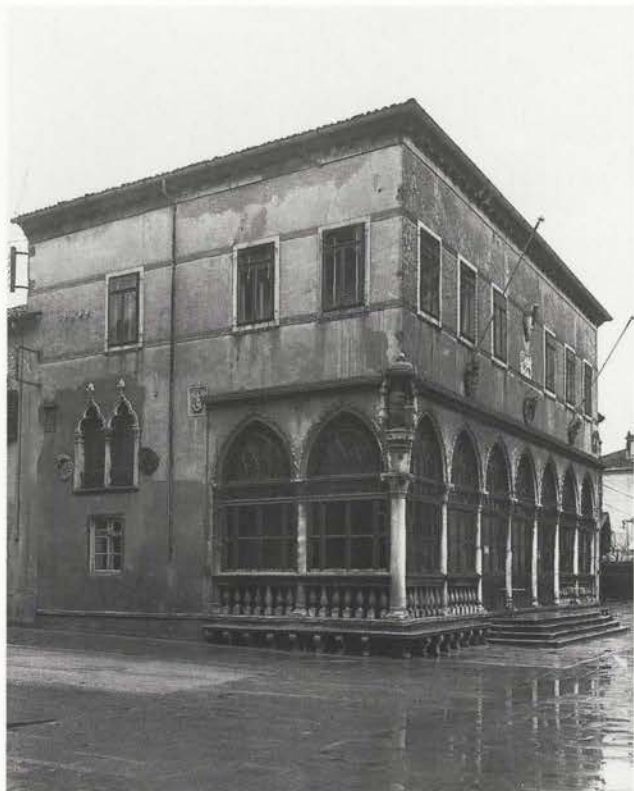
Loggia in 1935. "The adaptation was most thorough in 1846 when the Gothic arched vaults were closed by wooden frames as part of the rearrangement of the interior..."

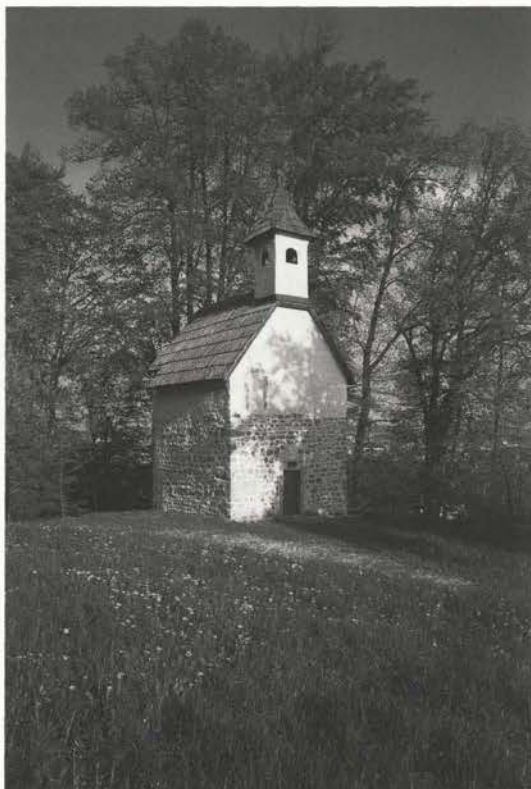
The chapel of St. Peter after the renovation. “Before architectural research the chapel created the impression of a Renaissance building with some Gothic elements. The Romanesque core was discovered only after the removal of the plaster...”

Before architectural research the chapel created the impression of a Renaissance building with some Gothic elements. The Romanesque core was discovered only after the removal of

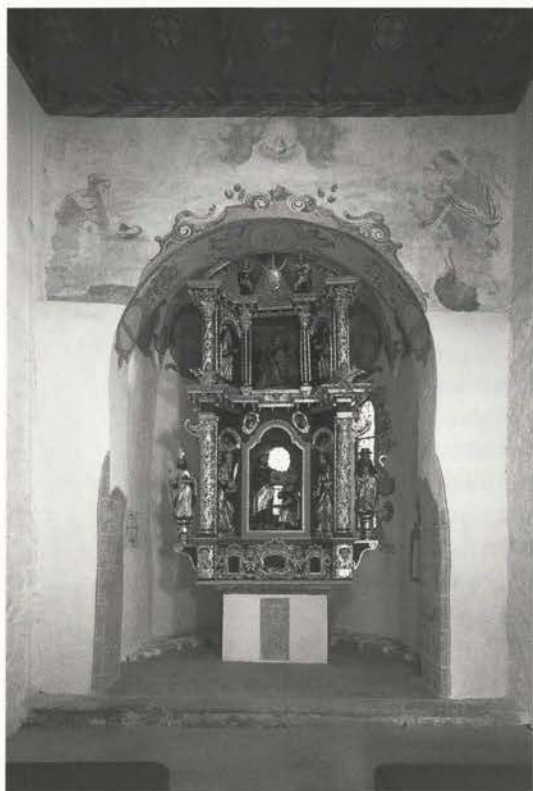
View of the main altar.  
"The presbytery was occupied by the altar consecrated to St. Peter, protector of the chapel..."

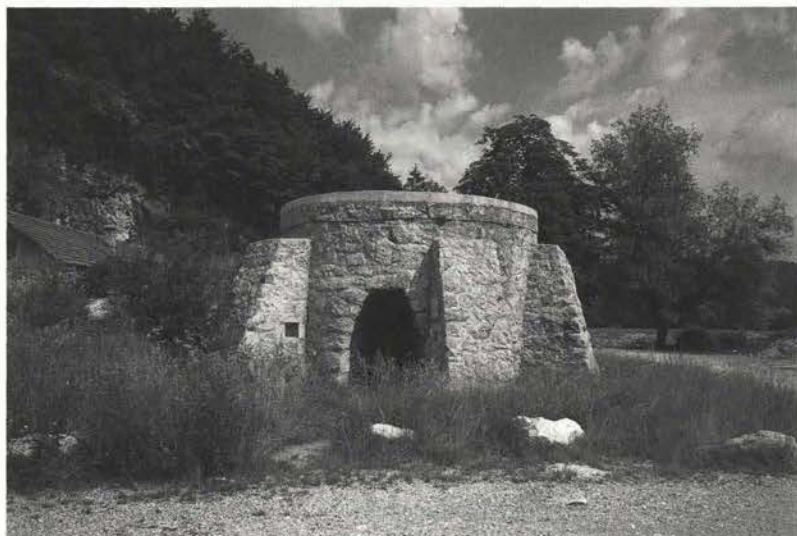
Renovated lime-kiln in Podutik. "There were usually five lime-kilns readied for operation every year. The production increased after the earthquake in Ljubljana at the end of the previous century..."

The structure was in a bad condition. The roof had been re-

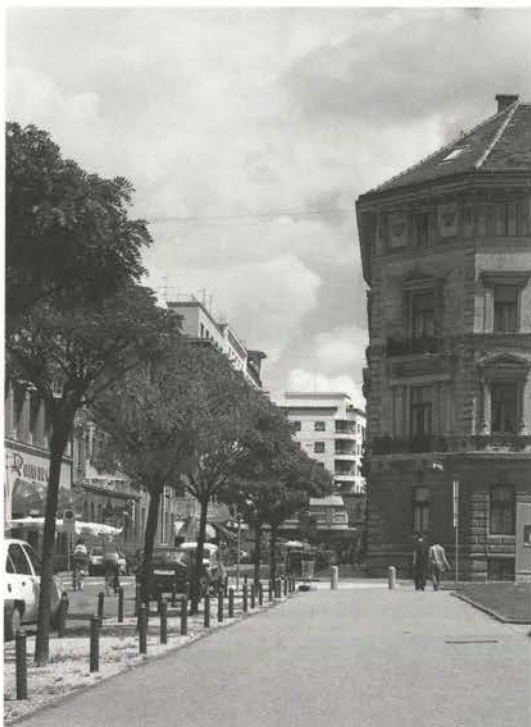
Renovated avenue along Cankarjeva Road. "The southern side of the avenue was replaced in 1990..."

in successive parts. After 1988 old trees have been gradually removed and replaced with new ones. The last part was replaced in 1997 in the area of the House of the Nation, which had been planted first. Steel poles as bollards were erected on the edges of the sand surfaces to protect them from parking. The avenue is regularly trimmed every year and damaged trees are replaced so that in ten years of gradual reconstruction the proper appearance of the avenue will be achieved, similar to that in the photographs of 85 years ago.

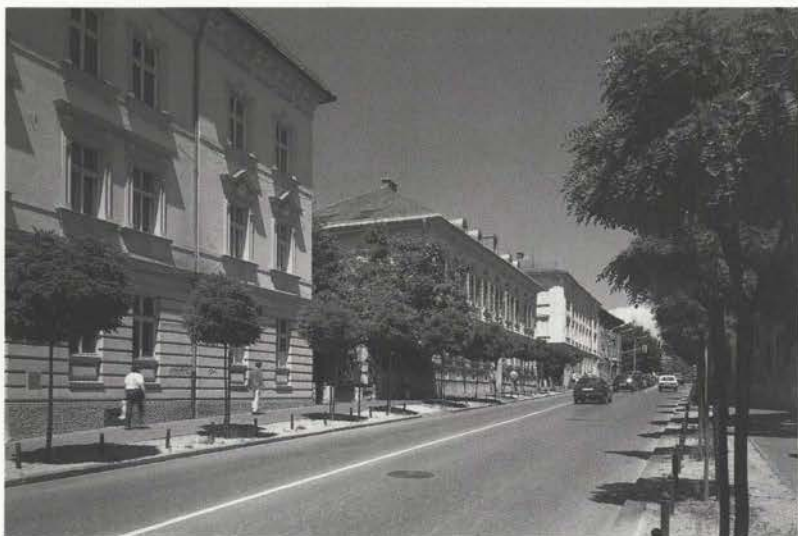
Renovated avenue along Resljeva Road. "The birches were removed in 1991 and replaced by the original variety of ball-shaped robinias along both sides of the street..."

original variety of ball-shaped robinias along both sides of the street from Trubarjeva Road to Komenskega Street. Parking between the trees was prevented by steel bollards. In the sixties the rest of Resljeva Road was planted with lime-trees and beech trees. The trees are still well preserved, and consequently the entire avenue will only be replaced with ball-shaped robinias in case of deterioration.

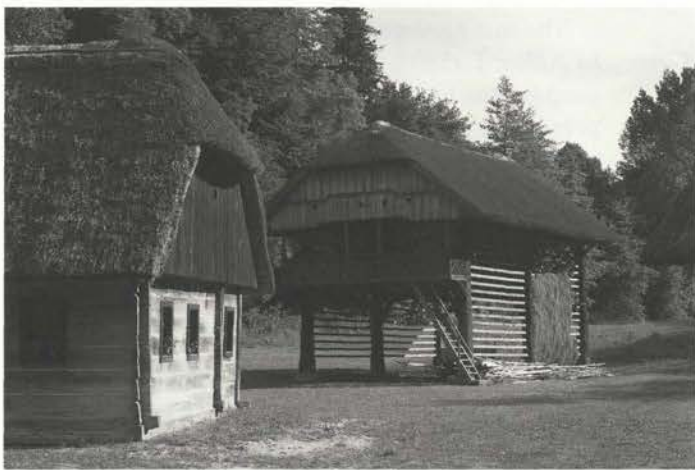
The Banič house with a hay-rack in the background. "In 1992 the possibility turned up to transfer the Banič house and reconstruct it.."

the Banič house, reconstruct it in its former height in relation to its surroundings and to renovate its roofing joinery and the thatched roof. As a consequence the missing part of the house was left open and visitors can rest there. The internal division into rooms was basically preserved. The entrance to the closet and one of its walls were reconstructed. The room will serve as the director's office and a souvenir shop.

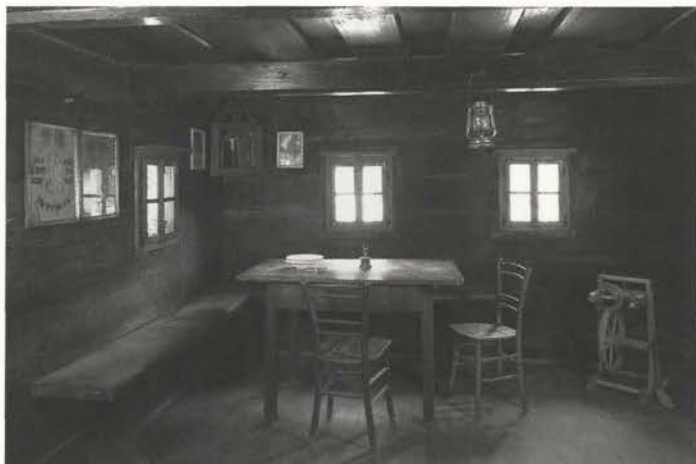
Main room (the so-called "great house") in the Kegljíč house. "Little furniture was preserved at the time of the dismantlement of the house..."

Existing materials were respected to the utmost during the dismantlement, transfer and reassembly of the buildings. All necessary reconstructions were performed on the basis of existing documentation and individual component parts that were no longer usable. Most of the material was successfully preserved in the case of the Kegljíč house. The entire wattle vault or "šija" of the black kitchen was successfully transferred. The bread oven was reconstructed with the material matching that at the original location. Only the internal vault was built of new brick, so that the oven could still serve its purpose. The concrete floor in the hall including the black kitchen was replaced by a brick one. The wooden floor and the windows and gables of the house were renovated and reconstructed on account of their dilapidation. The cellar floor made of trodden earth was renovated as well. The rooms were furnished with proper household items. Little furniture was preserved at the time of the dismantlement of the house, therefore the missing furnishings had to be documented, found and purchased from the inhabitants of neighbouring villages. The administrative office of the open-air museum was erected next to the Kegljíč house, as planned.

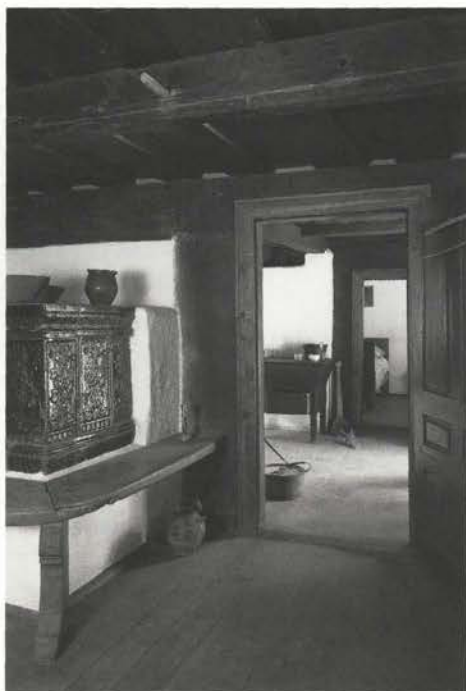
View of the interior of the Kegljíč house. "Most part of the material was successfully preserved in the case of the Kegljíč house..."

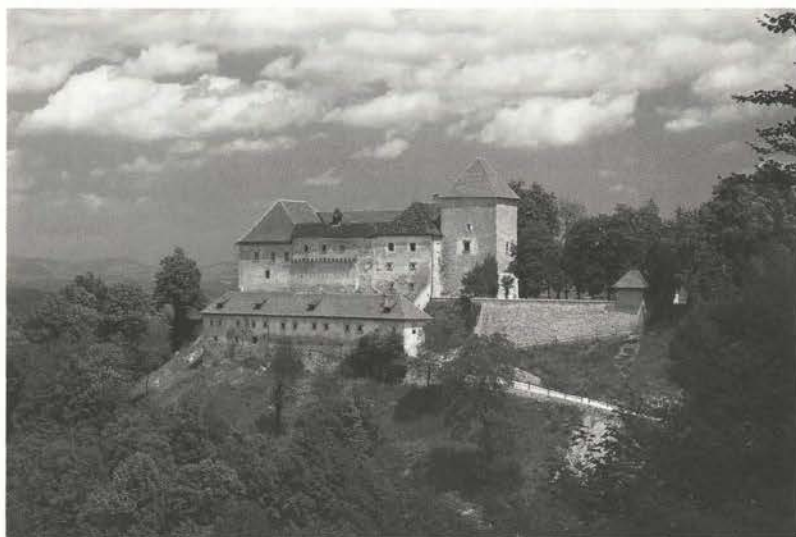
View of Podšreda castle. "The abundance of valuable Romanesque elements offered an exceptional opportunity for the renovated castle to become a model of the mediaeval chivalric castle..."

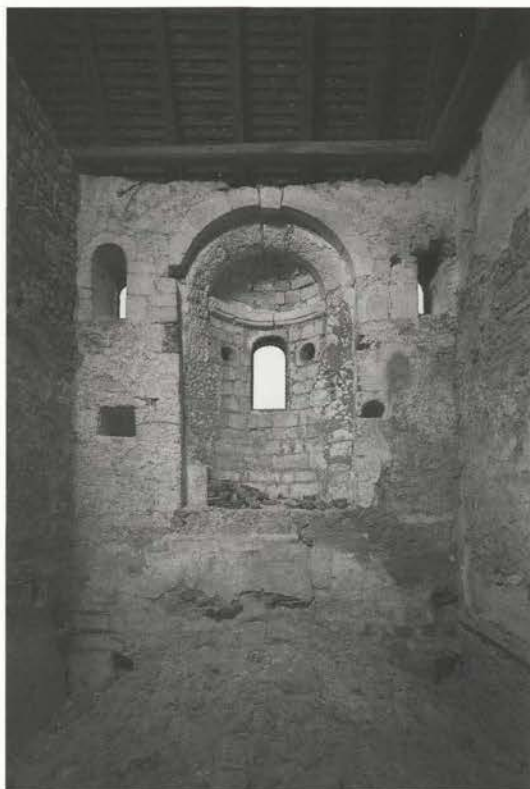
Romanesque chapel. "...the planned programmes anticipate further reconstruction of the most eminent Romanesque elements of the castle (the bergfrid with a wooden gallery and a two-level chapel)..."

In those cases where the planned interventions will not harm the architectural elements from former historical periods the planned programmes anticipate further reconstruction of the most eminent Romanesque elements of the castle (the bergfrid with a wooden gallery and a two-level chapel) in accordance with current methods of conservation. This means that all subsequent interventions will be performed in such a way that realized decisions concerning the conservation could be corrected or reversed at any time so as to re-establish the original state of affairs before the beginning of the renovation. Thus a neo-Gothic gallery was hidden by a reconstructed timber

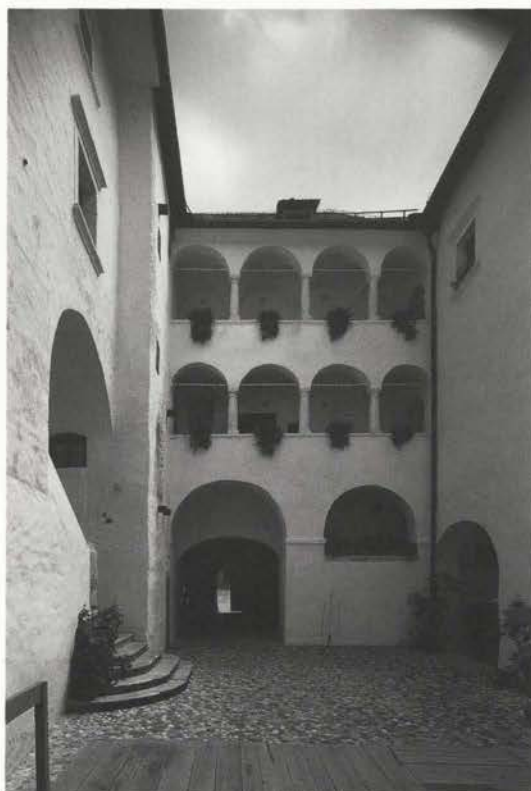
Courtyard of the castle.  
 “Thus a neo-Gothic gallery was hidden by a reconstructed timber framed wall in the upper part of the arched corridor next to the northern mansion...”  
 .....

framed wall in the upper part of the arched corridor next to the northern mansion, so that the gallery can be re-opened any time and presented in its proper renovated condition.

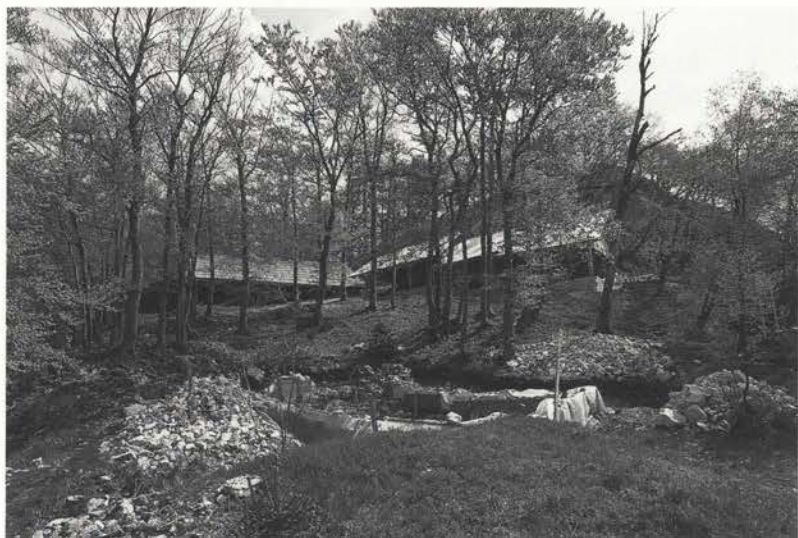
Archaeological excavations in 1996. "Intense investigation of settlements of that period discovered the exceptional range of changes in the settlement picture of the south-eastern Alpine region..."

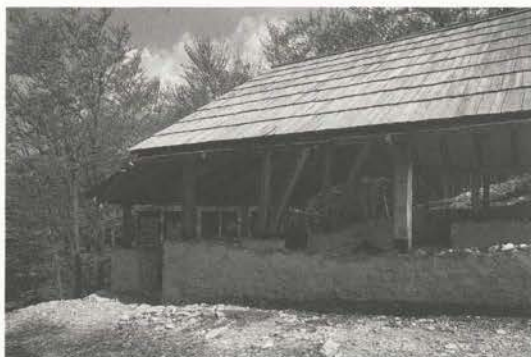
Presented remnants of the old Christian church. "The church was presented to such an extent that it can again serve its original purpose..."

Physical and chemical analyses of old mortar were performed before the beginning of the restoration, and the most appropriate sand quarry was selected in the neighbourhood on the basis of the results. An experimental wall was subsequently built at the location and various kinds of mortar were used for it. After a year of observation the decision was taken to strengthen the interior of the original walls with concrete and to use the so-called extended mortar on the fronts. New foundations were made for the structures of late Antiquity and drainage was fixed around them to prevent humidity and consequently frost. The better preserved fronts were thoroughly cleaned by jets of water, and the incisions between the stones were refilled with new mortar. Less visible fronts were copied on plastic films at a scale of 1:1 and subsequently dismantled. The interior of the walls was cleared of humus, roots and disintegrated mortar. Visible parts

of the walls were subsequently reassembled so that each stone was placed in its original position, precisely according to the drawing on the film. The interior of the wall was filled with concrete, and horizontal and vertical ties were inserted into it connected with the ties in the foundations. The crown of the wall was heightened a little, which prevented the crumbling of stones from the original parts of the wall, and metal supports for the roof connected with ties were installed into it. The construction of the roof was calculated for extreme weather conditions and its material (shingles) was adapted to the surroundings so that the heightened part would function as an independent extension, and not as a reconstruction of the original roof that was not known. The floor in the church was restored with the discovered original technology. The bench for priests and the altar were only cleaned and strengthened with new mortar. All works were thus performed in accordance with the basic principle: to preserve the utmost authenticity and simultaneously to secure the maximum strength of historical structures.

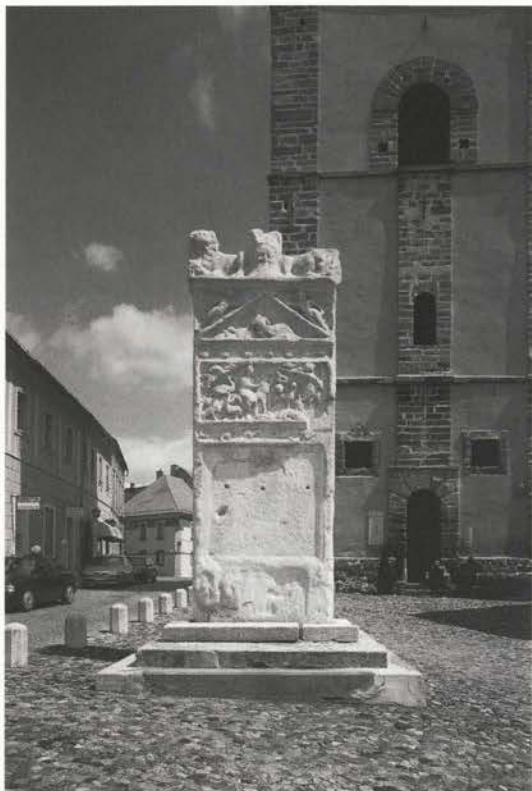
The Orpheus Monument.  
“Part of the so-called  
Povoden open-air lapi-  
dary...”

There were some attempts at the restoration of the monument during recent decades and some works, the purpose of which was to restrain the irrepressible decay of the monument that Peutinger reported five hundred years ago, Felsner a century ago, and Abramić seventy years ago. Unfortunately, the documentation of these interventions was inaccessible and on account of that it was impossible to evaluate the performed work. Members of the Institute for the Protection of Natural and Cultural Heritage of Maribor could only establish that the monument was in a very bad condition, since individual layers scaled off and the rough marble grains crumbled.

The black crust of dirt had to be removed first with particular care so as not to damage the monument. Various means were used for that. The most damaged parts were subsequently protected so as to stop the disintegration of the surface. Artificial resin was injected deep into the rifts, equal to the one subsequently used for the protection of the surface.

Architect Giancarlo Calcagno,<sup>11</sup> entrusted with the restoration of the monument, used the vacuum technique for strengthening cracked layers so that the artificial substance would penetrate down to the undamaged base of the monument and thus restore its firmness. The performed measurements according to which the hardening agent penetrated to an average of 5.93cm proved that the aim was achieved.

In the final stage the monument was sealed with stainless bungs and epoxy resin, hollows and rifts were retouched so as to minimize the surface exposed to the rain and the surface was coated with a waterproof layer that would not turn yellow or create an impermeable film.

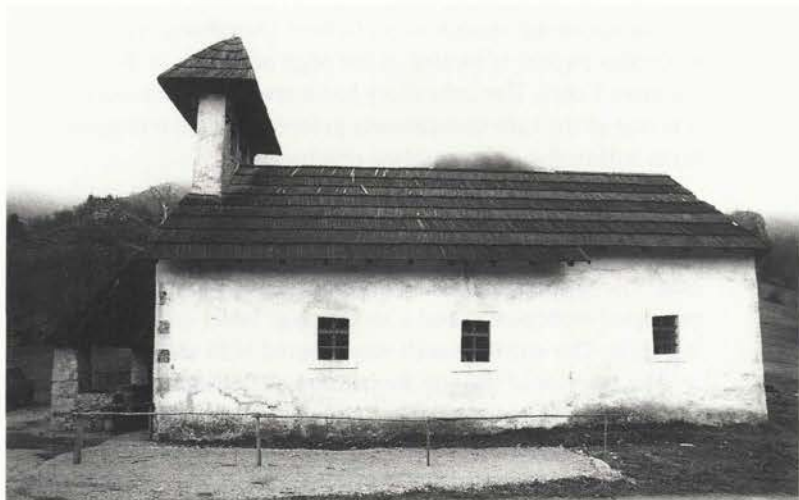
Church of St. Gilbert before the restoration. "The decayed roof covering was the cause of the exceptionally bad state of the succursal church and had seriously endangered the architecture and the furnishings of the church..."
