The European Heritage Days Cultural Routes 1999 Guide to Monuments

# Contents

## Cultural Routes – The Cultural Trail Begins Right Here

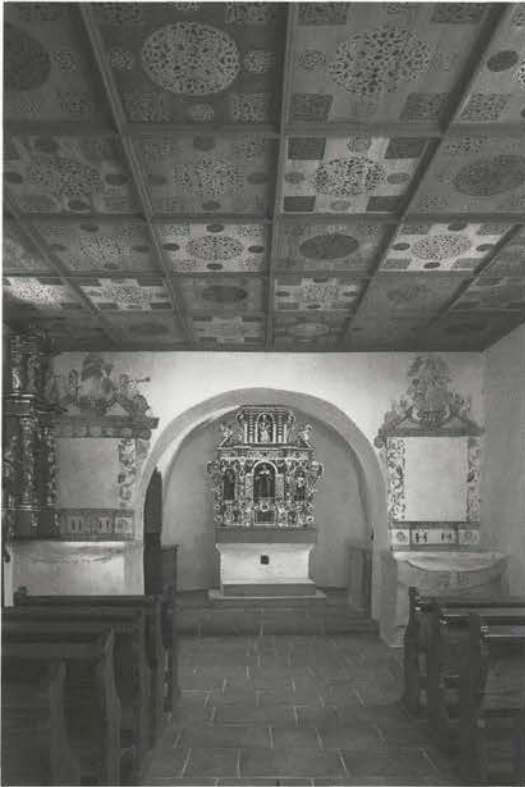
View of the renovated interior. "The building regained its original appearance of a stylistically homogeneous architecture from the turn of the 16th century..."

Between 1986 and 1991 basic restoration works were performed, which prevented further dilapidation of the church. The roofing above the nave and the presbytery was replaced and the tie against earthquakes was constructed in the attic.

The replacement of the decayed shingle roof followed, yet the original appearance as to the form of shingles and the method of covering was preserved. Before the beginning the wooden coffered ceiling was removed and brought to the restoration studio, together with the wooden pulpit and the northern side altar consecrated to St. Barbara. A new supporting wooden ceiling was constructed in the nave as the foundation for the coffered ceiling returned to the church in 1988. The foundations of the southern wall of the nave were strengthened with concrete dur-

The drainage installed along the northern wall at the beginning of the renovation proved insufficient to remove humidity from the church. Therefore a new drainage system with an open ventilation shaft was constructed. Simultaneously the foundations of the nave were strengthened with concrete. The replacement of the roofing and roof covering of the belfry and the outbuilding concluded the basic restoration of the church as the basis for further renovation.

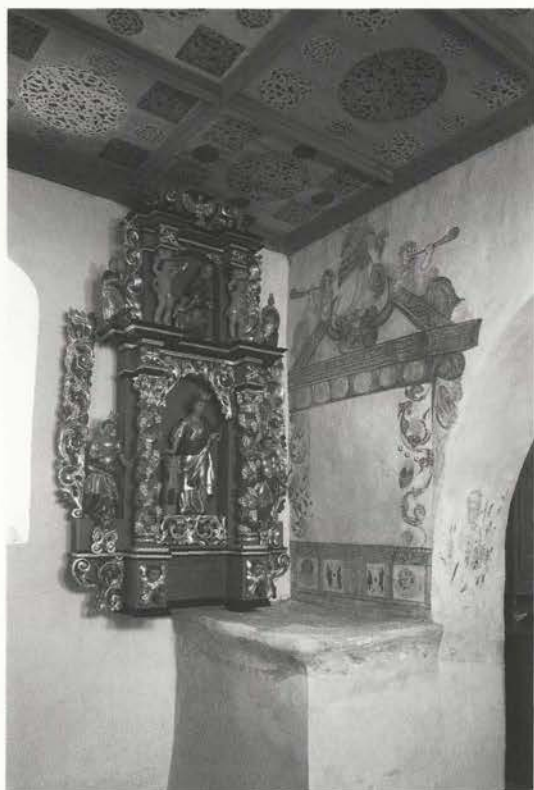
Altar of St. Barbara. “On account of the presentation of the altar architecture painted on the triumphal arch wall the golden Baroque altar was placed against the northern side of the nave...”

dows on the basis of preserved elements. It was possible to partly reconstruct and present four window openings, through which the building regained its original appearance of a stylistically homogeneous architecture from the turn of the 16th century. All the paintings in the interior and exterior were coated with preservatives, and subsequently the decayed plaster in the nave was replaced by a new one.

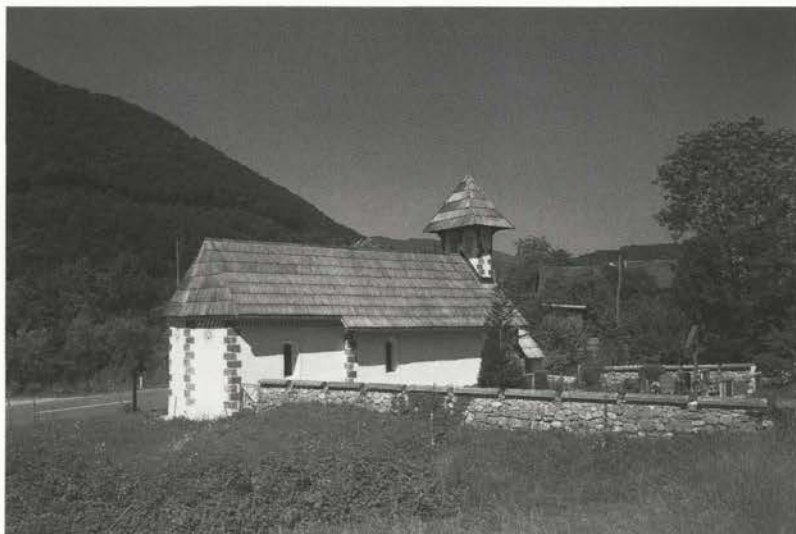
Renovated exterior of the church of St. Gilbert. "After several years of effort to preserve the church from ruin the restoration of the building was begun in 1986 by the Institute..."

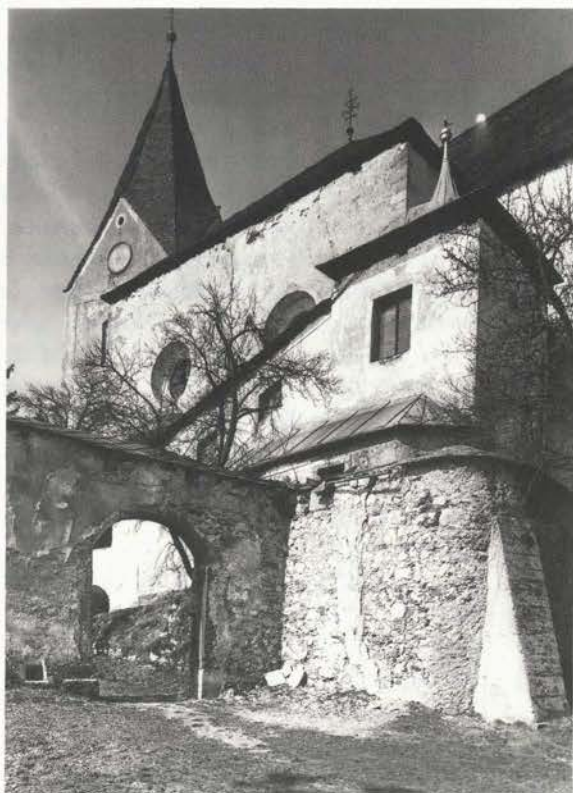
The church before the renovation in 1977. “The condition of the monument complex was critical particularly as far as the construction was concerned...”

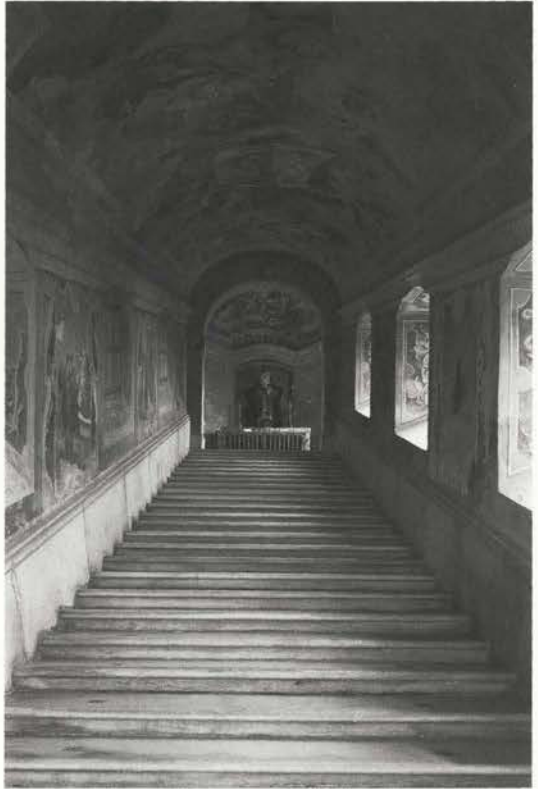
The holy stairs. "The frescoes were painted by the Baroque painter Anton Lerchinger in the seventies of the 18th century..."

technique, which produced a series of problems in the restoration: the physical opening of the paintings on the entire surface of the church, strengthening of hollow parts of the plaster with Casein glue, strengthening of coloured layers, filling the missing parts, and retouching. The same procedure was used for the ribs of the vault which were painted as well. The data gathered during the removal of the plaster were used for the reconstruction of the strip-shaped ornament executed in grey-white shades and burnt sienna. The removal of plaster on mouldings revealed remnants of polychromatism, yet insufficient for the reconstruction. An opening of an indefinite purpose was discovered in the north-western corner of the vault construction. It was subsequently closed and the plaster was deepened. There were no remnants of painting on the western wall, while there were clearly discernible traces of two rectangular openings. Another fresco of Mother of God in a frame made of coils was on the southern wall of the nave with

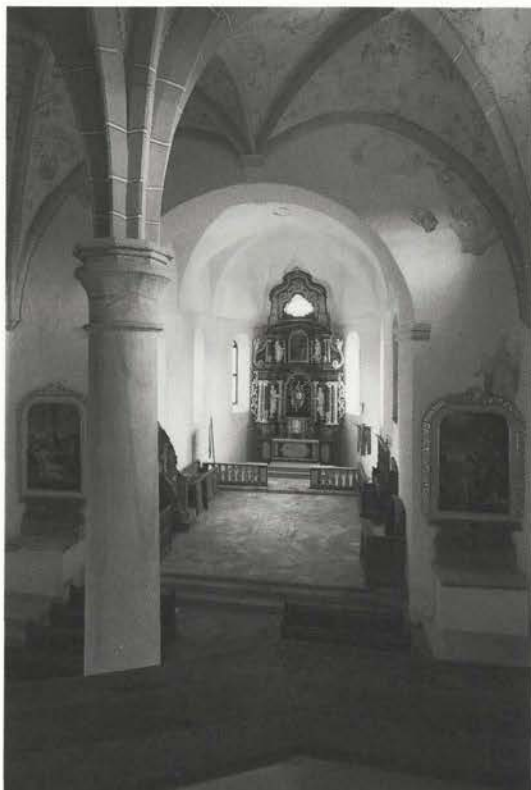
View from the nave to the presbytery. "The church of St. Pancras had undergone the greatest transformation during the Baroque period. A large presbytery was added to the uniform space of the chapel of Berthold the Patriarch..."

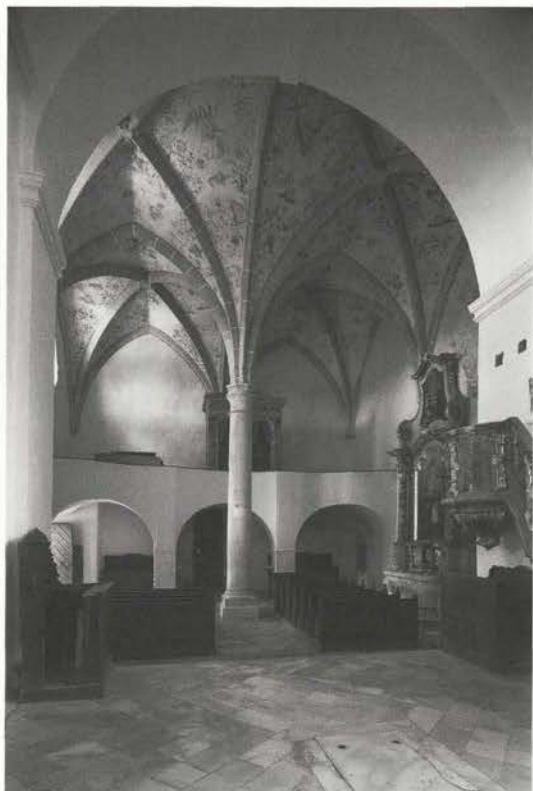
Central column with the cross vault of the nave. "Attention is drawn particularly to the central monolithic column as the bearer of the cross vault. A Roman column found in the ruins of the near-by antique settlement of Colatio was presumably used for it..."

The volume of the monument erected around the year 1240 differed from most monuments in the same cultural area created during the Romanesque period that were subsequently taken over and adapted in the Gothic style. Attention is drawn particularly to the central monolithic column as the bearer of the cross vault. A Roman column found in the ruins of the near-by antique settlement of Colatio was presumably used for

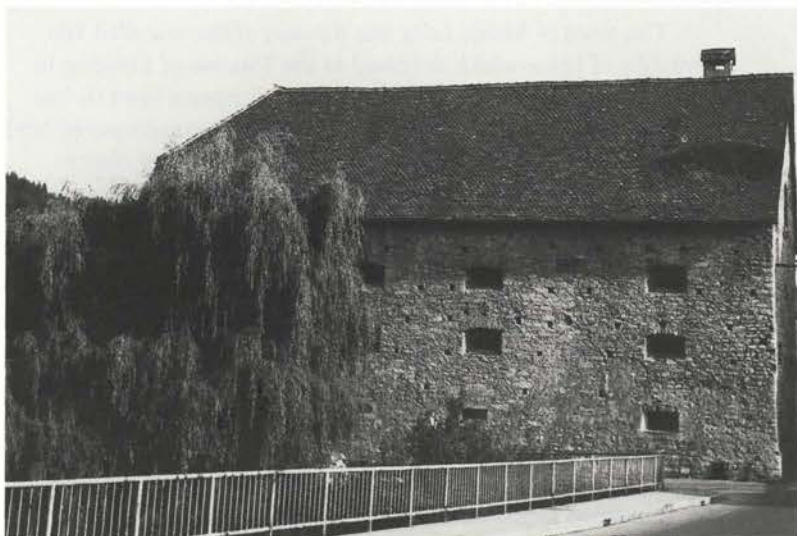
Exterior of the granary before the renovation. "The principal duty of the granary official was to ensure that bondmen paid their obligations regularly..."

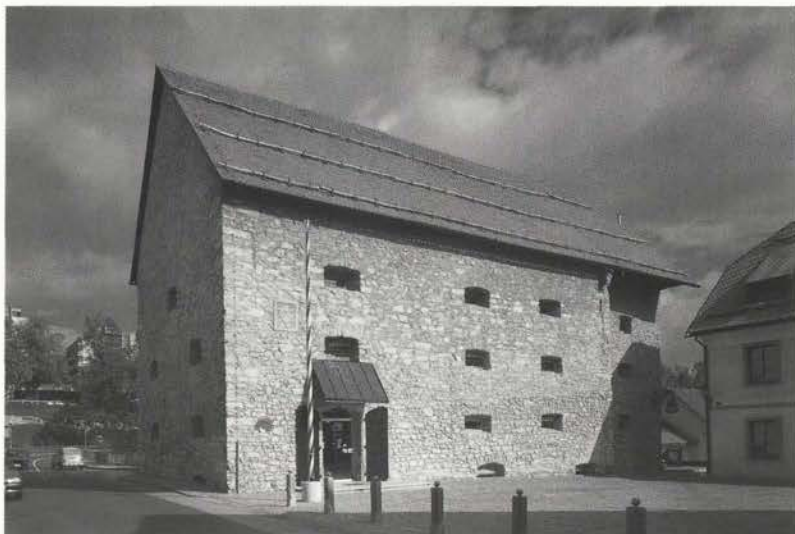
Exterior of the granary now. "The exterior of the building had hardly changed over the centuries..."

The exterior of the building had hardly changed over the centuries. The greatest changes took place on the eastern side: in the second half of the 18th century the town walls and the upper part of the defence tower were pulled down. The remnants of the tower were presented on the southern side beneath the eaves. According to the arrangement of the windows the stone portal from the 19th century presumably replaced the original entrance on the southern side.

- to preserve the stone-built construction without plasterwork,
- to preserve and restore all stone-cut details (windows, portal, reliefs),
- to present the preserved parts of the tower beneath the eaves on the southern side,
- to re-establish the original conditions of the western part by the removal of the staircase, the lift and the partition walls and thus unify the halls again. To restore the communication between the floors by the removal of the brickwork between them and by a new staircase, thus ensuring the openness of the former tower from the ground floor to the attic. The demand to preserve and restore all stone-cut architectural elements was also logical: the stone columns, window frames and consoles. All the timber beams were preserved as well.

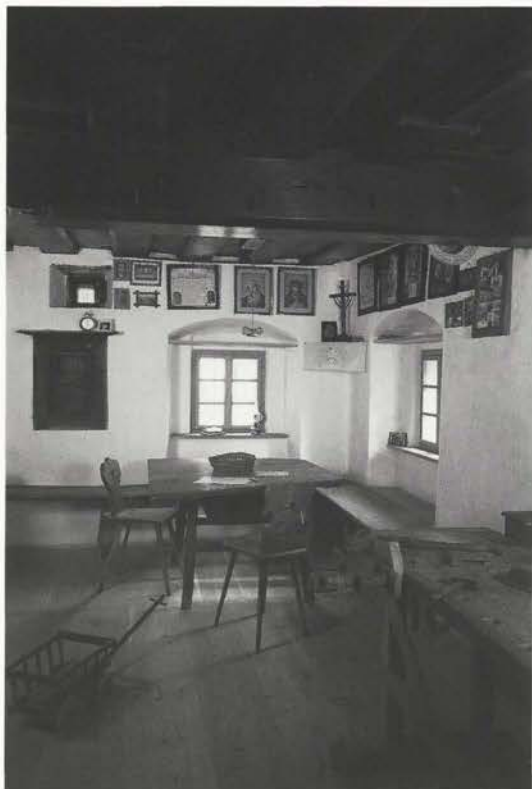
The "house" in the Pocar farm. "The year 1775 incised on the beam in the "house" probably marked the time the construction was completed or the residents moved into the new house..."

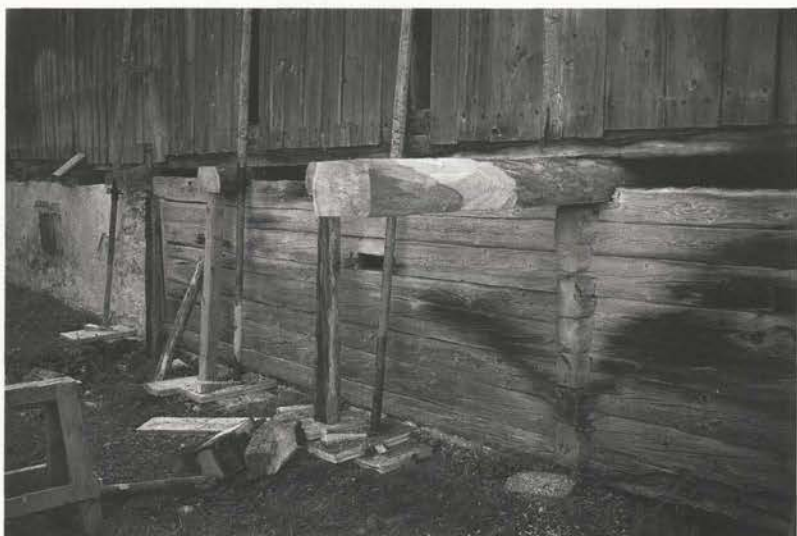
Renovation of the outhouses. "The walls of the hayloft were panelled with vertical boards fixed with wooden tacks to the beams of the supporting timber construction..."
