The European Heritage Days Series
Cultural Routes 2000 Guide to Monuments

THE EUROPEAN HERITAGE DAYS SERIES *concept by* JERNEJA BATIČ *written by* ANKA AŠKERC, UROŠ BAVEC, MAG. TADEJ BRATE, MODEST ERBEŽNIK, MAG. MOJCA GUČEK, IRENA KRAJNC HORVAT, DR. JOSIP KOROŠEC, MOJCA ARH KOS, SVJETLANA KURELAC, NIKA LEBEN, RENATA PAMIČ, DAMJANA PEČNIK, DARJA PERGOVNIK, ROBERT PESKAR, JUDITA PODGORNİK, JELKA SKALICKY, ANDREJKA ŠČUKOVT, DAMJANA PEDIČEK TERSEGLAV, ALENKA ŽELEZNIK *publisher* INSTITUTE FOR THE PROTECTION OF CULTURAL HERITAGE OF SLOVENIA, CANKARJEVA 4, LJUBLJANA, SLOVENIA *publishing executive* JANEZ KROMAR *editors* JERNEJA BATIČ, DAMJANA PREŠEREN *english translation* BARBARA SIMONITI *language editor* MARK ALEXANDER VALENTINE *photography* MIRAN KAMBIČ *designed by* ID STUDIO *main typography* SCALA & SCALA SANS, FS1 *other photographs, plans and sketches* ARCHIVE OF INSTITUTE FOR THE PROTECTION OF CULTURAL HERITAGE OF SLOVENIA, HISTORICAL ARCHIVES OF LJUBLJANA, NATIONAL MUSEUM OF SLOVENIA *printing coordinator* BOŽNAR & PARTNER *color reproduction* HIFI COLORSTUDIO *printed by* SCHWARZ 800 copies LJUBLJANA, MARCH 2002

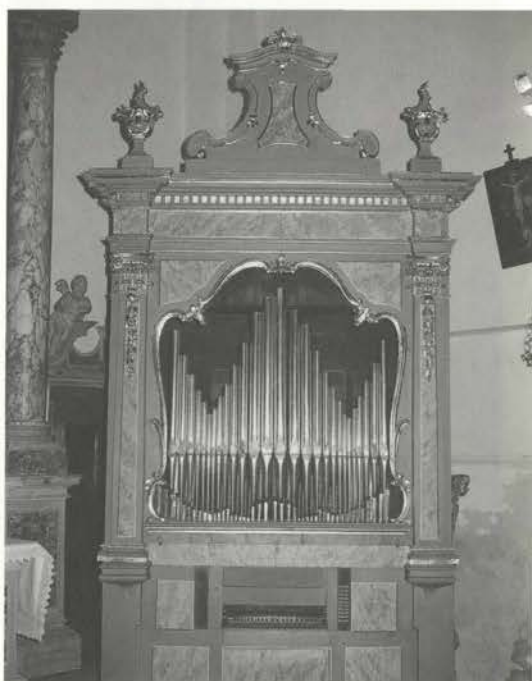
The positive with seven organ stops from the succursal church of the Virgin Mary of Alieto in Izola was built by an unknown Venetian workshop in the first half of the 18th century. The instrument obtained new prospective pipes made of zinc at the beginning of the Second World War. The condition of the instrument before the restoration demanded by the Inter-regional Institute for the Protection of the Natural and Cultural Heritage of Piran was relatively good in view of the area of the abandoned church. Despite humidity, the level of worm infestation was negligible; the keyboard was the most damaged part, apart from some damage to the metal pipes. Some of them were missing, together with the curtain covering the prospect. After a complex removal of the layer of dirt and varnishing the wood against pests, the damaged parts of the instrument were restored and the missing ones replaced: copies of the pipes were made according to the model of similar ones from the church of St. Anna in Koper. The organ was tuned and an electrical ventilator installed for working the bellows. The cabinet received a second coating of grey paint and the golden decoration that was bronzed were cleaned mechanically and using various solvents. It was established that the fields of the cabinet were originally covered with marmoreal painting and the remaining

polichromatism was of a light grey shade. Since there were hardly any remnants of the original paint, the commission decided for a reconstruction. After the dismantling, the wooden elements of the upper endpiece were cleaned, conserved and re-gilded.

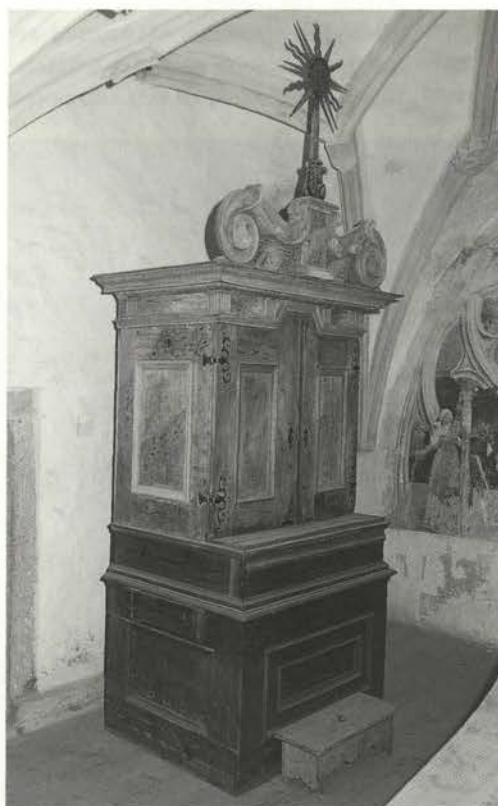
Organ in Zaprice Castle

The fate of the portable organ from the Zaprice castle near Kamnik was somewhat different. It was built by master Marko Gšbel from Ljubljana, brother-in-law of organ-builder Janez Jurij Eisl, in 1743. The instrument with three stops was repaired in the 19th century and, apparently, in the 20th as well. An analysis of the condition of the instrument revealed that the pipes in the prospect were damaged and some of them were missing, similarly to several from the interior; the wooden parts were disintegrated and subsequently pasted together; the pistons were not tight, a third of the springs were broken, the bellows were torn and some keys were torn away from the keyboard. After dismantling and cleaning the instrument, the missing and dilapidated parts were reconstructed and pasted, wooden elements coated with protective varnish, bellows mended, pistons, channels and windpipes tightened and keyboard renovated. The air pressure was regulated and instrument tuned. The cabinet was newly polished, and the missing ornaments were renovated and re-gilded.

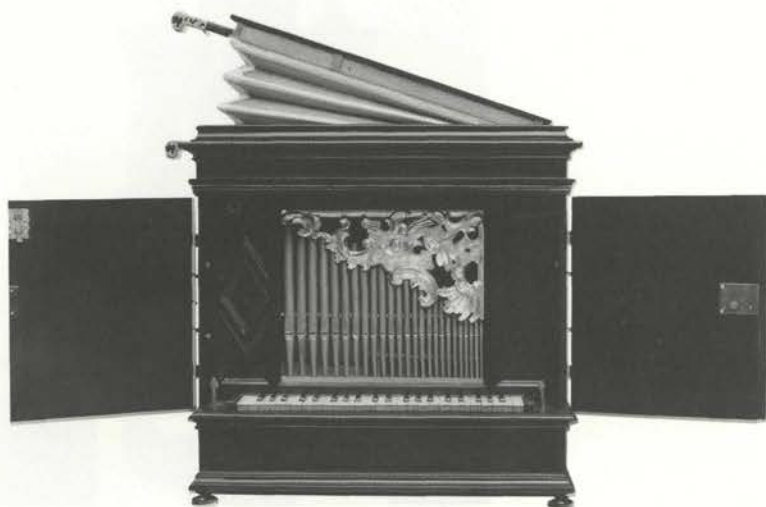
Organ in the Church of the Assumption of the Virgin Mary

The organ of the monastic church in Olimje was the subject of final restoration. The instrument was built by Janez Frančišek Janaček in 1764 or 1765. Despite damage caused by the course of time, it was preserved in its original form due to the abolition of the monastery at the end of the 18th century. The humidity in the church, the level of worm infestation and consequences of bats nesting in the instrument caused the severest damage. However, some was additionally produced by insufficient maintenance. After the programme confirmed by the Institute for the Protection of the Natural and Cultural Heritage of Celje, the instrument was dismantled, dirt removed and cleaned, and the damaged parts restored, to be followed by conservation, reconstruction of the missing parts and setting up new ones and, additionally, by tightening the rifts and perforations. The instrument with fourteen stops was tuned in the old, non-tempered manner. Anton and Gregor Podkrižnik renovated the painting of the cabinet, completed it using missing elements, restored the angels in the upper endpiece and re-gilded the relatively rich and elegant decorations.

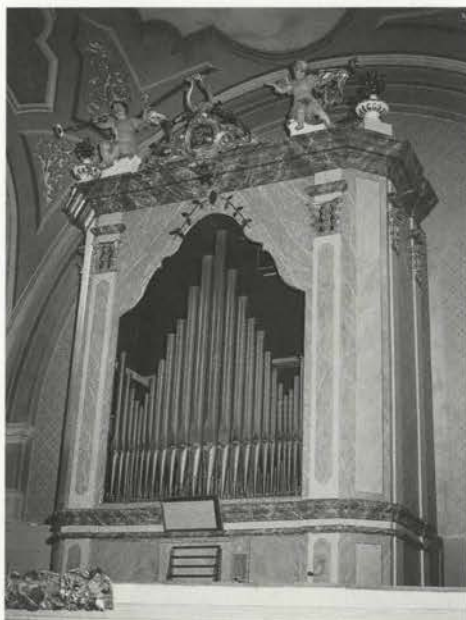
Organ in the Church of the Mother of God

The bad condition of the organ in the parish church of the Visitation of the Virgin Mary in Petrovče was primarily the consequence of subsequent maintenance works and of various workshops. The instrument was built by the Venetian organ-builder Gaetano Callida, who originated from the renowned workshop of Peter Nakič, in 1796. In the second half of the 19th century, new bellows and a new keyboard outside the organ cabinet were made by the local artisan Franc Naraks, which transformed the entire treatment of the instrument. An even more thorough reconstruction of the organ was performed by Franc Jenko from Ljubljana in the middle of the 20th century. He removed three stops and added two new ones on the pneumatic windpipe. Transformations were additionally performed on the Contravassi pedal stop, yet the presence of pneumatic elements was to the disadvantage of the sound quality. Other damage was caused by worm infestation of the wood and dilapidated leather, wire joints and the lining of the keyboard; more than half of the pipes were damaged as well. The keyboard was returned to the organ cabinet and the transformations performed in the past removed in the restoration process performed at the behest of the Institute for the Protection of the Natural and Cultural Heritage of Celje. The instrument was thoroughly cleaned, conserved and protected, the decayed elements were

replaced, and the pipes retuned in the temperament typical of Venetian organs from the end of the 18th century. The cabinet was also subject to numerous renovations in the past. According to analytical results, the restoration programme proposed the removal of subsequent paintings and decorative elements and the reconstruction of some parts of the cabinet. It was structurally strengthened and extended depthwise, and the marmoreal paint on the frames was renovated. The statue in the upper endpiece was renovated as well.

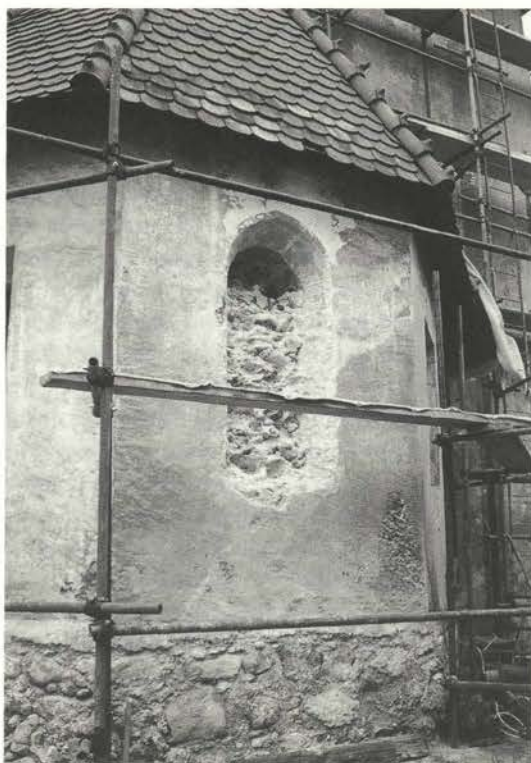
Discovery of a Gothic window on the presbytery: "In the 18th century, the side windows of the presbytery and the window in the southern wall of the nave were rebuilt in rectangular forms and the window behind the main altar was built up..."

The new presbytery was initially illuminated by means of pointed windows with stained surrounds built in the Gothic tradition. During the Baroque renovation of the interior when the walls were decorated with stucco ornaments, the side windows of the presbytery and the window on the southern wall of the nave were rebuilt in rectangular forms and the window behind the main altar was built up. The windows were glazed anew directly before the thorough restoration,

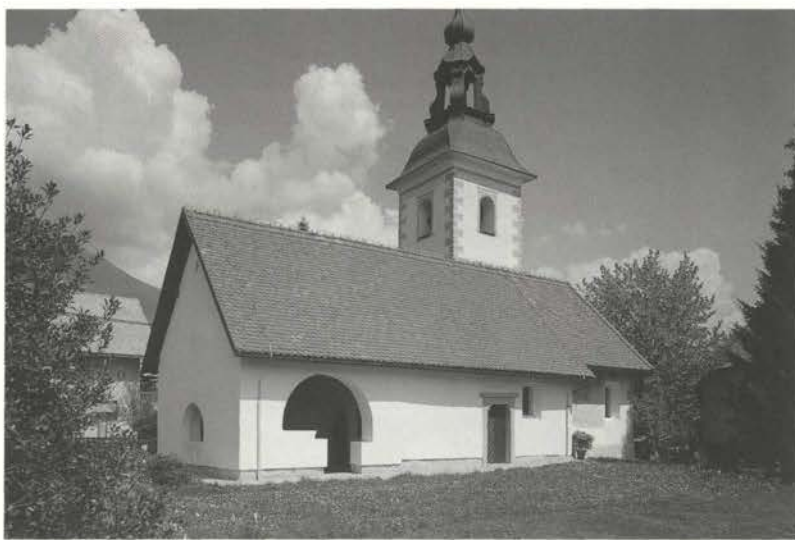
Exterior of the church: "It is hoped that the monument is now saved from further ruin as a result of the enumerated works and that some of its original freshness has been restored..."

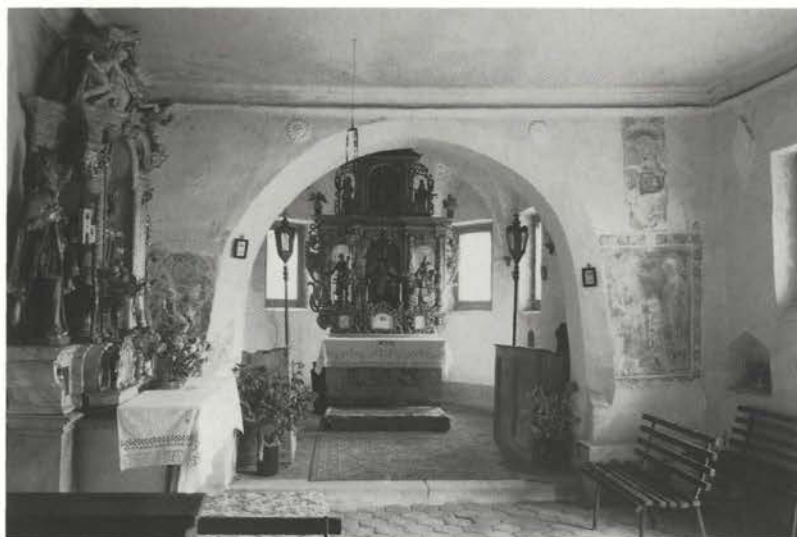
Interior of the church: "After renovation of the plasterwork on the facades and in the narthex, the work was continued in the interior of the church..."

a new roof together with the parish priest, Jože Klun. The dilapidated roof caused moisture permeation on the juncture of the roof and the bell-tower. Consequently, the fresco plasterwork began to fall off and the wooden supporting ceiling was rotten. The bell-tower seemed to be in good condition. However, after the construction of scaffolding and the opening up of plasterwork on account of architectural paintings, typical of the Gorenjska region, it turned out that the wooden ties above the belfry were completely rotten so that the roof was "standing" on the walls merely "out of habit". The rotten ties had to be removed and the openings filled with new ones, to be followed by the renovation of plasterwork and reconstruction of the painting in the fresco technique. Trial boreholes revealed three layers of painting: the earliest, Renaissance layer with corners in graphite grey, the early Baroque layer with green corners and a border beneath the eaves, and the late Baroque layer with the painting divided into fields. Since the early Baroque layer was artistically more complete and included painting of the embrasures, the decision was taken to renovate the second phase. After the renovation of the plasterwork on the facades and in the narthex, work was continued in the interior of the church, where the form of the Romanesque apse was indicated in the paving. Trial boreholes were made in the whitewash, plasters that were dilapidated and moist were removed, a new wooden ceiling was erected

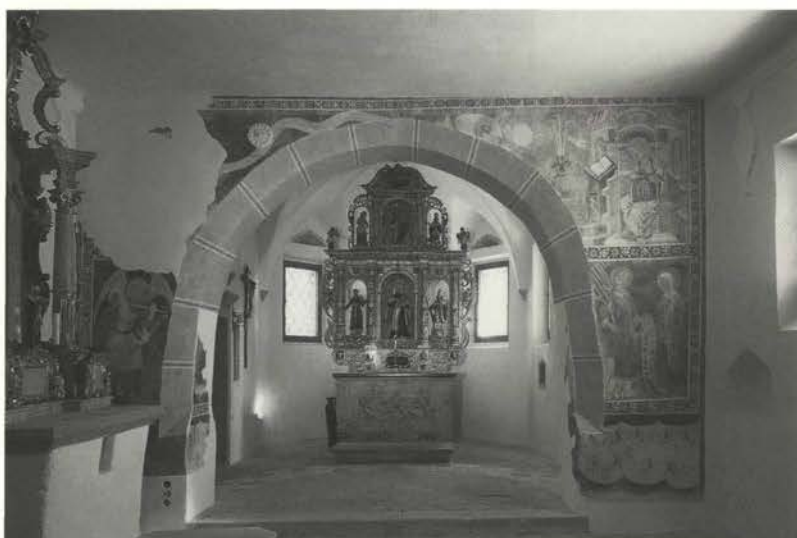
Discovered painting on the triumphal arch: "The identical drapery of the angel and, above all, the image of the Virgin Mary confirmed that the frescoes were painted by the same master who worked in Žiganja Vas near Tržič in the second decade of the 15th century..."

was discernible even before the renovation, so that Vladimir Snoj continued to uncover them in 1991. The process was subsequently completed by Tone Marolt who restored the frescoes. On account of moisture permeation, the fresco with the scene of the Annunciation with the angel was partly ruined in the top left-hand corner. Only a fragment of the drapery of the angel and the inscription stripe was preserved, while the depiction of God the Father handing the incarnated Jesus to the pregnant Virgin Mary was fortunately preserved on top of the triumphal arch. Mary was depicted sitting on a wooden throne next to a reading desk. Three saints were painted beneath the Annunciation: St. Michael in a picturesque knightly habit weighing souls on the left-hand side, St. Radegund, the patroness of the church, on the right-hand side, and St. Lawrence with a spit; the latter two were depicted holding a chasuble.

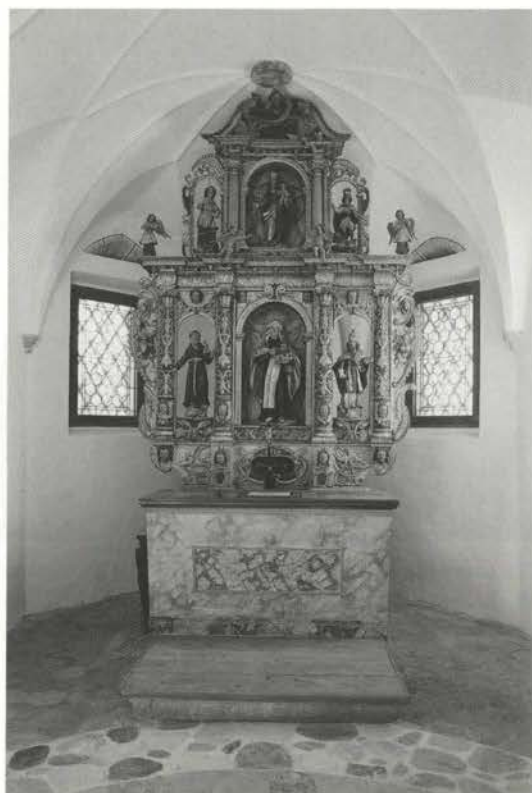
The main Renaissance altar with the date 1658: "The central niche contained the patroness of the church, St. Radegund, holding a model of the church in her hand..."
.....

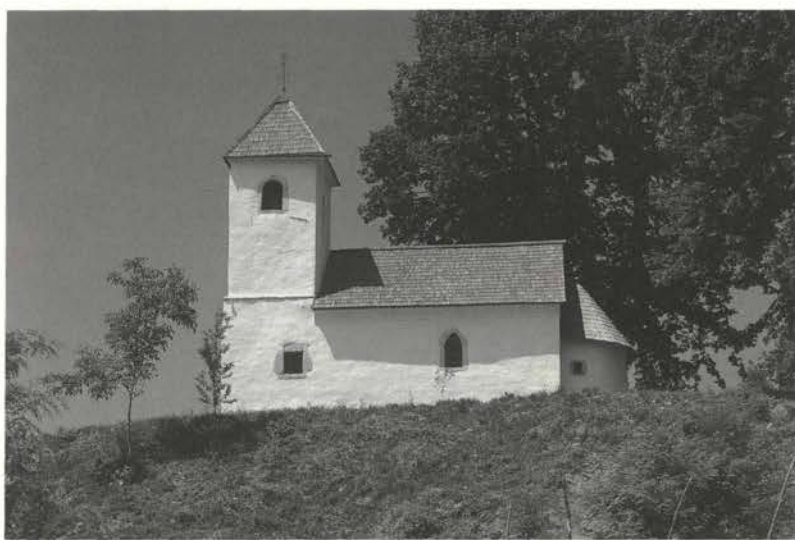
View of the church after the restoration: "The church is an important example of our heritage on account of its interesting history..."

The structural repair of the tower was the most demanding intervention of the latest renovation of the church. Its successful execution was the result of work performed by engineer Stojan Ribnikar and mason Lojze Mirtič. The structural problem was solved by the substitution of partly decayed oak beams of the northern and eastern walls of the tower with ferro-concrete supports leaning on the longitudinal walls of the church instead of on the Baroque vault. The reparation further included the installation of semi-circular horizontal ties against earthquakes and the injection of walls with lime. This was followed by the restoration and presentation of the church.

The renovation works on the exterior included the construction of a new roof and roofing covered with shingles – the way the church was covered until 1869. Investigations of the plasterwork on the southern wall of the nave revealed remnants of a large fresco of St. Christopher and a partly visible inscription of the donor. The remnants were copied on film and subsequently taken off since the dilapidated plasterwork of the facade was completely replaced with new lime-cast that was smoothed entirely using trowels.

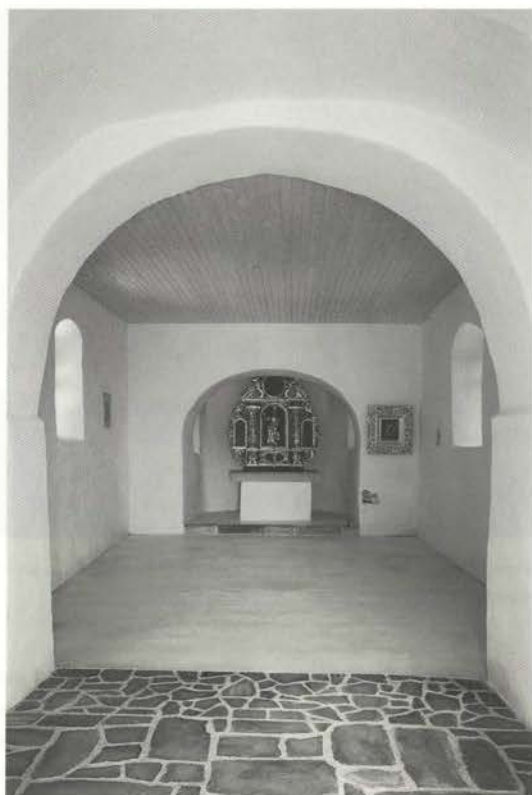
View of the interior: "The main altar was an outstanding piece of the modest interior furnishings of the church, apart from the full-size late Gothic statue of the Virgin Mary with Jesus..."

The main altar, unprofessionally restored in 1902, was an outstanding piece of the modest interior furnishings of the church, apart from the full-size late Gothic statue of the Virgin Mary with Jesus, renovated and partly reconstructed in the 17th century. Due to humidity, insects and the decay of the original binding, the altar with the images of three saints, an angel and the Crucifixion was in a very poor condition. Investigations of the body of the altar revealed that the original gilding and polychromatism were in such a bad state that they could not have been preserved. The restoration therefore included gassing, strengthening the wood, modelling some new elements, gilding and polychromatism. The restoration of the statues was professionally more difficult since only the side statues of Sts. Anna and Apollonia and that of the Crucifixion in the upper endpiece belonged to the altar, while those of St. Helen and the angel were of later origin. The side statues were relatively well preserved, although a part of the left arm of St. Apollonia was missing and had to be reconstructed on the basis of an old photograph, while the original polychromatism and part of the gilding could have been retained. The consequence of that was a slight discord of colours between the body of the altar, the side statues and the statue of St. Helen. Nevertheless, the decision was taken to present St. Helen in its original appearance discovered by means of trial boreholes.

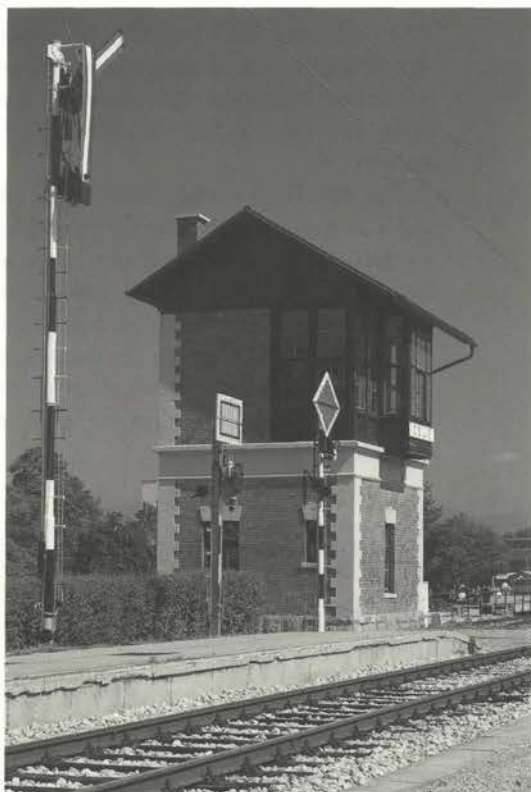
Renovated signal box:
 "The Southern Railway Board comprehended the new situation and granted the construction of the most advanced signal box of that time on its lines."

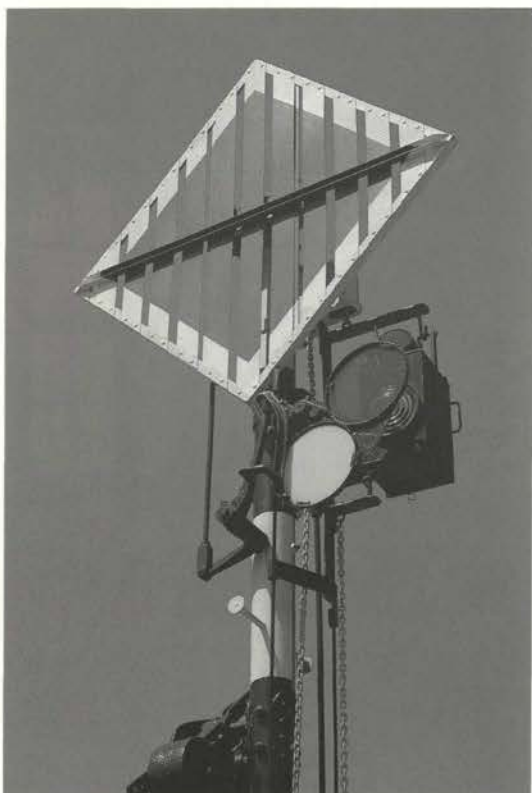
Signalling mechanism:
"The signalman moved a switch to its left or right position by moving a certain lever, thus opening or closing the signal."
.....

The operating principle of the signal box was very simple, but the execution was rather complicated. The signal box was connected with the railway transportation office in the main railway station by telephone, through which basic commands were given for operating the switches or points and signals. They were moved in a very simple manner. Two steel cables connected each signal and switch with the

signal box. A complicated system of wheels, guides, conduits and brackets connected the switches mechanically with the control lever mechanism in the tower. The signalman moved a switch to its left or right position by moving a certain lever, thus opening or closing the signal. The entire mechanism was executed so smartly that it was electrically connected with the railway transportation office in the station. When the signalman moved a switch, his activity was signalled to the railway transportation office where it was recorded and the lever in the signal box was simultaneously blocked. Possible errors

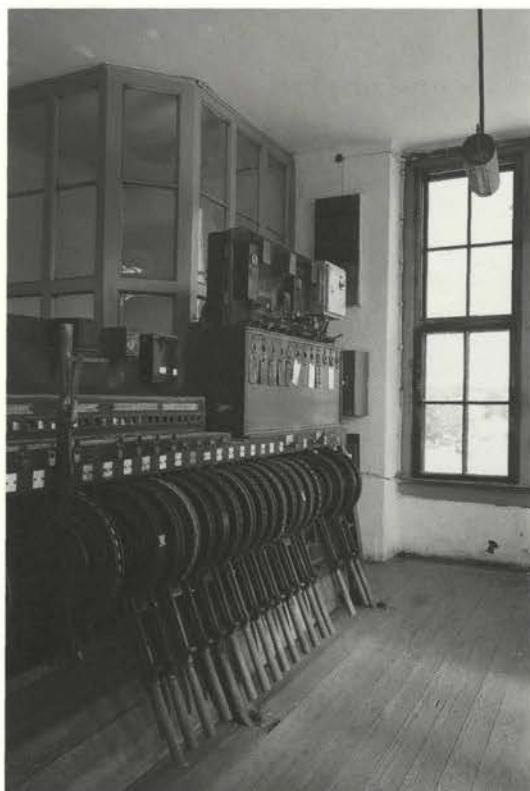
Interior of the signal box:
 "A complicated system of wheels, guides, conduits and brackets connected the switches mechanically with the control lever mechanism in the tower."

were prevented by such a procedure since the signalman was prevented from moving the same lever twice by mistake. The mechanism was constructed in such a way that the entrance and exit signals could only have been opened in cases when the line was safely set up and protected (i.e. locked). The system operated safely using a series of electromechanical devices. It was produced by the company Siemens & Halske from Vienna.

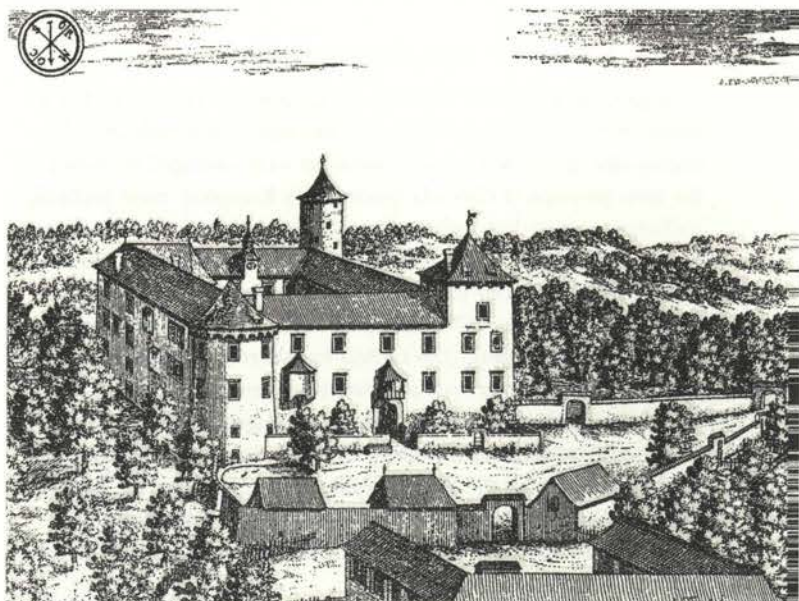
Valvasor's depiction of the castle in his book *The Glory of the Duchy of Carniola* from 1689: "Valvasor's engravings depicting the castle from all perspectives formed the basis for the reconstruction of several parts of the building and presentation of the castle."

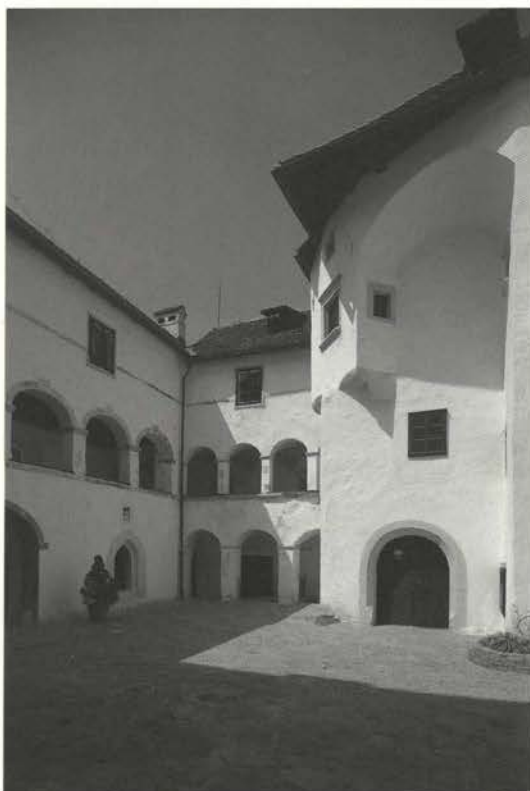
View of the renovated courtyard: "Trial boreholes made from the inside of the wall indicated the original entrance. The present semi-circular portal was built in..."

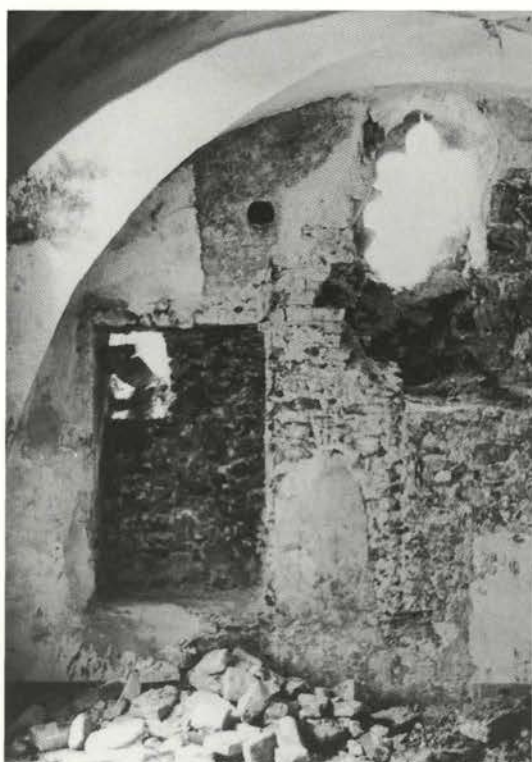
View from the inside:
 "The north-eastern turret
 – the opening up of a
 Gothic window with a
 trefoil conclusion..."

of sandstone and the building technique of the walls in the 17th century. Another entrance to Valvasor's room was discovered on the first floor of the western wing as well as a supporting beam from the 17th century. A late Gothic window with a pointed conclusion was discovered on the first floor of the north-eastern wing after the removal of the external staircase. The western and southern facades were renovated according to the technology using ten-year-old slaked lime in a single layer. The three-sided prominence on the western facade (the apsidal conclusion of the former chapel) was reconstructed. The staircase in

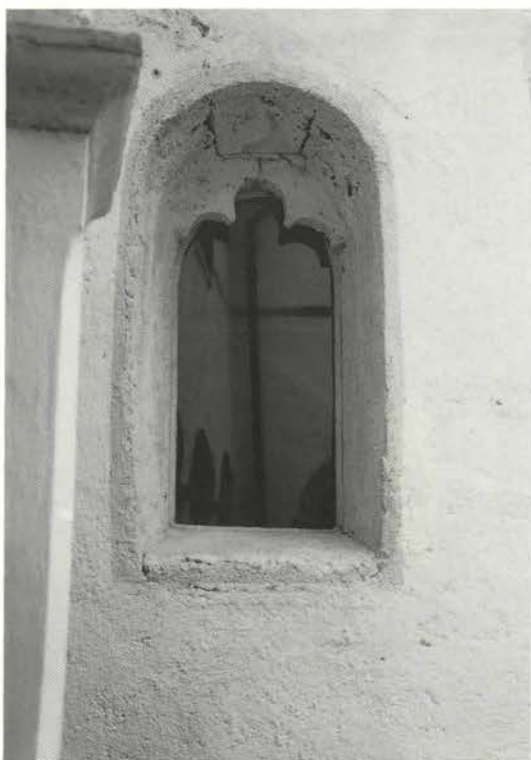
Renovated Gothic window: "The removal of the staircase facilitated the discovery of a small Gothic window with a trefoil conclusion on the western facade of the turret."

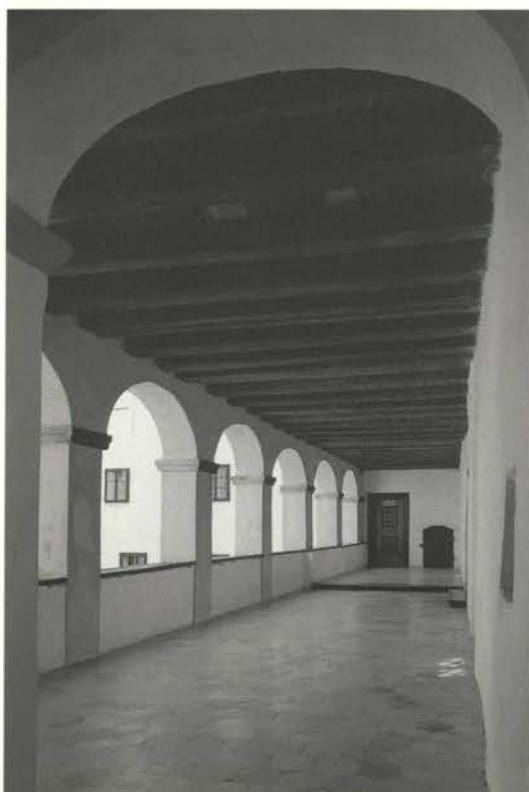
Renovated arched hallway in the southern wing:
 "The most extensive construction intervention was performed at the beginning of the 1980s, i.e. the renovation of the attic and the second floor of the southern wing. The project was executed by architect Oton Jugovec..."

the courtyard, the only entrance to the arcaded part of the northern wing, as stated above, was removed, the position of the original entrance on the ground floor of the north-eastern turret was discovered simultaneously and a semi-circular stone portal was erected. Central heating was installed in 1978 and the restaurant on the ground floor was opened. Several rooms were renovated in 1980: the knights' hall in the western circular turret, the vestibule and the rectangular hall, Valvasor's study and the adjacent room. The furnishings for the reception on the ground floor and the knights' hall with the vestibule were purchased; the Technical Museum of Slovenia set up the exhibition of printing and the furnishings for the vestibule of the wedding hall. Excavations were performed in front of the western facade of the castle in the summer of the same year, and students from the Ljubljana Faculty of Arts performed some surveying work in the interior. The facades in the courtyard and the covering of the northern and western wings were renovated in the following years. The most extensive construction work was performed at the beginning of the 1980s, i.e. the renovation of the

attic and the second floor of the southern wing. The project executed by architect Oton Jugovec anticipated a unification of the hall on the second floor and the attic. After the removal of the hall ceiling the roof construction was built in a new style, i.e. with strained steel ties connecting the ridge of the roof with two horizontal junctures. The geodesic collection was exhibited in the hall covered with a hanging ceiling concluded by the circular south-eastern turret. The next major intervention was the reconstruction of the clock-tower according to the plan by the Regional Institute for the Protection of the Natural and Cultural Heritage of Ljubljana. The construction of the eastern wing roofing was replaced simultaneously. The rafters were joined in the old manner by tree-nails. The illuminated interior can be viewed through glass. The cellar of the northern wing including the tomb, the knights' hall with the vestibule in the circular turret, and the chapel next to the entrance to the castle had been renovated by 2000. The renovated altar painting for the chapel was a contribution of the Religious Museum from Stična. The well, deepened at the behest of Valvasor from eight to ten fathoms (a fathom was 1.896 metres), was thoroughly cleaned and a water pump was installed, so that water is available to visitors. The furnishings and fittings were gradually completed with the purchase of antique furniture, and the exhibited items were renovated (cabinets, chests, tables, chandeliers, armour and weaponry). Some furniture was lent by the City Museum of Ljubljana, mirrors and the organ cabinet for the library (wedding hall) were made according to the plan by architect Staša Blažič Gjura, and the organ was the work of the Organ-Building Workshop of Maribor. The cellar rooms in the northern wing and both turrets were intended for the restaurant with the preservation and inclusion of all the original architectural elements, while the present premises of the restaurant are to be transformed into promotion and information premises in the future. Basic renovation works were performed in the cellar of the northern wing; the preliminary design and structural evaluation for the cellar of the north-eastern wing are being prepared so as to connect them with the ground floor.

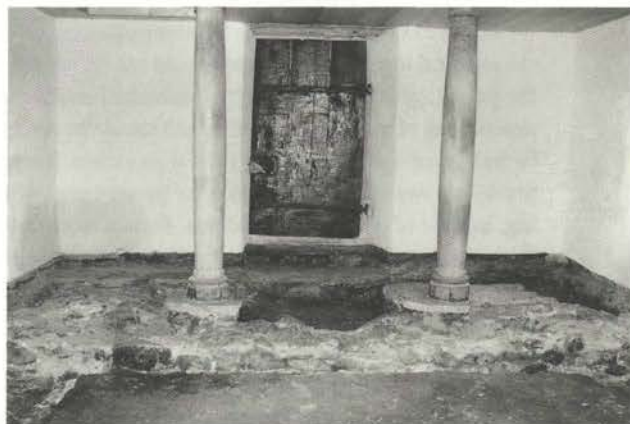
Archaeological surveys in the interior of the church: "The conservation and restoration surveys contributed some new discoveries about the phases of development of the building. It was established with certainty that the original single-nave church with a square presbytery came into being in the second half of the 12th or beginning of the 13th century."

The works continued in the interior of the church of St. Agnes. Archaeological investigations were carried out before the replacement of the paving, which has become an established routine in the case of renovations of mediaeval churches. As usual the survey turned out to be well grounded. The foundations of an earlier, Romanesque square presbytery were discovered inside the present one, which was surprising, in spite of possible expectations. Romanesque churches in Carniola (present-day Kranjska) regularly had semi-circular apses, while square presbyteries appeared merely in Styria and Carinthia (Štajerska and Koroška) under the influence of Northern and Central European models. There were only a few examples of such presbyteries in Carniola: Šmarjetna Gora above Kranj, St. Primus above Kamnik, Špitalič in the Tuhinjska Dolina valley and the lower chapel in Mali Grad in Kamnik. They were dated as belonging to the second half of the 12th or the first half of the 13th century. It is interesting that most square presbyteries in Carniola were located around Kamnik. Dr. Emilijan Cevc presumed on the basis of the church of St. Primus above Kamnik that the occurrence of that architectural type could have been connected with the influence of the Counts of Andechs, who had their seat in Kamnik. Archaeological surveys in the church of St. Agnes further discovered the foundations of the original western wall and thus the size of the Romanesque predecessor of the church. An intensive layer of charcoal next to the northern wall raised the even more interesting question of the existence of a possible timber narthex or church at that location. The discovered remnants of the Romanesque predecessor were indicated by ashlar laid in brick paving. The plan for the presentation was designed by the architect of the Institute, Aleš Hafner. The walls inside the church and presbytery were plastered and white-washed anew. No traces of paintings were discovered in the process.

The restoration of the interior furnishings and fittings completed the renovation of the church of St. Agnes on Golčaj. The conservation and restoration surveys contributed some new discoveries about the phases of development of the building. It was established with certainty that the original single-nave church with a square presbytery came into being in the second half of the 12th or beginning of the 13th century. However, the question of an earlier wooden narthex remained open. In the Renaissance period, the church obtained the

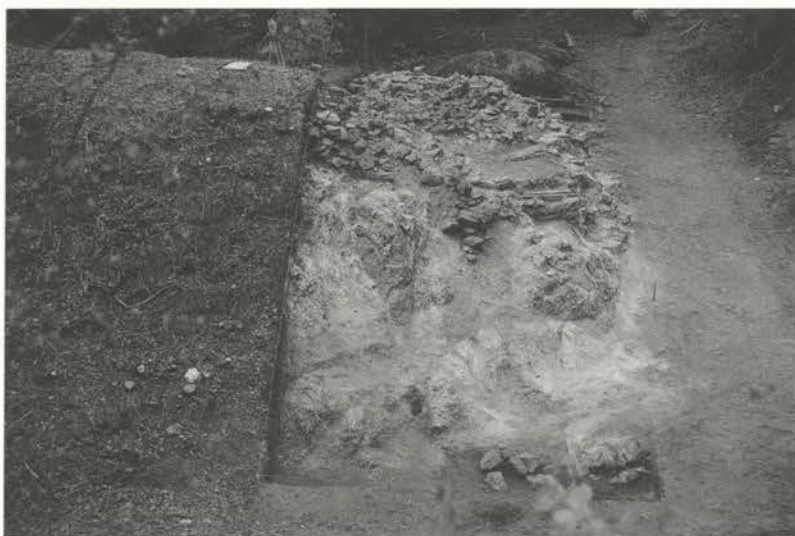
"The forecourt was also walled in and fortified with a deep moat to the south. Traces of walls, defence turrets and stone-built castle buildings of unknown purpose were discovered on the eastern and western sides."

turn of the 9th and beginning of the 10th century. The construction of the castle tower on the top of the crest largely destroyed traces of the earlier settlement. The tower was divided from the level of the forecourt by a moat. The forecourt was also walled in and fortified with a deep moat to the south. Traces of walls, defence turrets and stone-built castle buildings of unknown purpose were discovered on the eastern and western sides. The only partly excavated and presented archaeological remnant was the defence tower by the southern entrance to the forecourt.

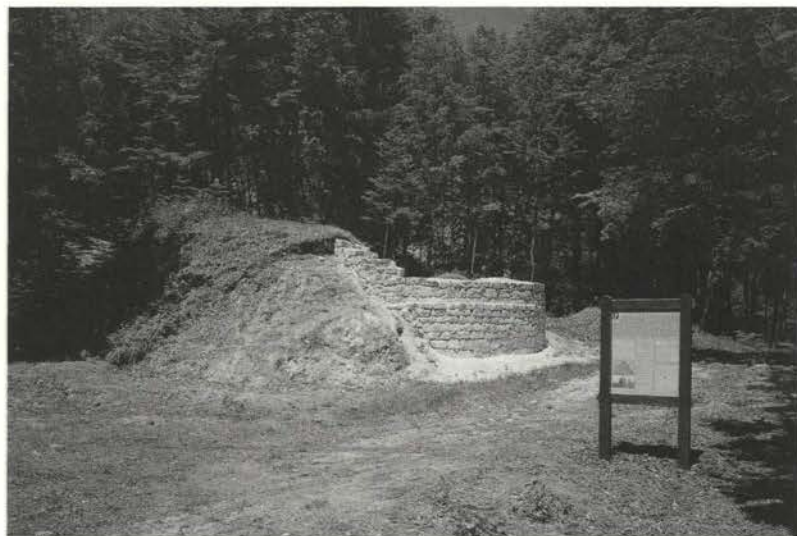
“The only partly excavated and presented archaeological remnant was the defence tower by the southern entrance to the forecourt.”

tower in the forecourt of the castle. The basic rule was to preserve the authenticity and durability of the excavated walls. Larger quarry stones from the layer of the ruins, separated in the process of excavation, were used for that purpose. It was still possible to trace the Romanesque manner of construction on the partly damaged external side with the use of lime mortar and some added white cement. The crown of the wall was somewhat heightened and slanted in order to drain rain-waters. For the purposes of drainage in the interior, the original walkway was protected by a membrane and drainage fill (of gravel and sand) on a thin levelling layer of foundation concrete slanting towards the drainage pipe. Additional layers of felt and sod were laid on it in order to ensure easy maintenance. The foundations, built very firmly and deeply into the decayed dolomite sandstone, facilitated the solution of problems of frost and erosion in the interior of the tower.

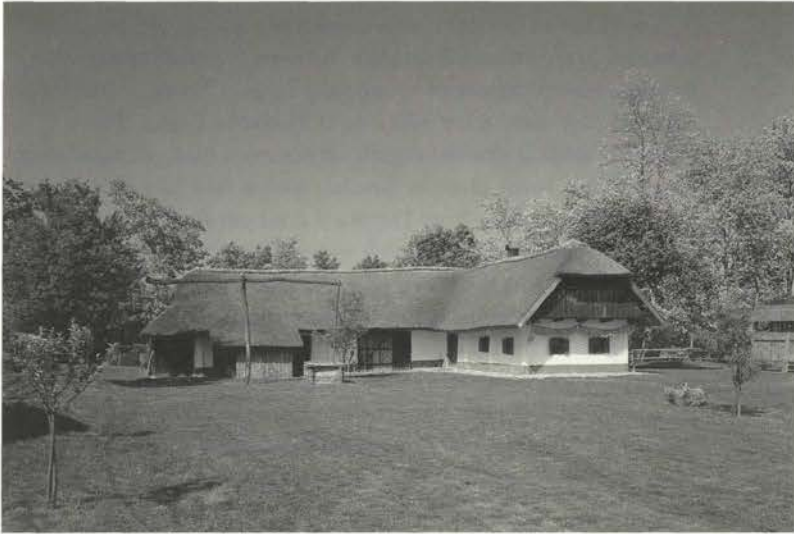
The renovated Dominko farm: "The Dominko house is situated slightly apart from the main road, protected from busy traffic."

The house is an L-shaped building consisting of a residential part and an outhouse. The building has a timber construction with simple roof consoles. It is plastered with clay plaster and whitewashed with lime. The parapet wall is painted in dark grey. The ridged roof with gables is thatched. Broad eaves cover the walkway serving as a communication route between the residential part and the outhouse. The

southern, front side of the house is bi-axial, with a wooden gable of the hayloft with ventilation slots. The entrance to the house is in the corner of the western side. The windows used to be protected with iron crosses and furnished with shutters. Entrances to the outhouses are in the southern side of the building. The large folding door leading to the barn has timber hinges.

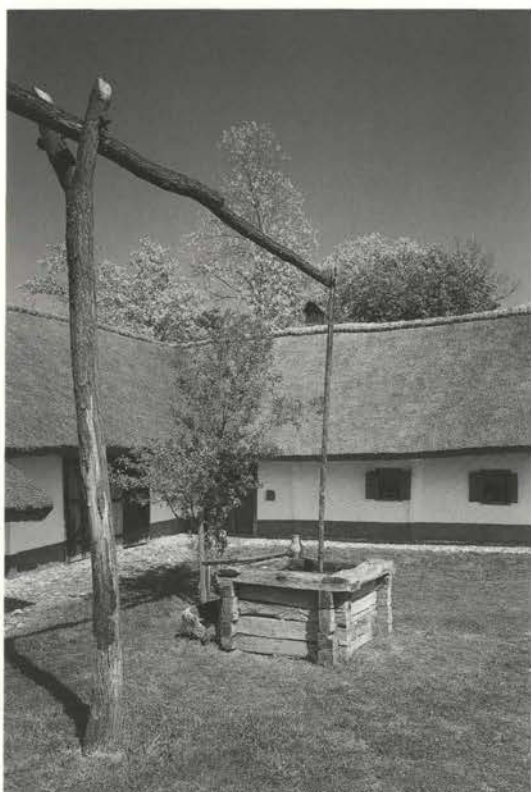
"The well in front of the house that was filled in before the Second World War was dug out again and renovated."

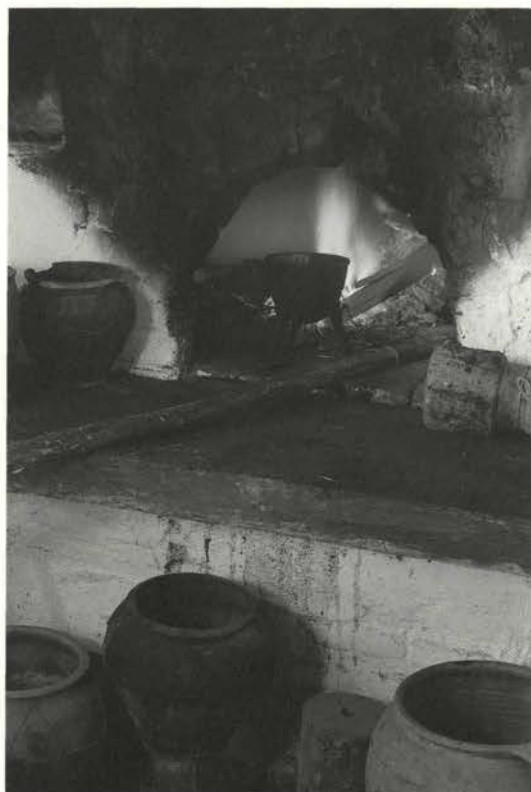
'Black kitchen': "The vaulted 'black kitchen' contained the fireplace with all the necessary utensils and old pots. The oak ledge in front of the fireplace was intended for iron pots and earthenware."

house and in the outhouse were furnished with the preserved fittings and furniture dating from various periods of time. The vaulted 'black kitchen' contained the fireplace with all the necessary utensils and old pots. The oak ledge in front of the fireplace was intended for iron pots and earthenware, a water stand was located in the corner and a bowl stand hung on the wall. The house with a finely made, simple timber ceiling was furnished with a bread oven featuring a colourful pattern on the tiles and with old furniture: a wardrobe, a chest of drawers and a bed; sometimes there were two of them or an addi-

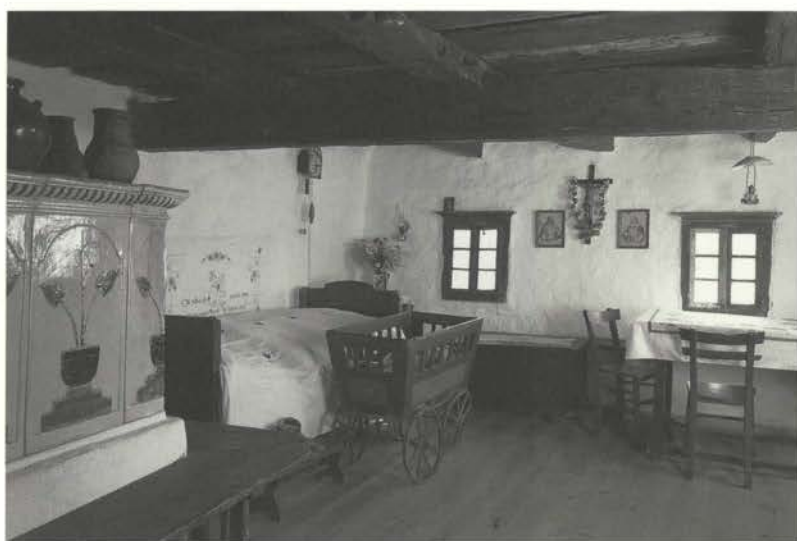
"The 'house' with a finely made, simple timber ceiling was furnished with a bread oven featuring a colourful pattern on the tiles and with old furniture: a wardrobe, a chest of drawers and a bed."

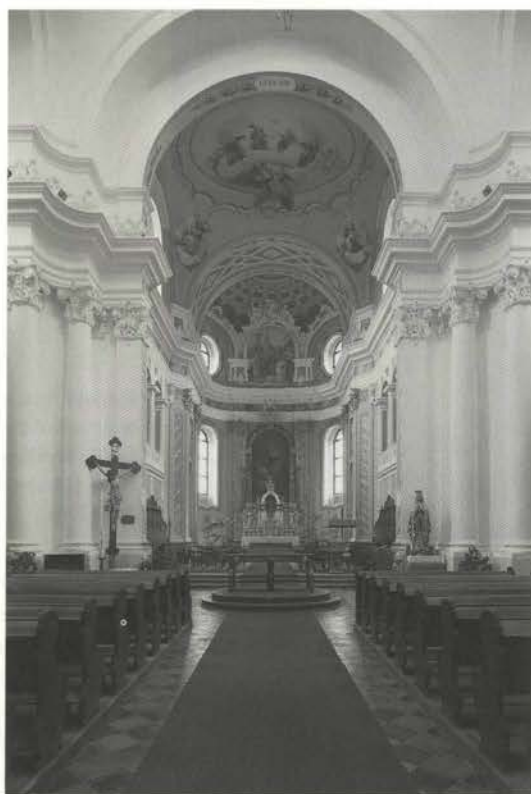
View of the interior: "Trial boreholes on the exterior and interior revealed that the church was not painted or shaded in several colours, despite some conjectures."
.....

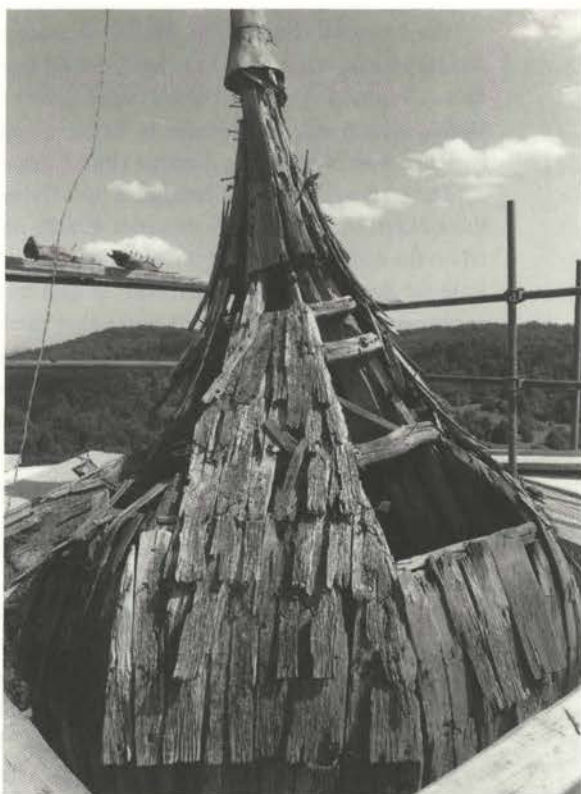
Dilapidated roof of the bell-tower: "The utterly decayed roof construction and covering of the Baroque cap of the bell-tower were replaced in that year (i.e. 1987)."

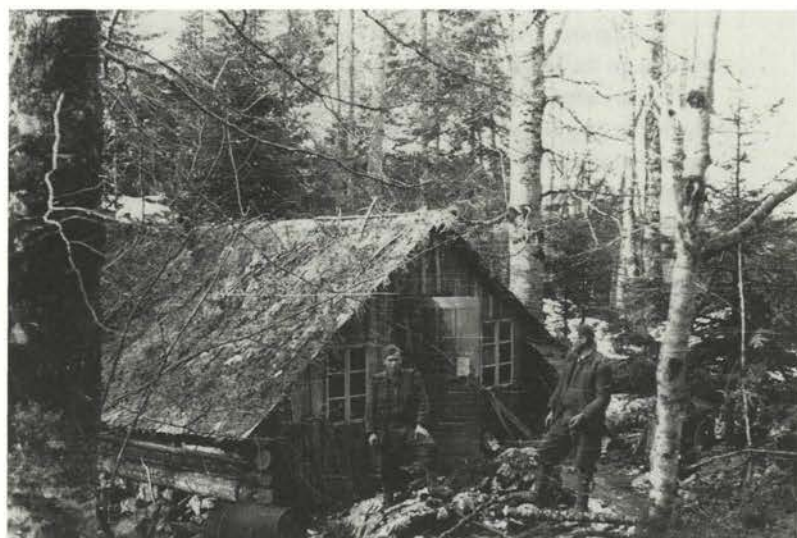
Hut for personnel in the Zgornji Hrastnik hospital, one of the hospital's two buildings; photographed by Janez Milčinski at the end of 1943 or beginning of 1944.

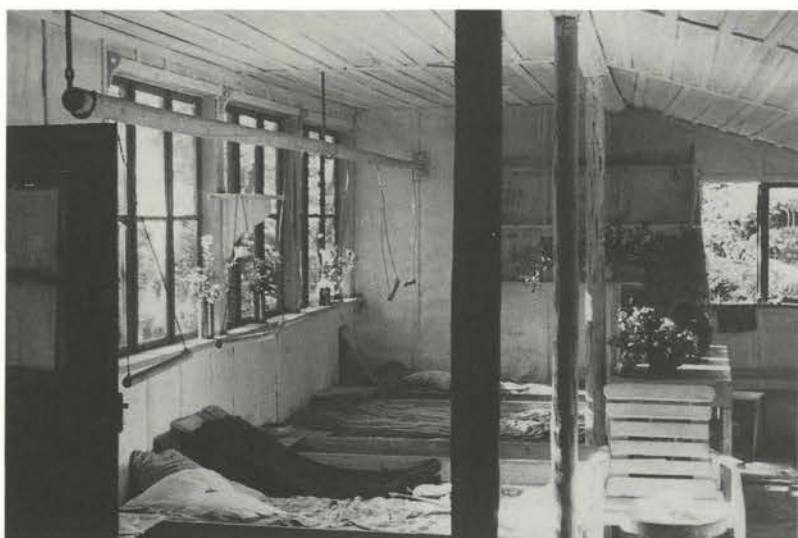
Septic hut, interior of the room after evacuation of the wounded in the period of danger in July 1944; photograph by Janez Milčinski.

The hut for the wounded with the surgery, i.e. the septic hut, was also in a bad condition. The entire covering had to be replaced. The elevation of the roof from 1955 was preserved in the process. The rotten logs of the lowest wall of the hut were replaced with new ones. The interior has remained unchanged since 1955. An attempt was made to reconstruct the original condition of the hut to the greatest possible extent on the basis of preserved photographs. Thus the walls were newly panelled with roofing card and whitewashed with lime. The entire hut was coated with wood preservatives.

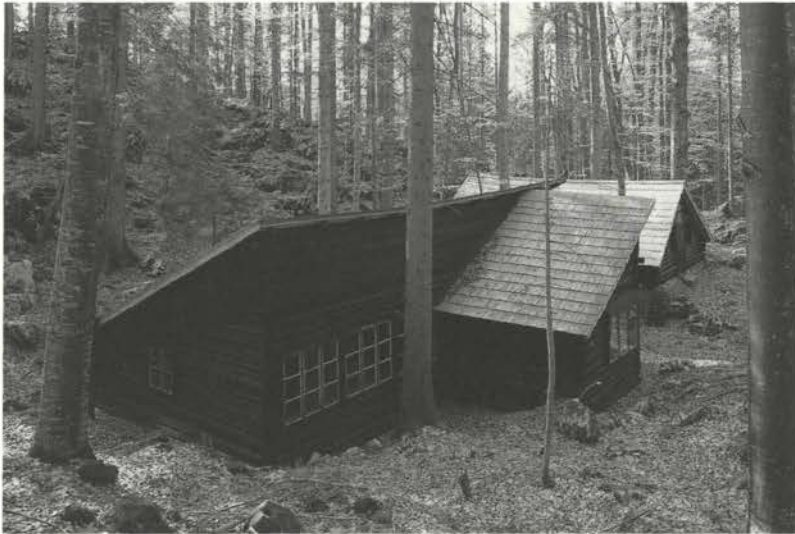
Renovated complex of the Zgornji Hrastnik hospital: "It came into being in the period when the enemy in occupied Europe was most powerful. It is a monument of the humane struggle and perseverance of the Slovene people..."

A thorough renovation of the Zgornji Hrastnik hospital was undertaken by the Institute for the Protection of the Natural and Cultural Heritage of Novo Mesto in 1996. A tree that fell down in strong wind damaged the aseptic hut in December 1995. The actual damage

to the hut was revealed only after the removal of the tree by foresters in April 1996. The shingle covering was destroyed and partly the construction of the roof as well. Fortunately, the interior was not destroyed with the exception of damage to the internal panelling made of roofing board, caused by humidity. Part of the construction of the roof and the entire covering were therefore replaced, as well as the damaged part of the panelling in the interior. The equipment and furnishings of the aseptic hut were preserved, while the photographs documenting the interwar activity of the hospital were temporarily removed.

The renovation of the other buildings of the hospital took place in 1999. The roof covering was replaced on all of them, and the dilapidated parts of the panelling were replaced with new ones. With the

exception of the roof covering, still made of shingles, the rest of the improvement works consisted of maintenance works and minor repairs. The kitchen was renovated in 1999, besides the hut for the wounded, the so-called kennel, the hut for personnel, laundry and sterilization room, bread oven and a minor repository.

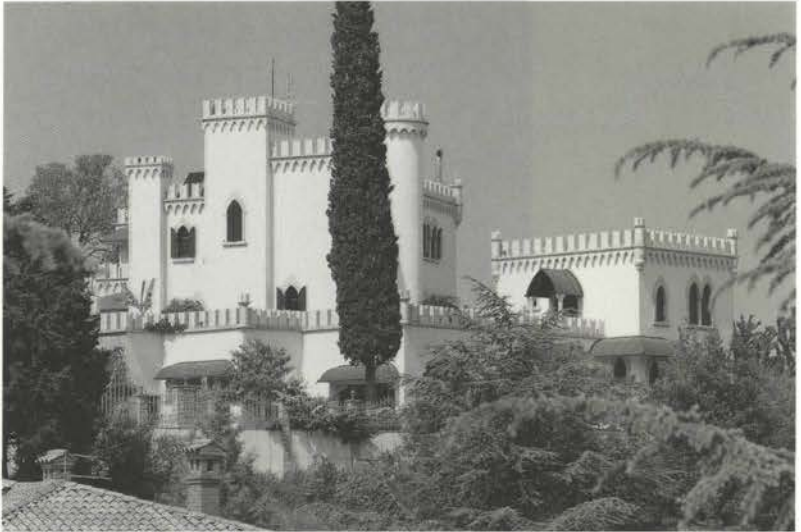
View of the renovated castle: "The castle was to be properly renovated and revived in its Historicist appearance as a residential building."

ods of renovation and the desire of the investor, the decision was reached to pull down the castle due to its extremely bad material conditions, and to reconstruct it with new materials. The guidelines and conditions of the castle renovation according to the conservation plan postulated the collation of documents of the existing building in order to facilitate the creation of plans for its reconstruction with all pertaining architectural details. The original paintings were therefore to be taken off the walls. A reconstruction of the painting of the main hall and the adjacent parlour was made. Since the castle was of mod-

est dimensions and no additional extensions could have been added, the investor decided to construct a basement and thus expand the residential area.

The renovation of the castle was begun in 1999. The structural design was prepared according to the guidelines and conditions of the conservation plan. A basic architectural scheme of the castle and details to the scale of 1:50 was made as a starting-point for further plans. Trial boreholes were to be made on account of the existing paintings. The painting of the main hall was discovered beneath two layers of paint. Since the trial boreholes indicated intense painting of the room in its entire height and also on all the walls, the recent layers of paint were to be uncovered and removed. The concept of the original painting from the Neo-classicist period confirmed the assumption that the hall was the most representative room in the castle. The painting depicted the illusion of an open space. The walls were concluded with painted architecture: columns, beams and an architrave in the foreground. The lower part of the room with parapet walls was painted with a balustrade and manifold drapery. Two types of columns with different decorations, i.e. gryphons, sphinxes, blossoms, wreaths and garlands, were included in the whole. The view was continued over the above-mentioned painting into a landscape. The window openings, entrance and fireplace were framed with particularly rich decorations.
