The European Heritage Days Series
Cultural Routes 2000 Guide to Monuments

THE EUROPEAN HERITAGE DAYS SERIES *concept by* JERNEJA BATIČ *written by* ANKA AŠKERC, UROŠ BAVEC, MAG. TADEJ BRATE, MODEST ERBEŽNIK, MAG. MOJCA GUČEK, IRENA KRAJNC HORVAT, DR. JOSIP KOROŠEC, MOJCA ARH KOS, SVJETLANA KURELAC, NIKA LEBEN, RENATA PAMIČ, DAMJANA PEČNIK, DARJA PERGOVNIK, ROBERT PESKAR, JUDITA PODGORNİK, JELKA SKALICKY, ANDREJKA ŠČUKOVT, DAMJANA PEDIČEK TERSEGLAV, ALENKA ŽELEZNIK *publisher* INSTITUTE FOR THE PROTECTION OF CULTURAL HERITAGE OF SLOVENIA, CANKARJEVA 4, LJUBLJANA, SLOVENIA *publishing executive* JANEZ KROMAR *editors* JERNEJA BATIČ, DAMJANA PREŠEREN *english translation* BARBARA SIMONITI *language editor* MARK ALEXANDER VALENTINE *photography* MIRAN KAMBIČ *designed by* ID STUDIO *main typography* SCALA & SCALA SANS, FS1 *other photographs, plans and sketches* ARCHIVE OF INSTITUTE FOR THE PROTECTION OF CULTURAL HERITAGE OF SLOVENIA, HISTORICAL ARCHIVES OF LJUBLJANA, NATIONAL MUSEUM OF SLOVENIA *printing coordinator* BOŽNAR & PARTNER *color reproduction* HIFI COLORSTUDIO *printed by* SCHWARZ 800 copies LJUBLJANA, MARCH 2002

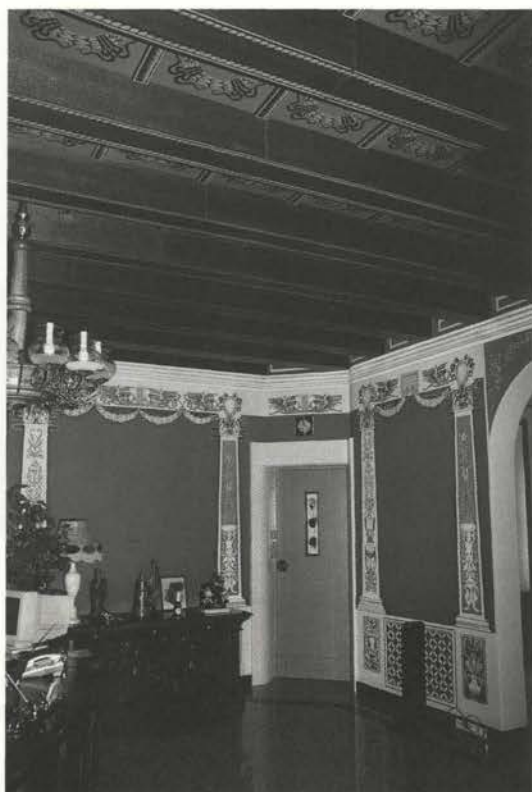
“The decorative painting of the hall and parlour was complemented by a painted wooden ceiling.”

The painting of the room belonged to the variety of stucco techniques, indicating that the painting was applied onto dry plasterwork. On account of that, uncovering the painting was a relatively difficult and time-consuming procedure, since the layer of paint that was not well bound with the base peeled off. Nevertheless, the entire painting was uncovered.

cover the painting of the parlour since it was not preserved. Despite the fact that it was made according to the model of a Gothic painting in a typical brick-red shade, it belonged to the Historicist period when the neo-Gothic painting complemented neo-Gothic architectural elements. The painting was limited to the wall between the hall and the parlour, while the room was decorated with the signs of the zodiac on simply formed shields.

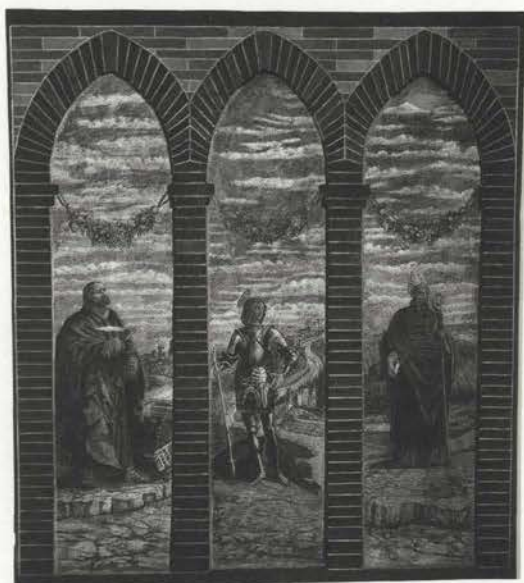
"A triptych located at the conclusion of the staircase [...]. Three full-size figures were painted in the openings: Mark the Evangelist, a warrior-saint and a bishop."

The only painting preserved on the first floor was a triptych located at the conclusion of the staircase that was preserved since it had never been whitewashed. A brick-red Gothic triphora with pointed conclusions was painted in the foreground. Three full-size figures were painted in the openings: Mark the Evangelist, a warrior-saint and a bishop. The selection of the saints was most probably con-

nected with representatives of the family who commissioned the painting. A landscape was depicted in the background that could have shown the surrounding area of the castle since a castle similar to the Gravisi castle was painted behind the central figure.

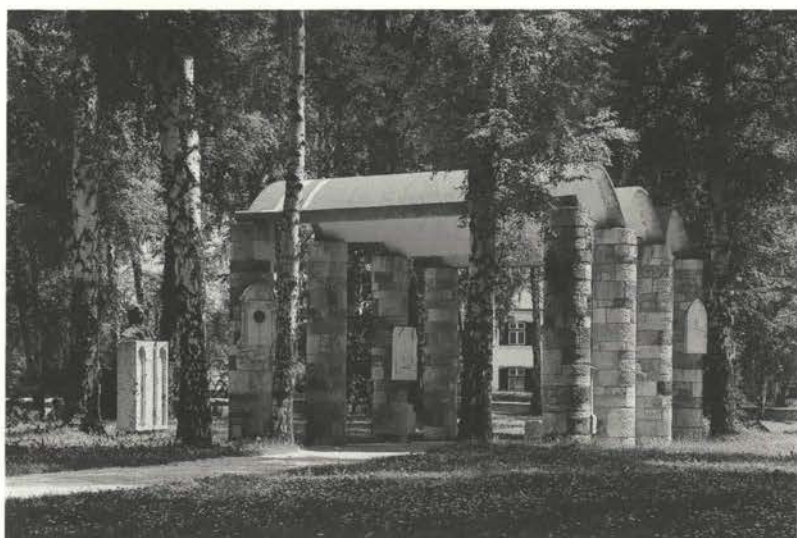
"An open hovel with a triply parted, semi-circular, concrete roof supported by eight circular columns was built at the location of the former chapel."

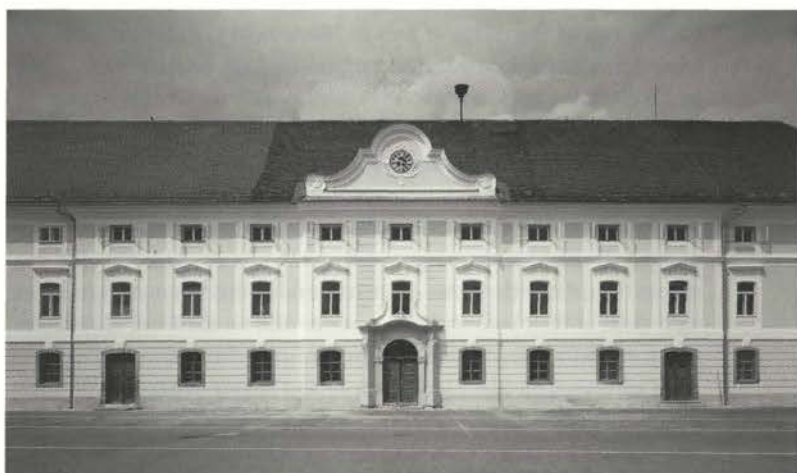
Renovated entrance wing of the manor: "Despite all transformations in the historical construction development, the Selo Manor complex has been preserved."

The proprietor began with a planned functional renovation of the complex on the basis of a conservation plan in 1995. Initially, the works presented merely an improvement of the existing bad conditions of the roofs and rooms. After a structural and construction evaluation of the building and the anticipated works involved it was acquired by the proprietor. Improvement works on the roof began, including renovation of the rooms on the mezzanine for future offices. Stucco decorations have been preserved on the ceilings of the halls on the first floor, and two vedutas painted in the fields above the door in the central hall. In the first phase, essential improvement works were performed on the stucco to be followed with restoration works on the stucco as well as the painting. A fairly well preserved Baroque painting was subsequently discovered in an auxiliary room next to the right-hand staircase beneath a thick layer of plaster. The pilasters with golden yellow Corinthian capitals surrounded pink fields in Baroque forms with broad ochre borders and stucco ornaments painted in white. The paintings in oil were decorated with sparse branches of greenery with red and blue blossoms occasionally intertwining the fields and connecting them with architectural elements. The lower part consisted of a stone parapet painted in the Baroque illusionistic style with wreaths, pilasters and pink oblong coffers. The jams of the windows were formed in the same manner.

The first phase of the renovation consisted of strengthening the marl base and the removal of installation remnants. Old damaged areas were used for new installations so as to avoid new damage. The restoration works planned for the future include the precise cleaning of the painting surface, putting the damage, application of new plas-

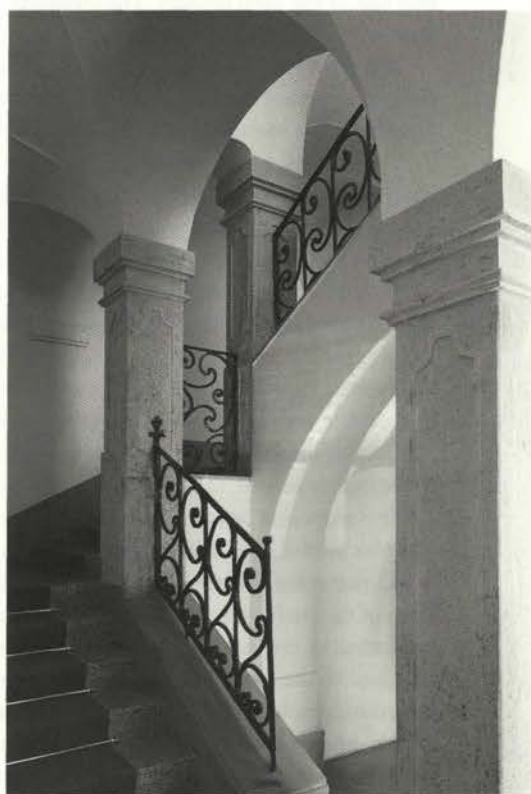
Baroque mirror staircase:
 "The proprietor began with a planned and functional renovation of the complex on the basis of a conservation plan in 1995."

The functional programme of the renovation dictated the preservation and renovation of the reception rooms adjoining the connecting Baroque staircases. The rooms at the rear side underwent several transformations in the historical development of the manor. The rear rooms were renovated for offices and business activities including the intermediate hallway. The hall with the preserved stone supports of the ceiling and the central column in the right-hand wing of the

manor was renovated and is intended for formal business activities. Regrettably, there are no traces left of the former Baroque chapel in the left wing of the manor that was recorded in archival documents from the year 1817. The architectural scheme and plan of the renovation were entrusted by the proprietor to architect Jani Vozel, who followed the established principles and conditions of renovation of the manor. Due to the complexity of the renovation works (e.g. of the painting and the portal) and great financial burden for the investor, the renovation has lasted for five years and is far from concluded. With the purpose to attract the attention of the public to the valuable Baroque external appearance of the manor, the investor has already executed the improvement and renovation works on the facade, prior to the final works in the interior. Regrettably, the execution has not taken into consideration all the provisions for the conservation renovation of Baroque plasterwork. The sculptor and restorer Bine Ambrožič renovated the front of the facade in voluted forms including the clock and stucco decorations and additionally the central com-

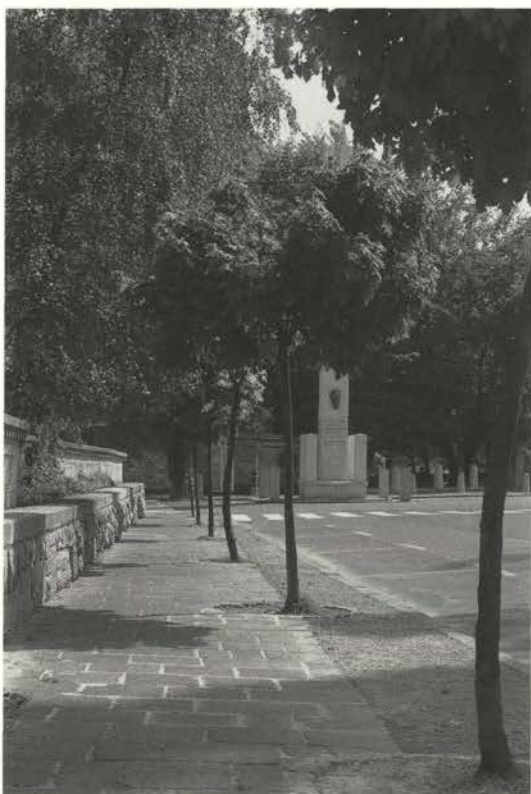
Vegova Ulica: "The walkway along the entire course of Vegova Ulica was paved with porphyry slabs and separated from the road with a sand surface planted with ball-shaped maple trees..."

The trees in the avenue have been partly damaged in their growth by snow and other causes during a period of approximately six decades. Consequently, they have been replaced by new ones at several locations over various periods of time. The avenue has thus lost its original unified appearance and its basic spatial function. At the beginning of the 1990s, the trees were replaced in individual sections

of the avenue. However, they were increasingly damaged by careless parking. Metal posts were therefore erected as a necessary evil, so that the trees were protected and were able to grow. The original appearance of the Plečnik avenue has thus finally been restored.

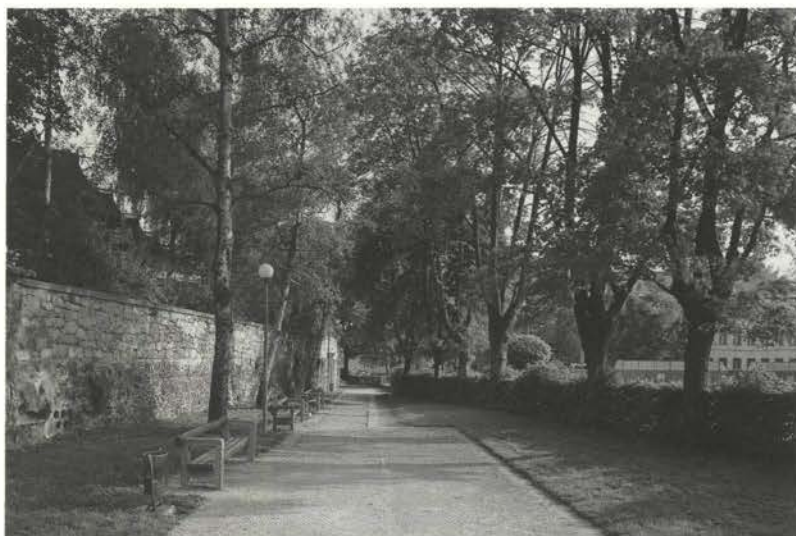
Emonska Cesta: "The trees on that side of the road were removed in the 1970s. They have been replaced several times since, but have always died away due to improper growing conditions."

A hotwater main was laid beneath the avenue by the playground in the 1970s so the trees on that side of the road were removed as a result. They have been replaced several times since, but have always died away due to improper growing conditions. The remaining part of the trees were removed in 1998 due to the beginning of the construction of the new University Library. The precondition for this intervention was, naturally, the reconstruction of the avenue along both sides of the road with the necessary removal of the main in order to facilitate appropriate growing conditions with a suitable distance and depth.

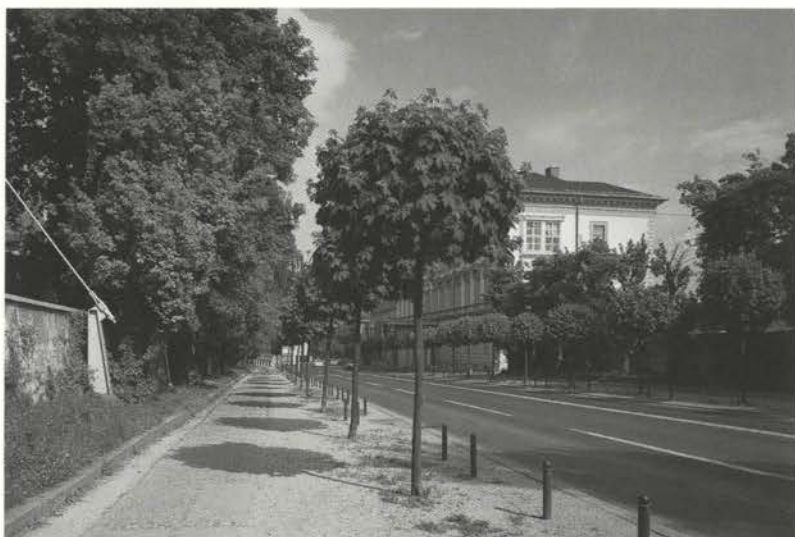
Zoisova Cesta: "The interior of the road planted with ball-shaped maple trees created a perspective impression leading the view along the road towards the River Ljubljana."

Similarly to the avenue along Vegova Ulica, the one along Zoisova Cesta has obtained an uneven appearance in the course of the growth of trees due to the replacement of individual damaged trees. In 1993 the entire course of the avenue was replaced with new trees and they were protected against cars by means of metal posts, so that they grow fully at present and the road is regaining its original appearance. Simultaneously with the avenue of ball-shaped maple trees, poplars were planted at the intersection with Emonska Ulica accentuating the beginning of the road and the corner of Križanke. The poplars were not planted there before, although they were drawn in the plans by Plečnik.

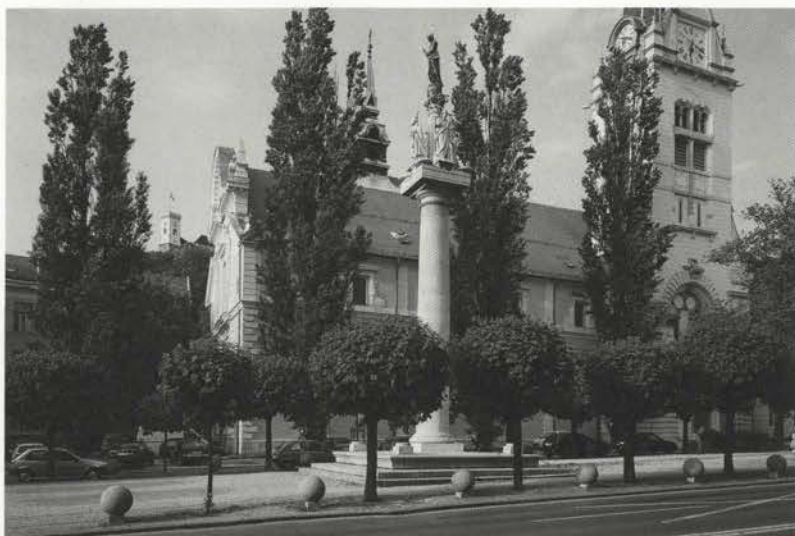
Levstikov Trg: "The regulation of the square with a circular layout and the plantation of ball-shaped maple trees thus concluded Plečnik's green avenue."

Only some of the ball-shaped maple trees were replaced in the

central area of the square. The rest are still from the original plantation since they were protected against damage by boundary stones. Corner poplars were planted along the perimeter of the sand surface by the church and in the square in front of it. As quickly growing trees of fragile wood, the poplars have already been entirely replaced with new trees of the same variety at the beginning of the 1990s.

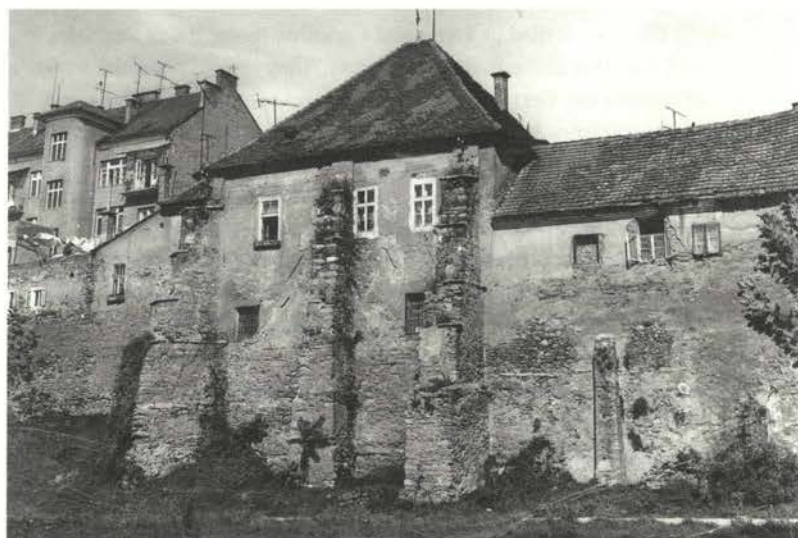
Synagogue before the renovation: "In mediaeval towns, it was decreed that the Jews were to settle merely in certain quarters of the town, i.e. located on the outskirts or along the city walls."

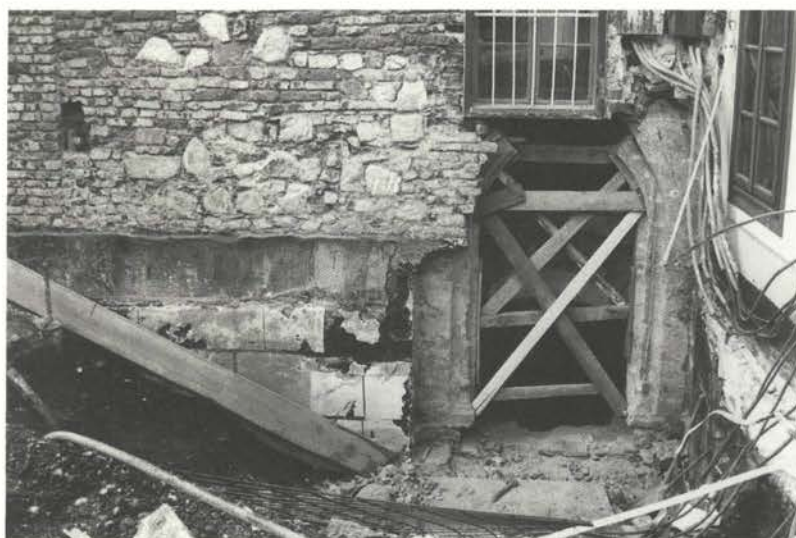
Gothic portal before the renovation: "The discovery of the external Gothic portal posed a somewhat greater dilemma, since it was located 1.5 m below the level of the square, therefore requiring intervention in the present regulation of the urban setting."

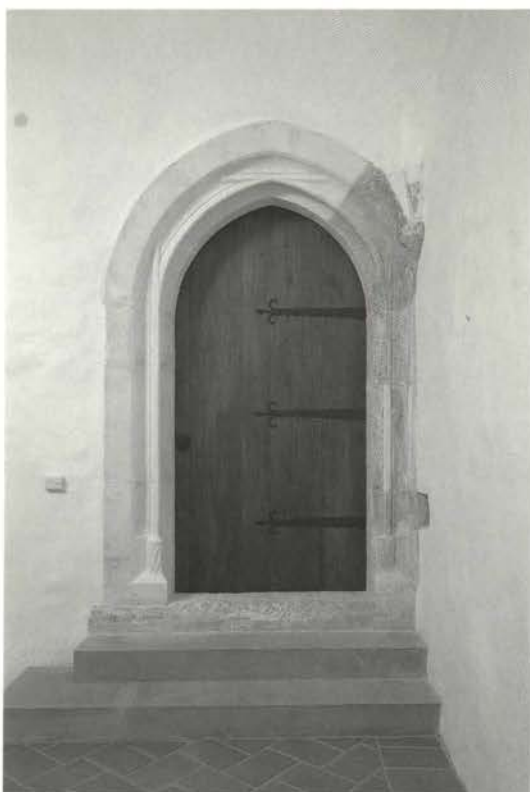
“Two partly preserved Gothic portals were discovered in the process of construction investigations, apart from remnants of Gothic windows [...]. On the basis of the finds, the data from earlier literature [...], it was possible to reconstruct the synagogue and present it almost in its entirety from a single period, i.e. the middle of the 15th century.”

Two partly preserved Gothic portals were discovered during the construction surveys, apart from remnants of Gothic windows in the southern, eastern and western walls, the niche where the Torah was kept and a partly preserved donors' window on the northern wall. After the removal of the fill above the vaults from the 19th century, a series of important architectural details was revealed, including consoles of Gothic ribs, Gothic mouldings and details of the vault ribs. In short, a series of data was discovered on the basis of which the plan for the reconstruction of the vault and the primary inclination and

form of the roof were made. On the basis of the finds the data from earlier literature and experiences of the experts with conservation works on other complex cultural monuments, it was possible to reconstruct the synagogue and present it almost in its entirety from a single period, i.e. the middle of the 15th century.

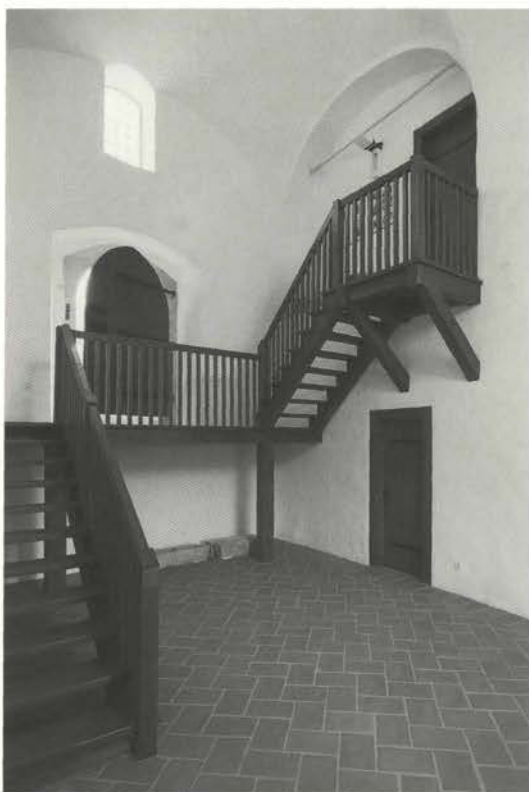
"All the doors and windows were made anew and the wooden staircase was built in the vestibule [...]. After the decision was taken to reconstruct the building from the 15th century, there were no major conservation dilemmas."

After the decision was taken to reconstruct the building from the 15th century, there were no major conservation dilemmas. Thorough construction surveys have revealed sufficient data to trace the appearance of the synagogue from that period. The most demanding task was the reconstruction and completion of stone-cut architectural elements like the ribs and mouldings of the Gothic vault, Gothic windows and rosettes, the reconstruction of the donors' niche and the entrance portals. All the doors and windows were made anew and a wooden staircase was built in the vestibule. All the rooms, with the exception of the office, were paved with hand-made brick paving. The internal and external plasterwork was prepared with the addition of tenesit, while sanitation plaster was used in the rooms where humidity was established.

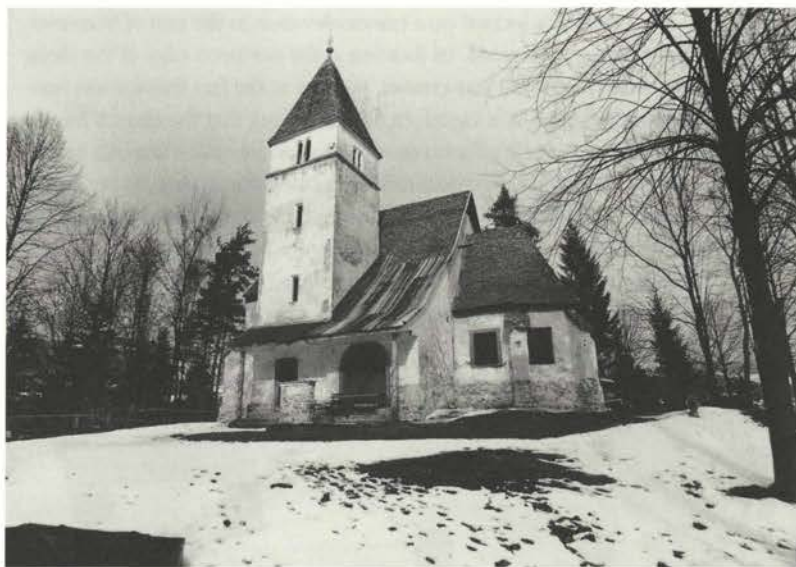
"The condition of the church was critical particularly as far as the construction was concerned, and the expressive quality of the monument was curtailed due to inappropriate interventions in the past."

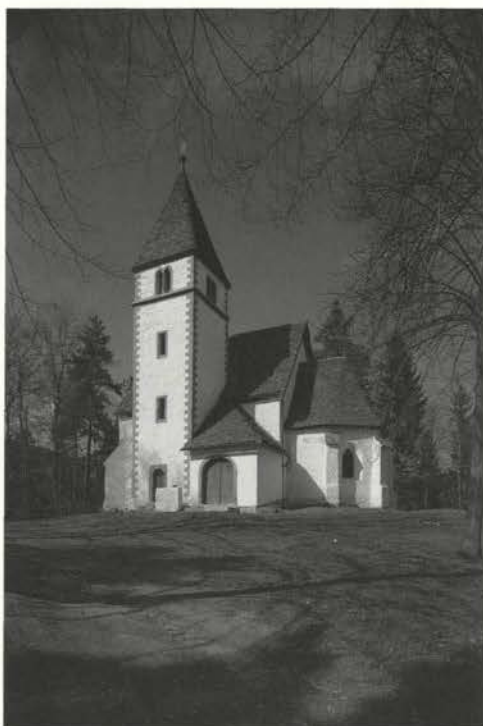
“The basic Gothic architecture of great quality with the Baroque chapel as an extension was thus successfully presented by means of newly formed roofs, primarily on the southern side.”

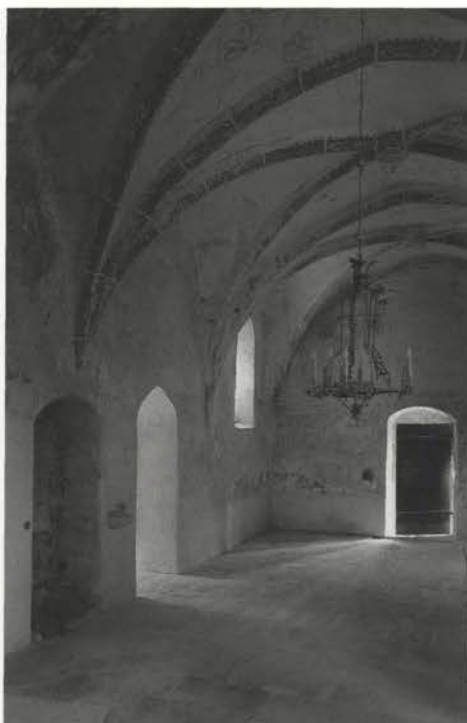
“Paintings were discovered beneath the top layers of plaster on the entire surface of the nave and the presbytery, probably originating from at least three different periods. [...] It was probably vaulted with cross arches only in the second half of the 15th century...”

The interior of the church was rather dull before the renovation: polychromatic Gothic ribs were thickly covered with plaster, and the same was true of the surrounds that were utterly robbed of their original appearance by subsequent transformations. Trial boreholes and other investigations were begun by uncovering the plasterwork

on the southern side of the church, where two Gothic windows were discovered that were built up due to the extension for the Baroque chapel. Another Gothic window was discovered on the eastern wall of the bell-tower. The original single-layer plaster was preserved on the walls of the bell-tower; it was strengthened and the missing parts reconstructed according to the model of the existing material. Paintings were discovered beneath the top layers of plaster on the entire surface of the nave and the presbytery, probably originating from at least three different periods. The plasterwork with frescoes was strengthened and fixed onto the walls. The missing part of the plaster where no paintings were traced was concluded and shaded in a colour corresponding harmoniously to the expressive interior. Individual local retouches are still to be performed on the painting, which will contribute to a more pronounced character of the painting itself.

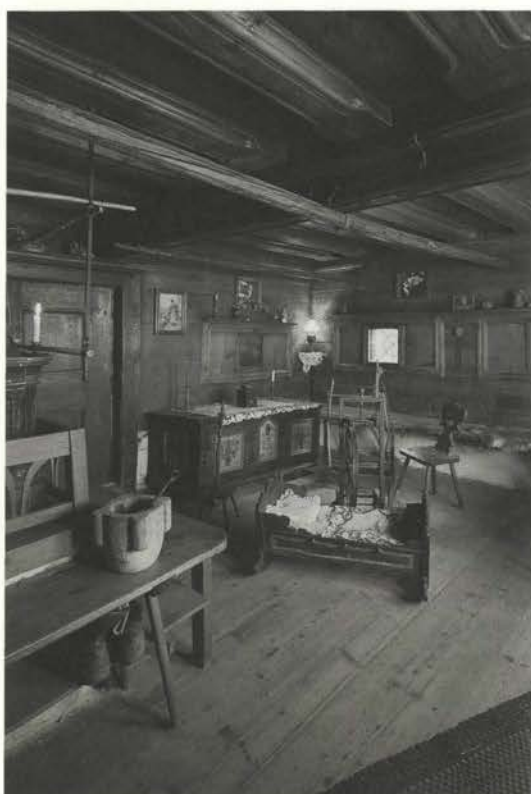
“Although the house in its present appearance and size came into being in the 18th century, the interior has preserved its Renaissance charm: a square chamber, a richly profiled ceiling common in houses of wealthy citizens in Škofja Loka.”

Although the house in its present appearance and size came into being in the 18th century, the interior has preserved its Renaissance charm: a square chamber, a richly profiled ceiling common in the houses of wealthy citizens in Škofja Loka, and sash windows framed with profiled frames. The furniture and other items were

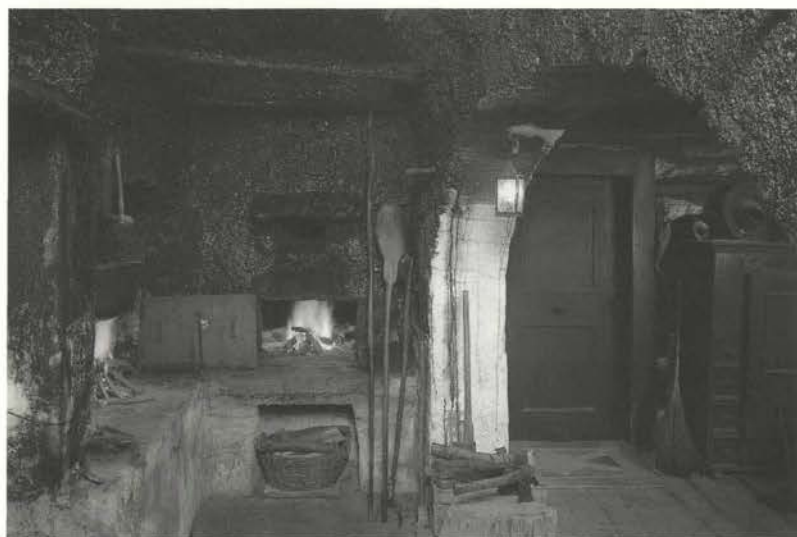
"The stone-built hall and 'black kitchen' were divided by a stone vault, the so-called 'šipovnik'; the name was derived from the German word 'Shifbogen' (i.e. 'ship arch') describing the type of vault. The entrance to the lower wooden house section and further to the closet was located on the right-hand side of the hall."

The Nace house is a partly stone-built, single-storey building with a rectangular floor plan and partial cellar. It was planned as the ‘black kitchen’ type that has been characteristic of the Alpine region since the 19th century. It could be defined as a typical Alpine house belonging to the region of Škofja Loka and Cerkljansko. The ground floor consisted of a residential part and an outhouse. The stone-built hall and ‘black kitchen’ were divided by a stone vault, the so-called

šipovnik; the name was derived from the German word *'Shifbogen'* (i.e. 'ship arch') describing the type of vault. The entrance to the lower wooden house section and further to the closet was located on the right-hand side of the hall, and to the stone-built granary on the left. The entrances to the outhouses were from the backyard. Access to the 'black kitchen' was also from there by means of a stone-built flight of stairs. The floor plan with the 'black kitchen' was repeated on the first floor. Only the upper house section and closet were located on the opposite side. There was a barn above the lower house

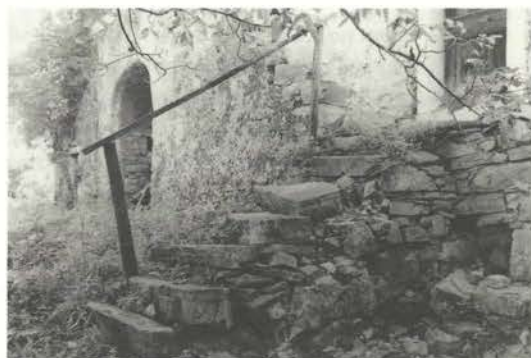
"The new entrance was located on the gable facade and thus oriented towards the south. A portal with a semi-circular conclusion was built in, bearing the date 1851. [...] When the renovation began in 1994, all the premises had been abandoned for several years and were in a poor condition."

Trial boreholes revealed that the residential area was originally smaller, single-storeyed and covered with a ridged slate roof. The house was raised by one floor in 1851. The inclination of the roof was changed and the roof was covered with tiles. The original entrance on the western side of the residential area was probably built up in the same year. The new entrance was located on the gable facade and thus oriented towards the south. A portal with a semi-circular conclusion was built in, bearing the date 1851. An unknown painter painted the fresco of the Crucified above the portal in the second half of the 19th century.

The residential area has undergone most changes. The transformations on the exterior are discernible primarily in the form of enlarged window openings. The transformation of one of them also damaged the fresco.

When the renovation began in 1994, all the buildings had been abandoned for several years and were in a poor condition. At the request of the proprietor, the renovation was initiated with the improvement of the outhouse, i.e. the cellar with the ‘faladur’ and granary. The existing walls were to be improved, roof and roofing renovated, external staircase and gallery mended and new doors and windows made. All the other roofs were renovated in the following years, together with the stone walls that were strengthened, and new doors and windows were made according to the existing models. The plaster on the facade was made anew.
