THE RESTORATION OF QUAGLIO'S WALL PAINTINGS
IN LJUBLJANA CATHEDRAL

The Restoration of Quaglio's Wall Paintings in Ljubljana Cathedral

A conservation-restoration project involving the wall paintings created by Giulio Quaglio (1668–1751)

on the nave vault and the western wall of the Cathedral of St Nicholas in Ljubljana, IPCHS Restoration Centre (2002–2006)

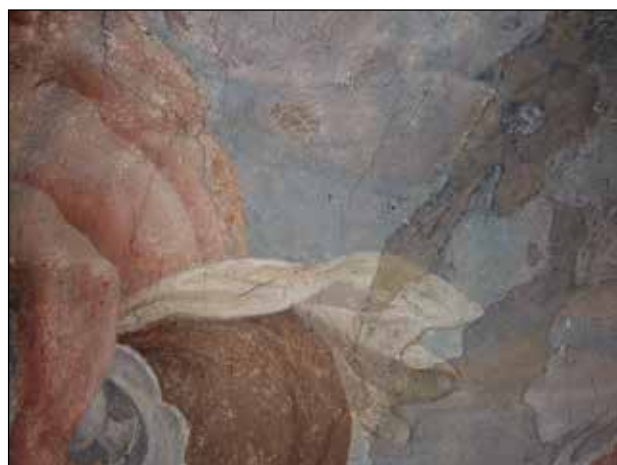
Figure 2: Traces of greater damage on the paintings on the western wall (5 December 2002).

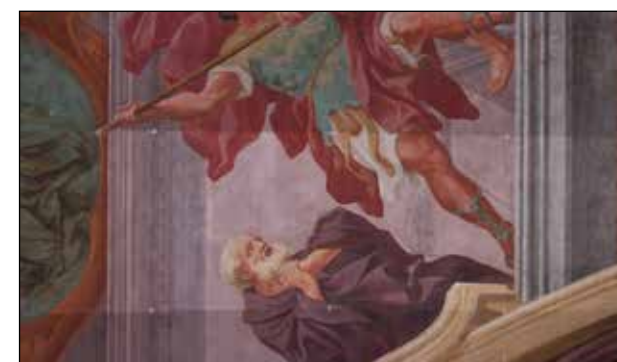
Figure 5: Mechanical removal of impurities (13 February 2003).

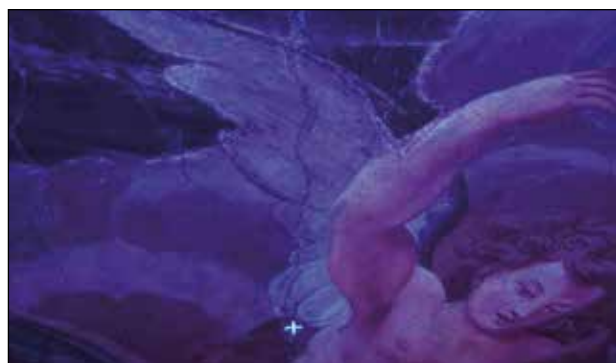
Figure 7: UV image of areas where cracks had occurred (30 June 2003).

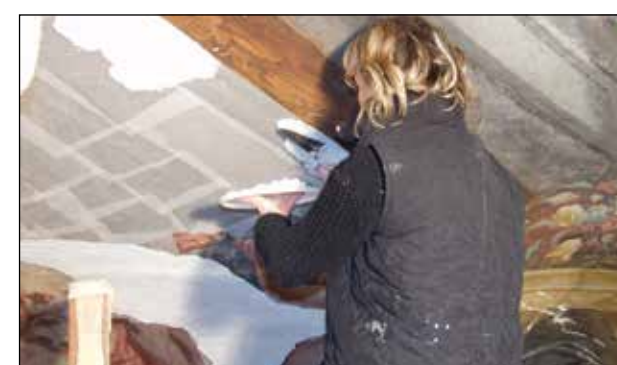
Figure 12: Beginning of chemical cleaning (25 February 2004).

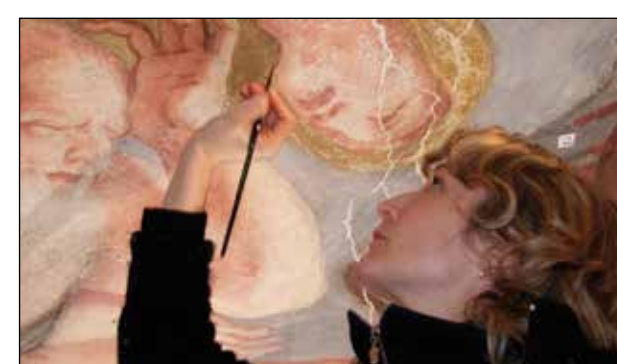
Figure 13: First attempts at retouching with ammonium caseinate (2 April 2004).

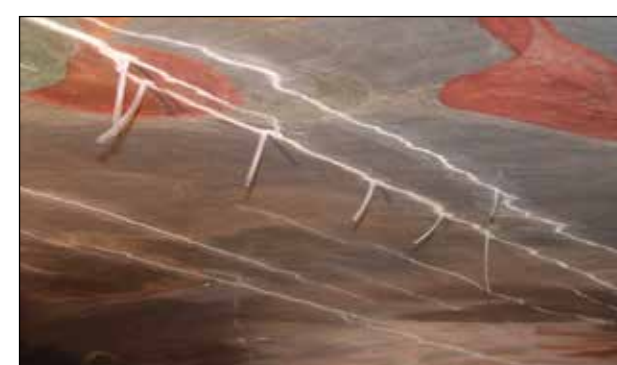
Figure 14: Inserting tubes for injecting (2 April 2004).

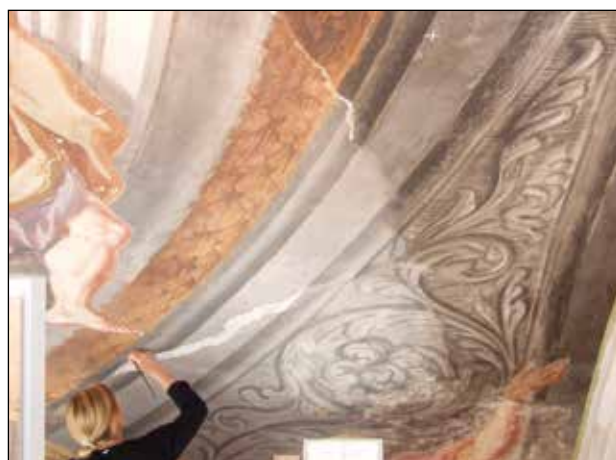
Figure 15: Darkened reconstructed vault painting, which occurred with the new application of plaster in places where the old plaster had fallen off during the earthquake of 1895 (28 May 2004).

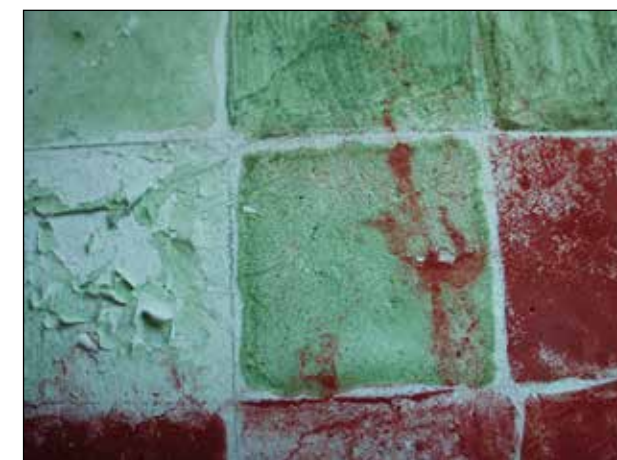
Figure 18: Samples of pigments and binders after the artificial ageing procedure was completed (7 January 2005).

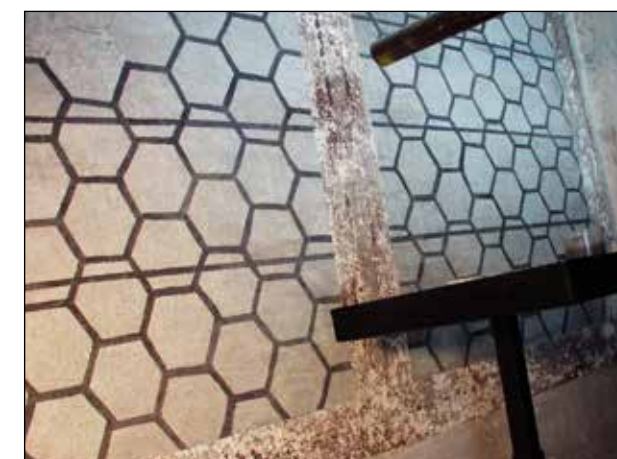
Figure 19: Retouching and reconstruction of the blind window (20 January 2005).

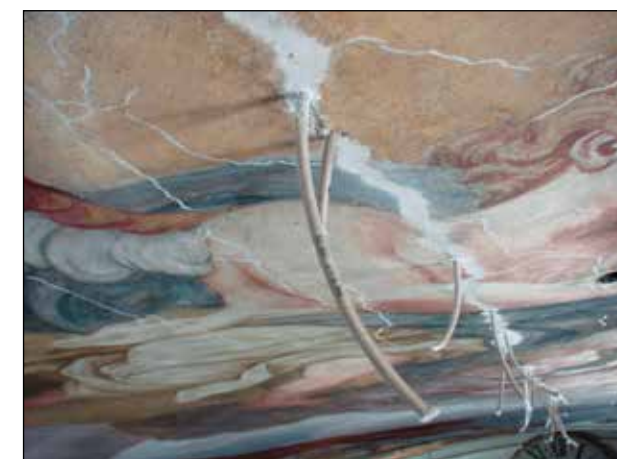
Figure 20: Tubes after injecting was completed (25 May 2005).

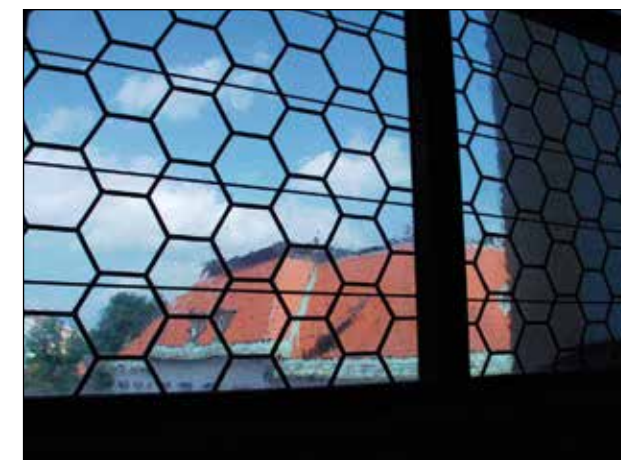
Figure 21: Installation of new stained glass (7 September 2005).

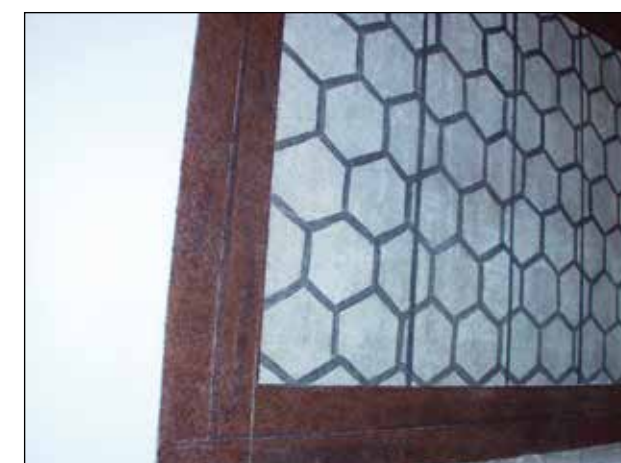
Figure 22: We can imagine the appearance and structure of the original windows from the two paintings of the blind windows (7 September 2005).

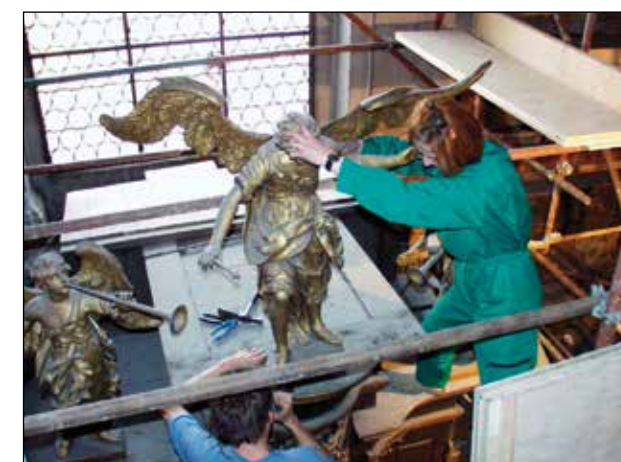
Figure 23: Dismantling of the organ sculptural decoration (27 February 2006).

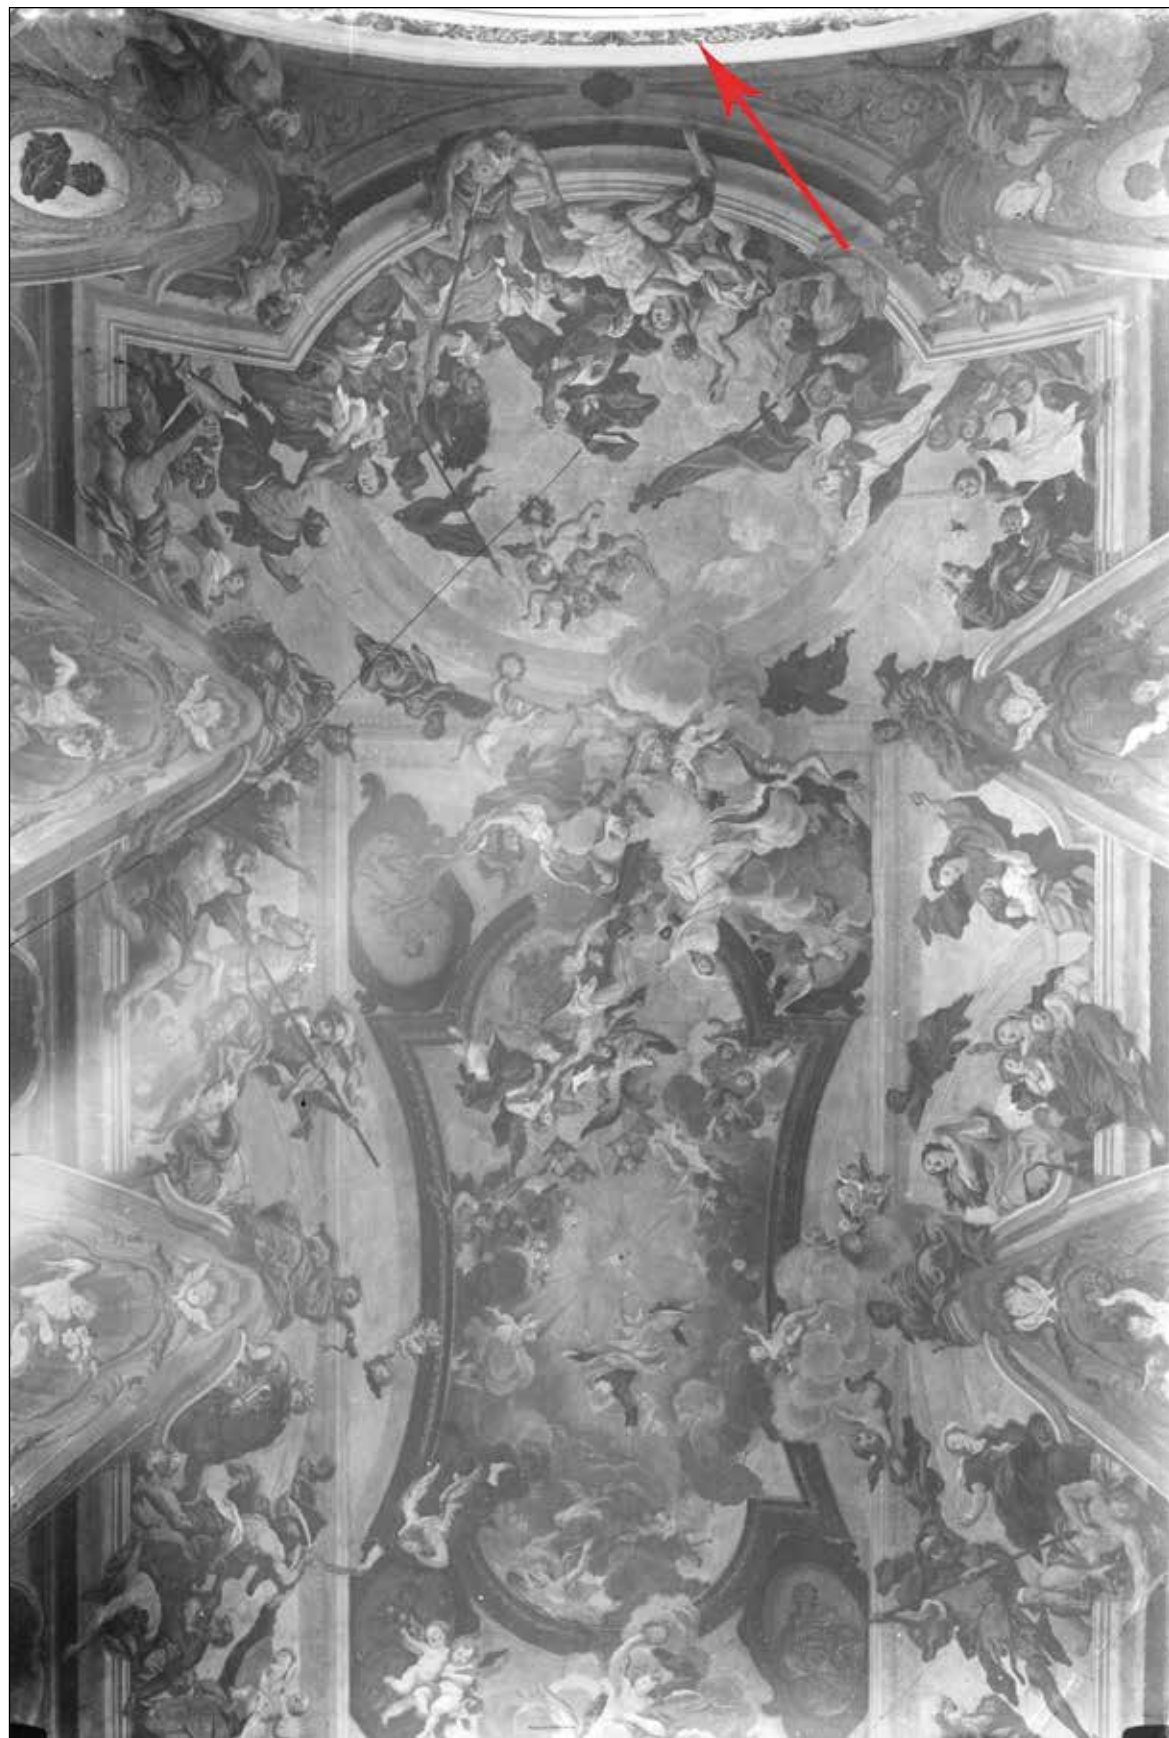
Figure 7a: A high quality photograph of the nave vault, photographer and date unknown, shows the condition of the painting after Jebačič's restoration. The vault painting appears "cleaned", there are no darkened cracks or stains; the arch painting is already visible.

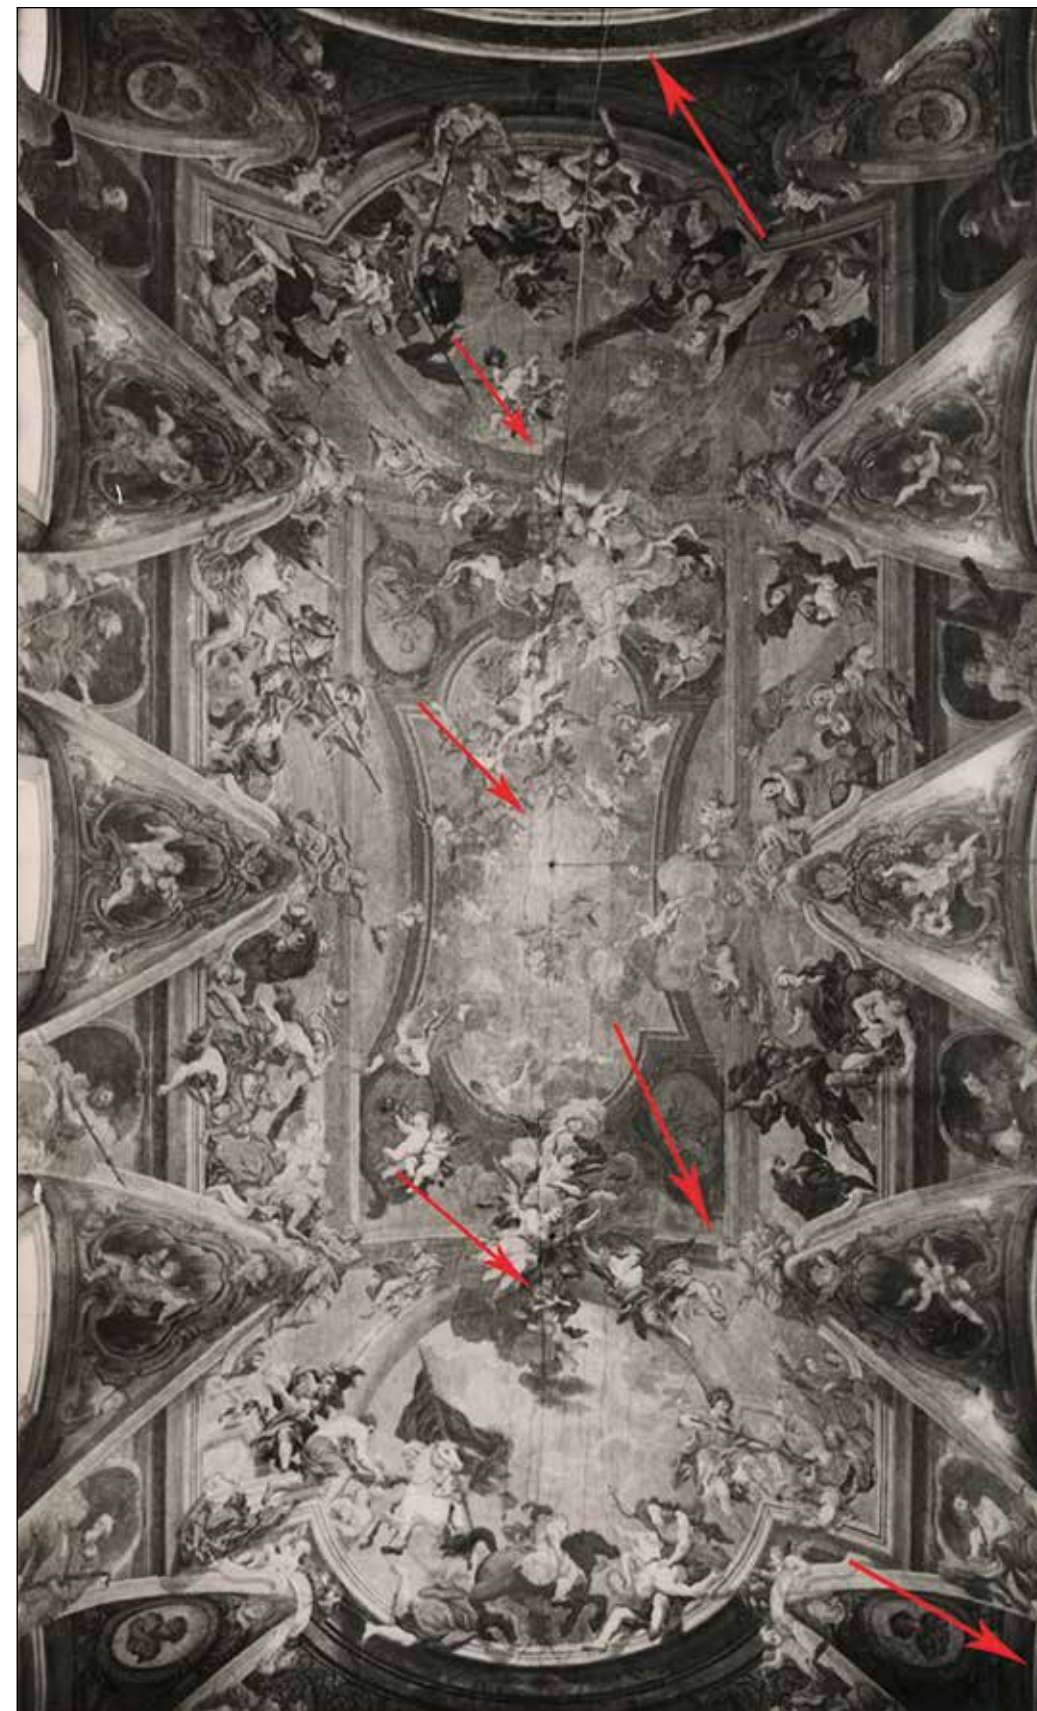
Figures 8a and 8b: The condition of the wall paintings in the 1940s, thought to be taken in 1941.
Figure 8a: France Stele's photograph of the nave vault painting showing cracks, with the arch wall painting, but no damage caused by damp (e.g. the head of *Bonitas*).

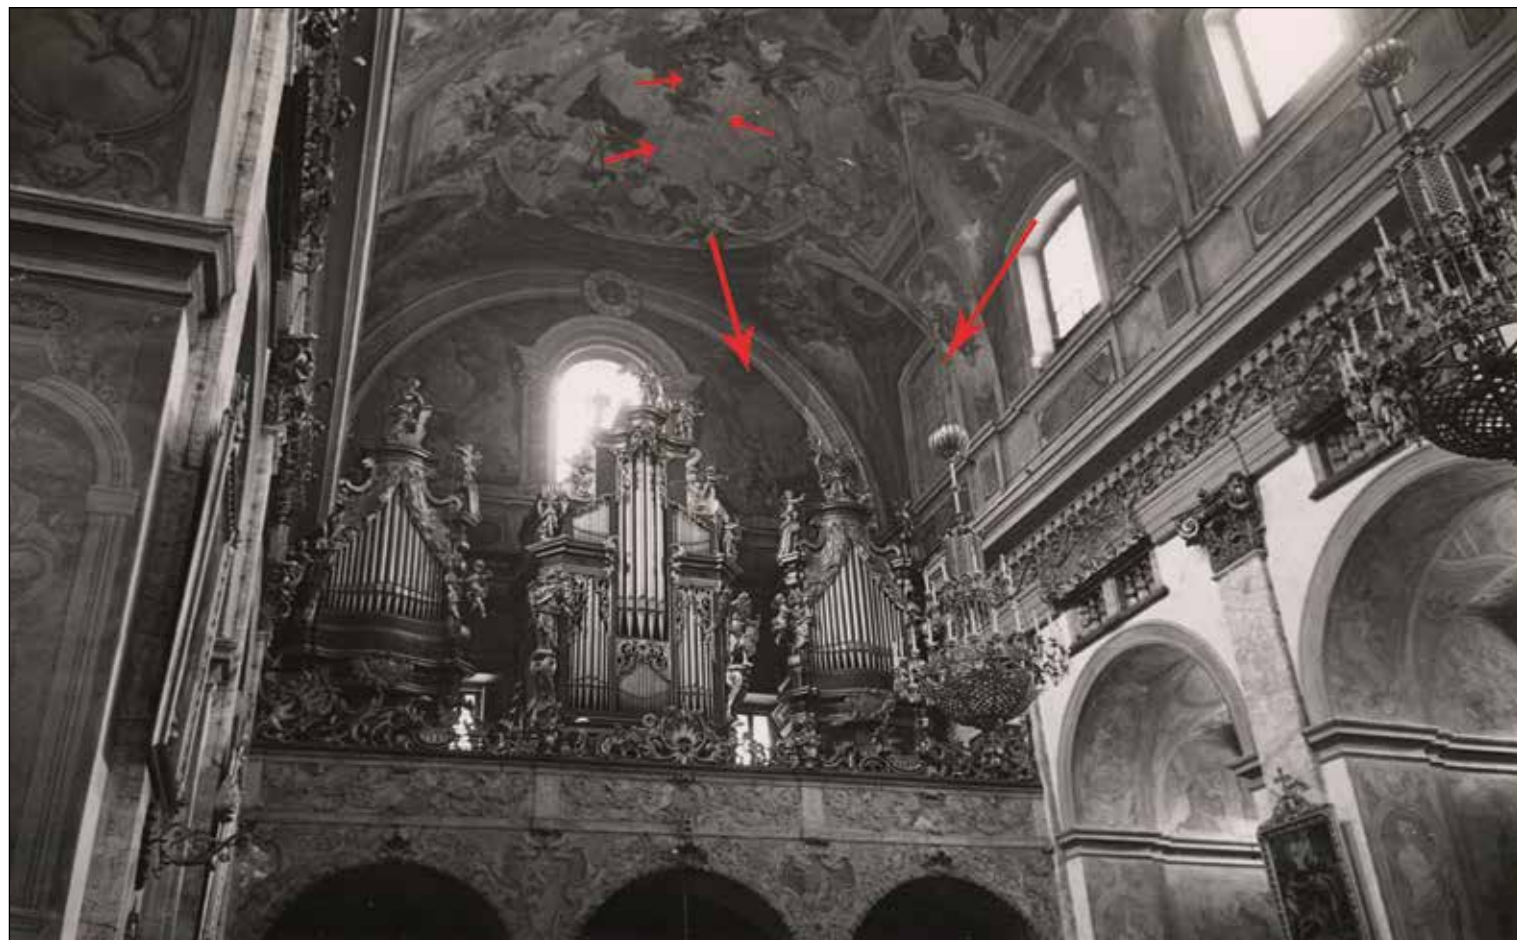
Figure 8b: A shot of the interior looking north-westwards, perhaps taken by Peter Železnik, with visible damages in the area adjacent to the bell tower and the decorative painting on the blind window.

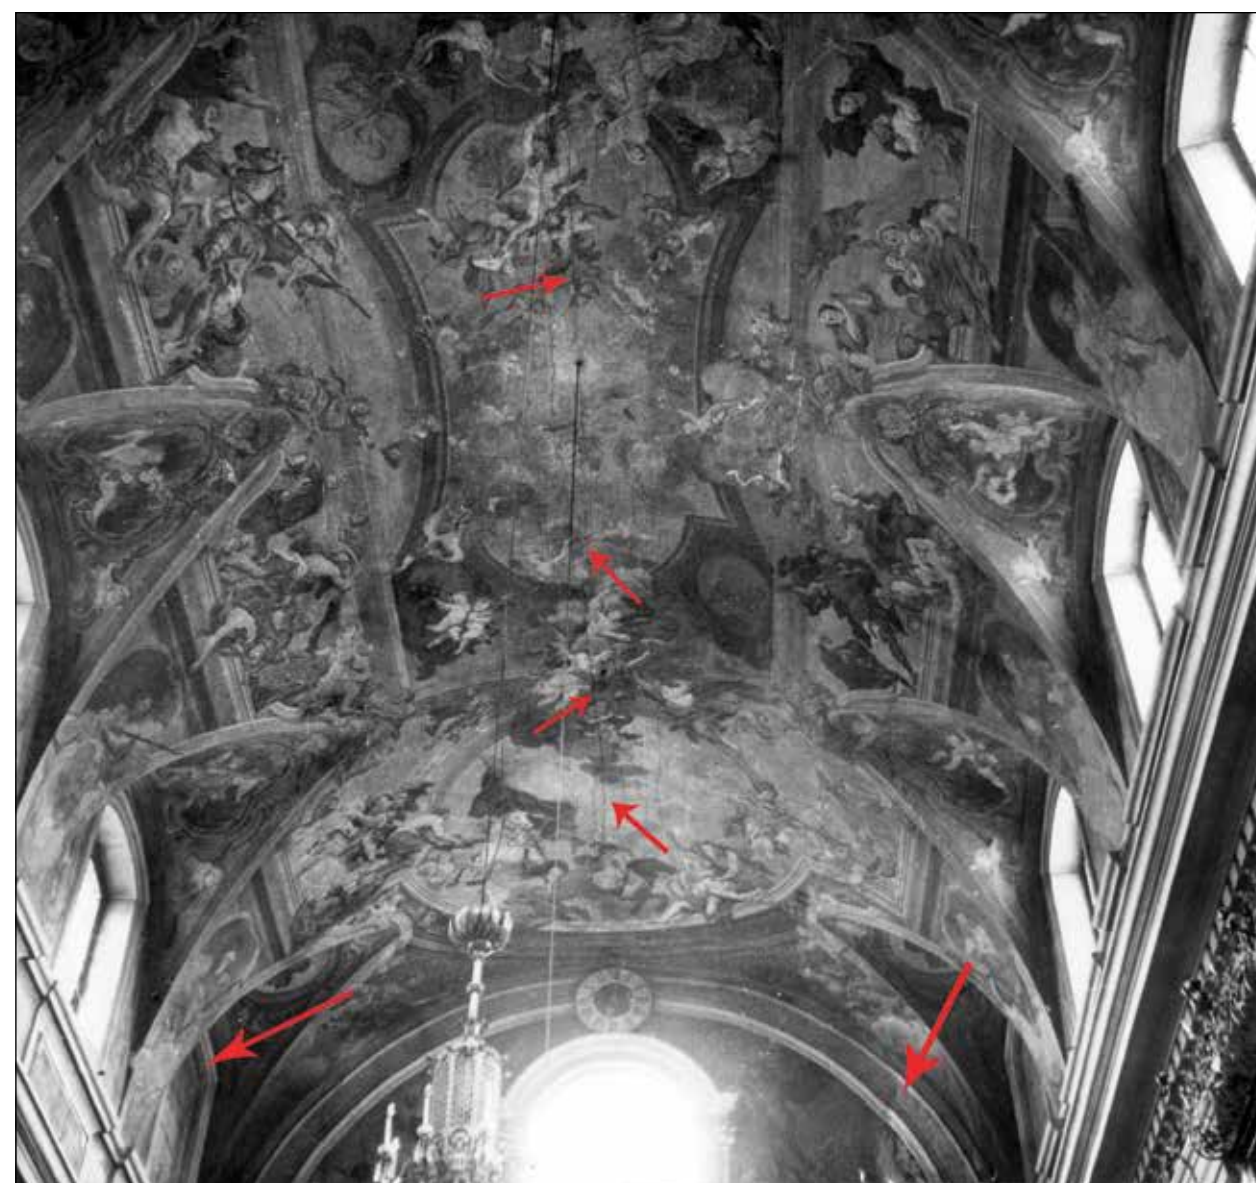
Figure 11a: The nave vault painting prior to Železnik’s restoration on a shot of the interior looking westwards, photographer and date unknown, shows cracks on the vault, damage in the north-western corner and the decorative painting on the southern blind window.

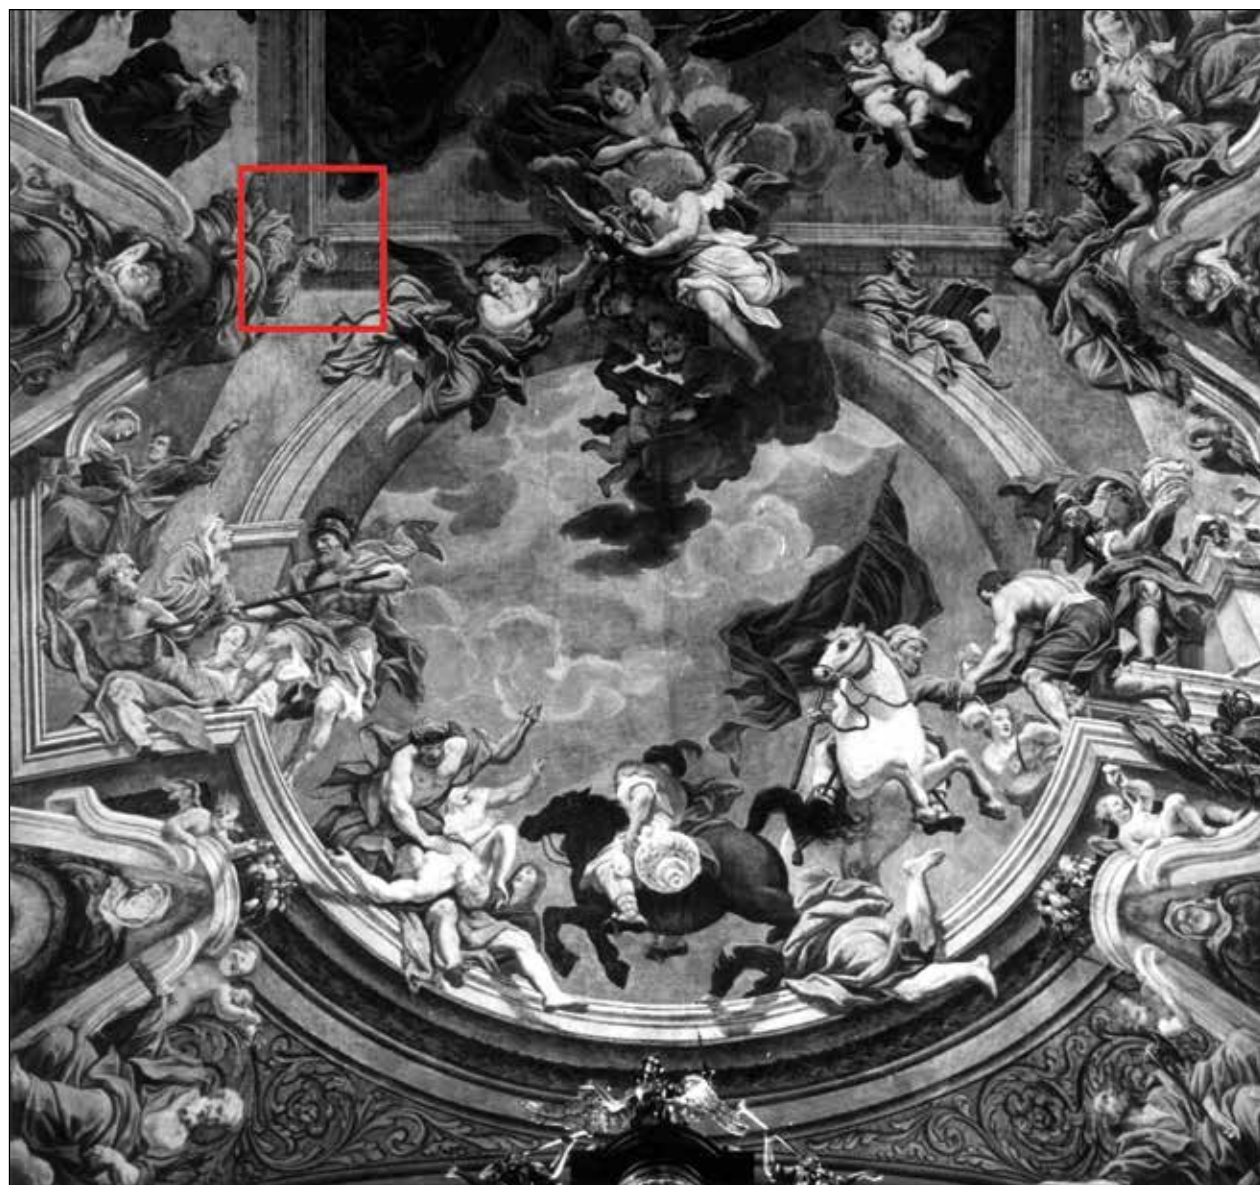
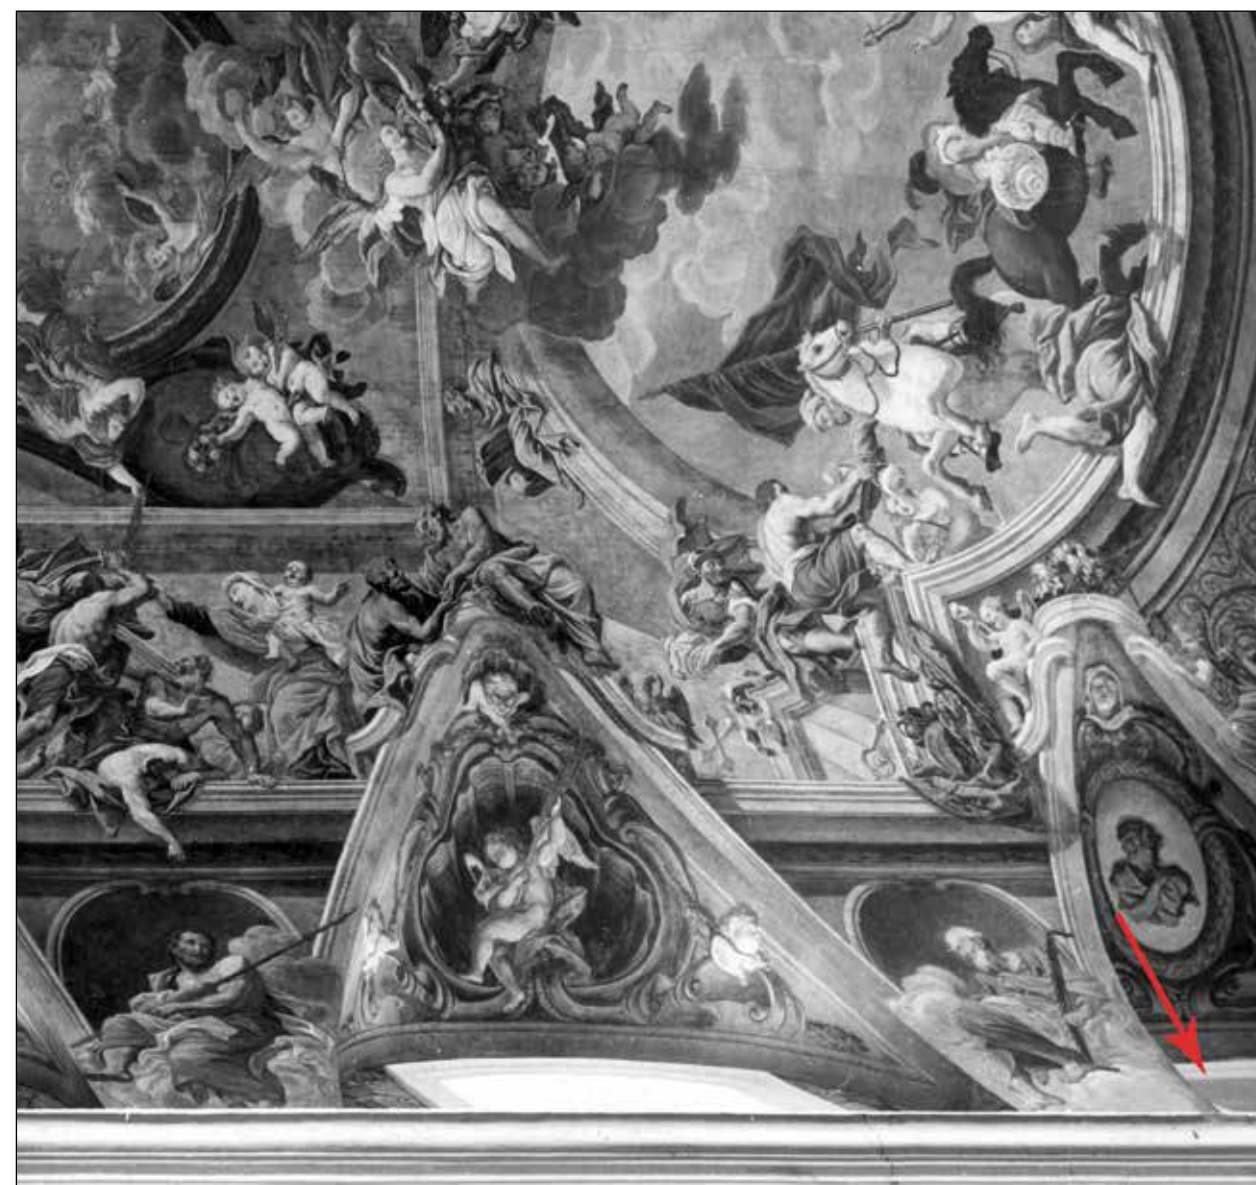
Figures 11b, 11c, 11d show the restored nave vault painting after Železnik's restoration in 1959/60; photographer and date unknown. **11b:** On the scene *Plundering Valuables from the Temple in Myra* there is no noticeable damage caused by damp (e.g. the head of the virtue *Bonitas*; **11c:** or darkened cracks and dirt, this also applies to photograph **11d**, where on the south-western section of the scene on 11b, we see a part of the southern blind window with the already whitewashed decorative painting (right).

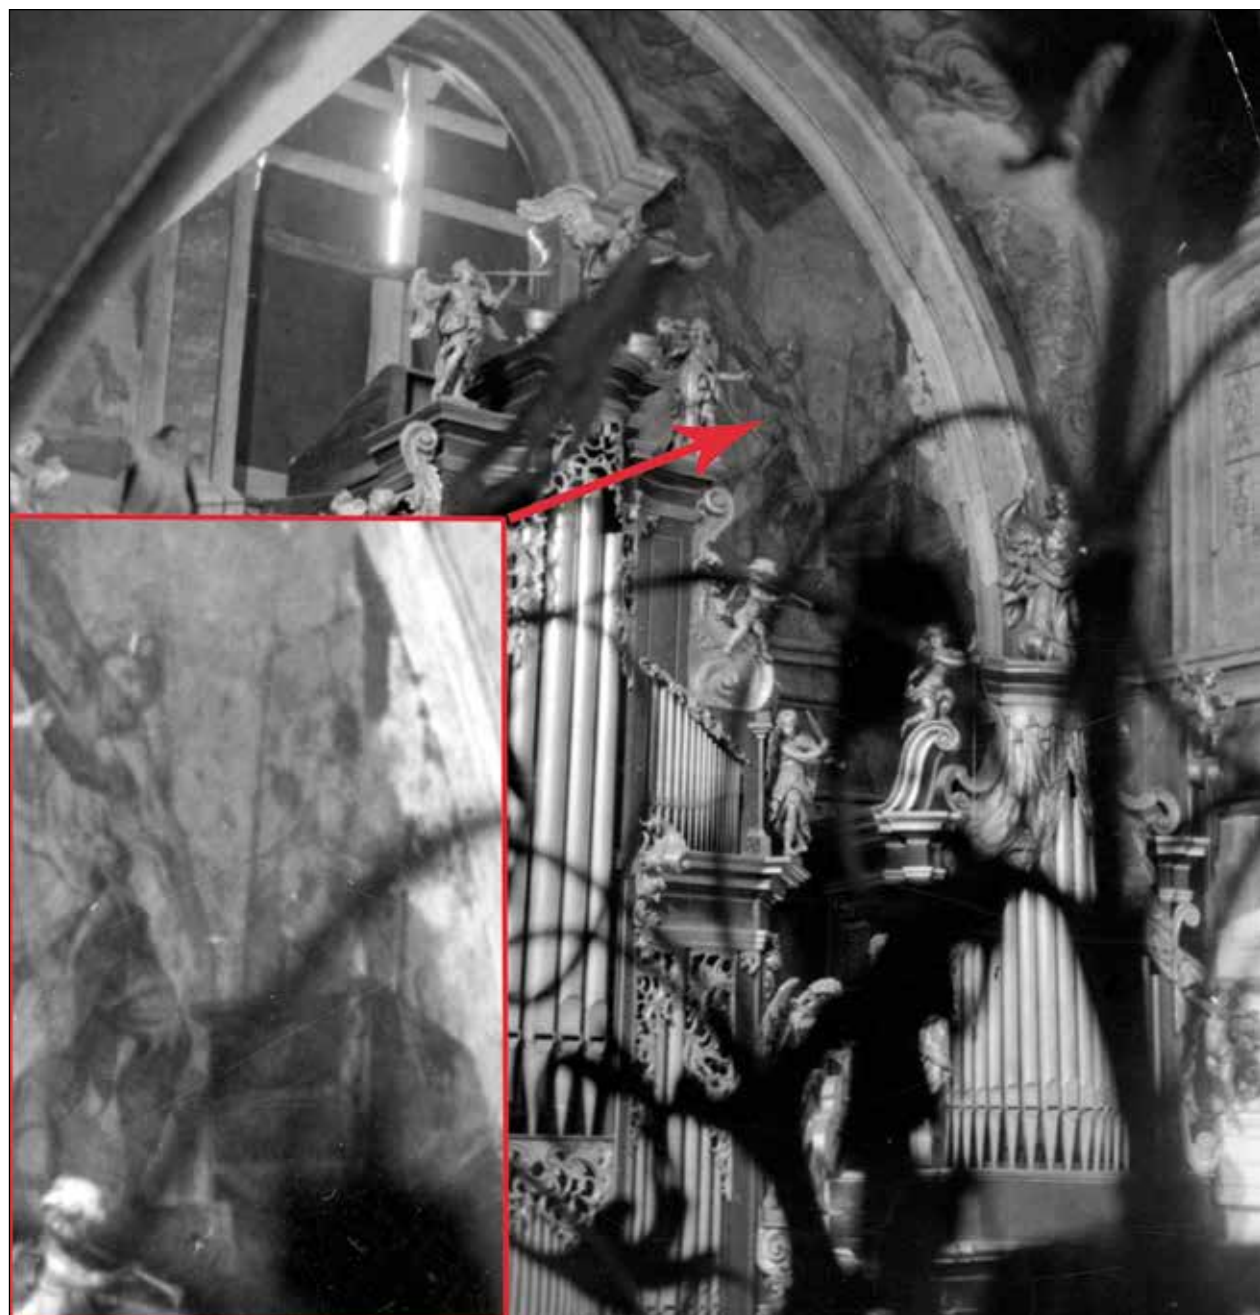
Figure 14a: The damage on the western wall was caused by the 1895 earthquake and by the restorations of the western gable and the organ. Jebračič's reconstruction of Nicholas's head can be seen on France Stele's photograph of the organ from 1952.

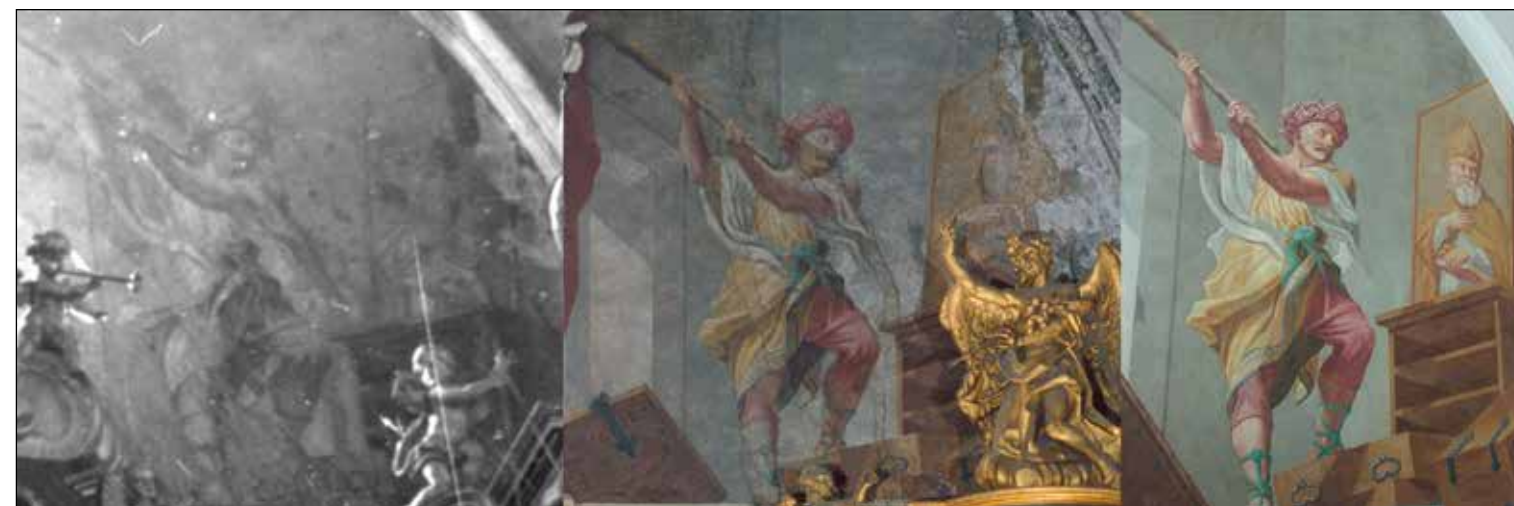
Figure 14b: A comparison of the condition of the western scene on the right in a detail: **14b left** from Šumi's photograph from 1952 to the condition in 1981 prior to the last treatment: **14b middle** and after it in 2006: **14b right**.

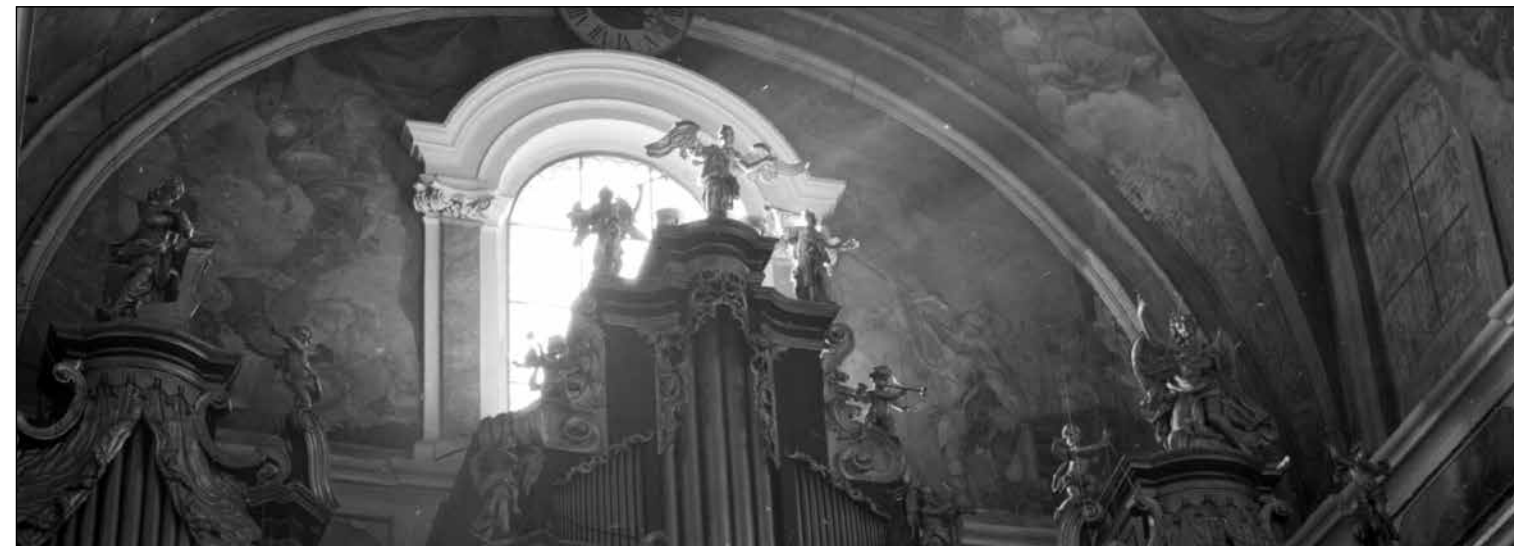
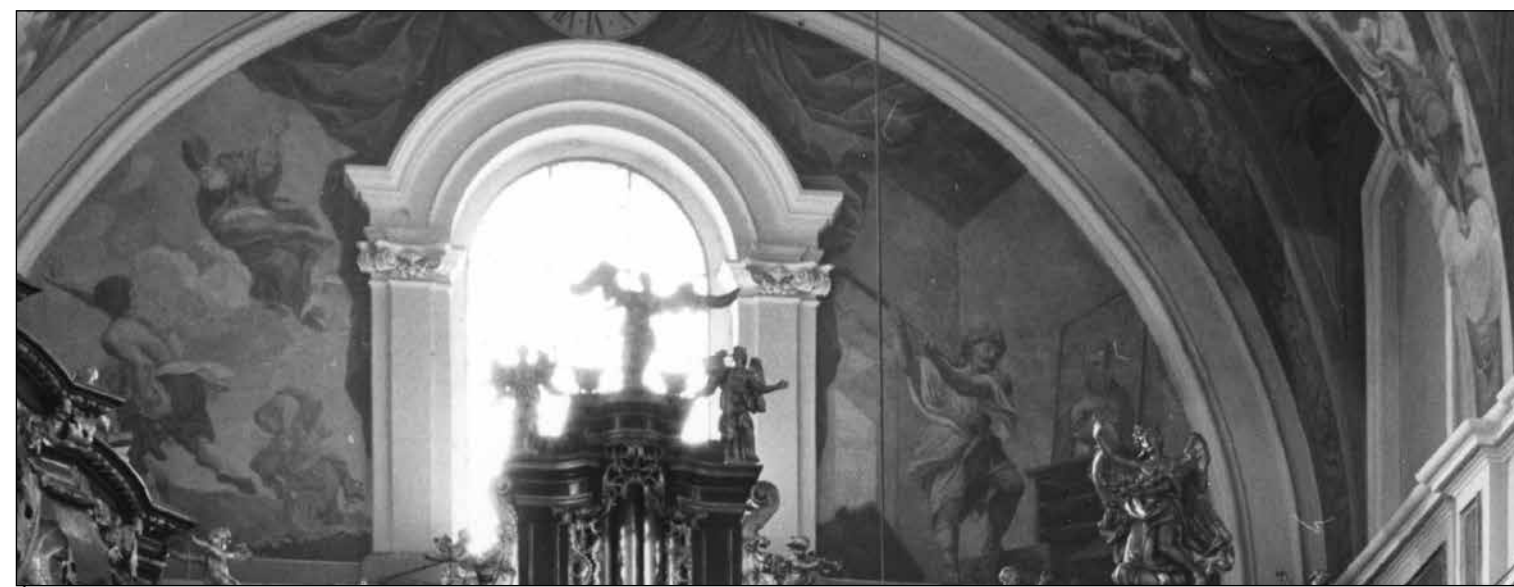
In a detail: **14c** from Šumi's photograph of the organ from 1952 the still unrestored western wall painting is visible; while a detail: **14d** from the shot from an unknown photographer and date, shows the restored condition, with the whitewashed blind window, probably after the 1959/60 restoration.

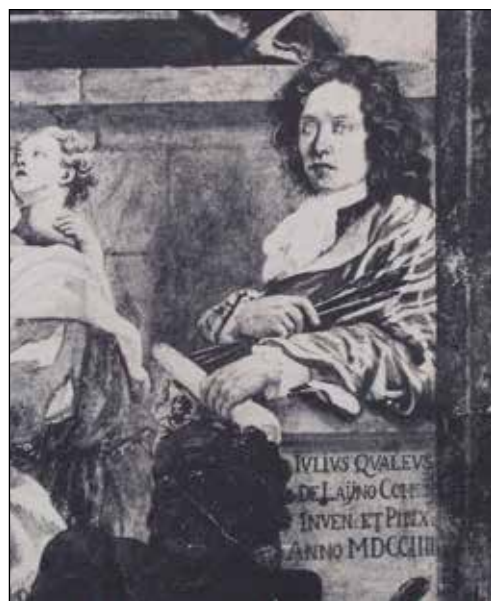
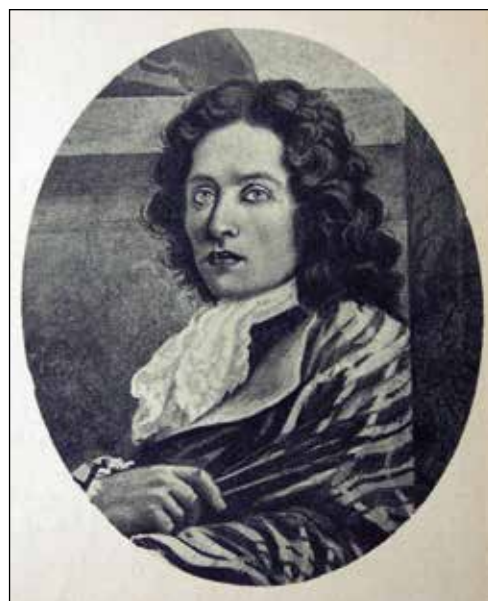
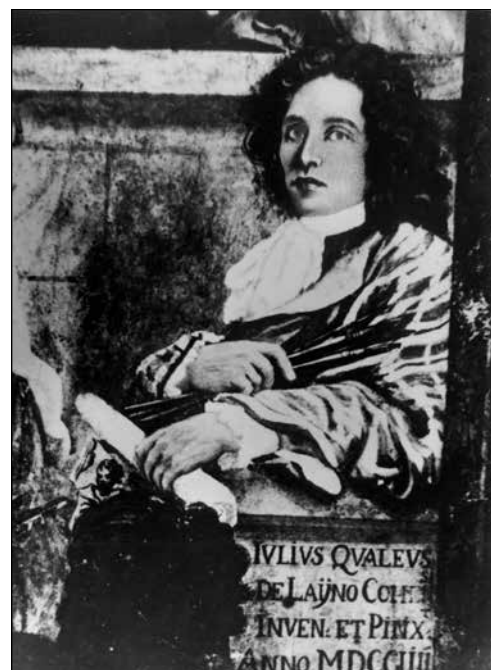
Figures 15a–15f: The consequences of the restorations of Quaglio's self-portrait. 15a: From before 1903, perhaps 1898, from Kotar's series of postcards (detail from figure 5b, p. 57).

15b: From before 1927 (published in *Ilustrirani Slovenec*, 1927, p. 393).

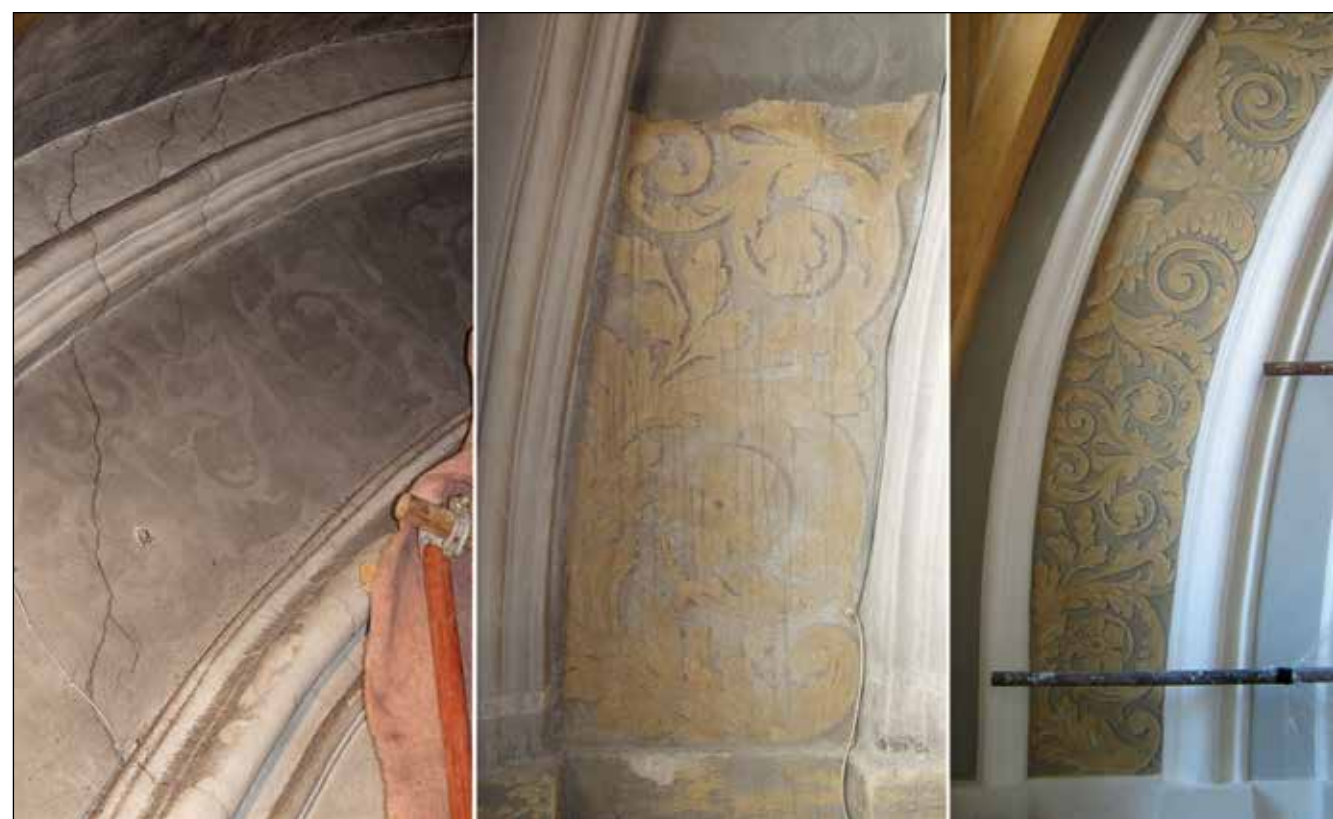
Figures 16a–16g: The decorative arch painting - a surprise during the last restoration: **16a** in 2002, prior to the last restoration, during the restoration in 2003 and after it in 2006.

The underlying painting was partly visible through the grey whitewash even before 2002. After removing the whitewash, a considerably damaged colour layer appeared, but we were still able to ascertain that the wall painting was originally painted very well using colour nuancing that gave it volume (figure 16a). It is an interpretation of the theme of intertwined acanthus leaves, with four winged angel heads positioned symmetrically two at each side. In spite of its stylised nature, the decoration has retained its plasticity. The foliage with the winged angel heads was painted in yellow ochre using the secco technique, which made it considerably more difficult to uncover the painting, whilst the grey base is most likely a true fresco.²⁰³ A question arises as to when and why the painting first appeared, who painted it and when it was whitewashed.

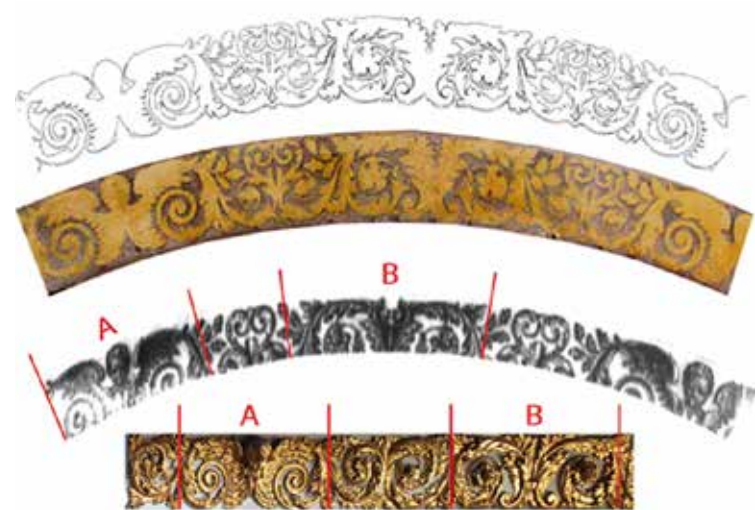
d

16b: A detail from a high quality photograph of the nave vault, photographer and date unknown (figure 7a), was of key importance in the restoration of the arch painting. **16c:** The winged angel head from the gilded stucco freeze under the main wall garland in the cathedral interior. **16d:** Comparisons of decorative patterns: the drawing of the arch painting, the painting now and in the past and the stucco work with the sequence A – a part of the pattern with the angel head and B – without the head.

we saw a precisely and very finely painted decorative band (figure 16b). The former decorative, repetitive symmetrical frontal wall painting on the photograph, due to its plasticity, gives the impression of being stucco work. We are assuming that this is the legacy of the typical decoration of church premises in the late 19th and early 20th century.²¹⁵ Showing what has been described as “*neo-Baroque vegetational architectural features*”,²¹⁶ the arch wall painting thus adapted to the character of Quaglio’s wall paintings and the Baroque stucco ornamentation, even surpassing to a certain degree the otherwise typical two-dimensional expression of historical decorative art. The assumed creator Anton Jebačič²¹⁷ is described by Žigon as in general a skilful compiler. She defined him as “*a good ornamentalist, who in the selection of suitable architectural ornaments knew how to accentuate an architectural space with simple decorations which completely and harmonically blend into spaces marked by different styles.*”²¹⁸ Let us mention two examples for a comparison with the Cathedral’s decorative wall paintings. The first is a detail from the arch wall painting in the neo-Romanesque parish church of St Simon and Jude the Apostle in Črnuče from 1901. This first larger work by Jebačič²¹⁹ is stylistically and formally closest to the arch wall painting in the Ljubljana cathedral. Žigon said that the wall painting with Romanesque patterns was of a completely ornamental character, accentuating the architectural elements of the church, giving it a subdued, light and warm atmospheric note. In comparison to the painting in the cathedral, it gives a flatter and more ornamental impression. It is thus clear that the painter in the cathedral adapted his work to the Baroque plastic character of the stucco work, which he copied in the light, warm colour harmony of yellow ochre (imitating the gilding). The second example is a detail from the painting of an ornamental band below the main wall garland in the presbytery of the parish church of St Anthony of the Desert in Železniki from 1891, which is the only wall painting by Ludvik Grilc (1851–1910).²²⁰ In comparison with the cathedral arch wall painting we can in the shape of the vegetation tendrils and leaves recognise a

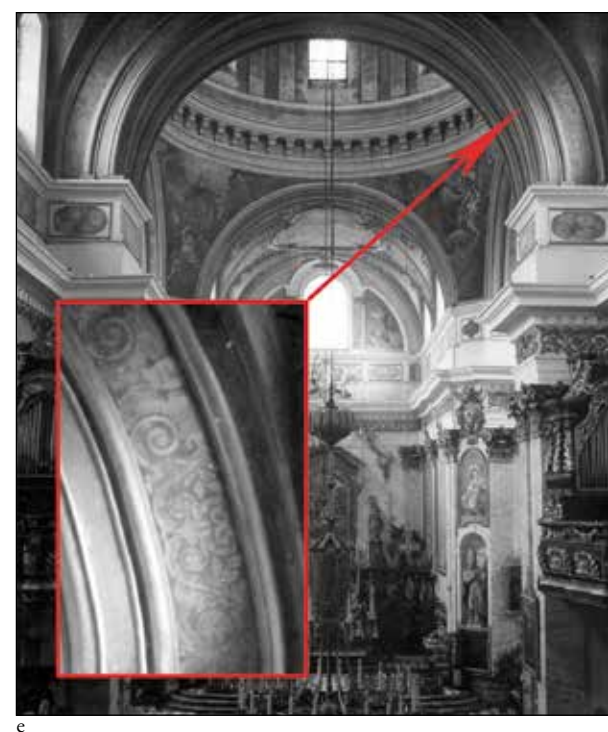
e

Figure 16e: Šumi's photograph containing the visible arch painting from 1952. **16f:** The shot of unknown photographer and date with whitewashed arch wall; probably after Železnik's restoration in 1959/60. **16g:** The present day church interior with the arch painting visible once more, 2009.

The first thing we found in our research was Mesesnel's photograph of the cathedral interior with a view of the arch, on which the decorative painting can clearly be discerned.²⁰⁴ When the photograph was taken is not known, but we can assume that it was during the War.²⁰⁵ On the reproduction of Kotar's photograph of the arch, published in 1903²⁰⁶ (figure 5a), the painting is not visible and on the photograph of roughly the same scene from Archbishop Jeglič's album, dated 1936, we can notice a darker trace, which could be the wall painting.²⁰⁷ The key discovery was Šumi's photographs from 1952, on which the arch wall painting is clearly visible (figure 16e).²⁰⁸ Photographs taken of the arch after that show only a grey layer of whitewash²⁰⁹ (figure 16f).
