THE RESTORATION OF QUAGLIO'S WALL PAINTINGS
IN LJUBLJANA CATHEDRAL

The Restoration of Quaglio's Wall Paintings in Ljubljana Cathedral

A conservation-restoration project involving the wall paintings created by Giulio Quaglio (1668–1751)

on the nave vault and the western wall of the Cathedral of St Nicholas in Ljubljana, IPCHS Restoration Centre (2002–2006)

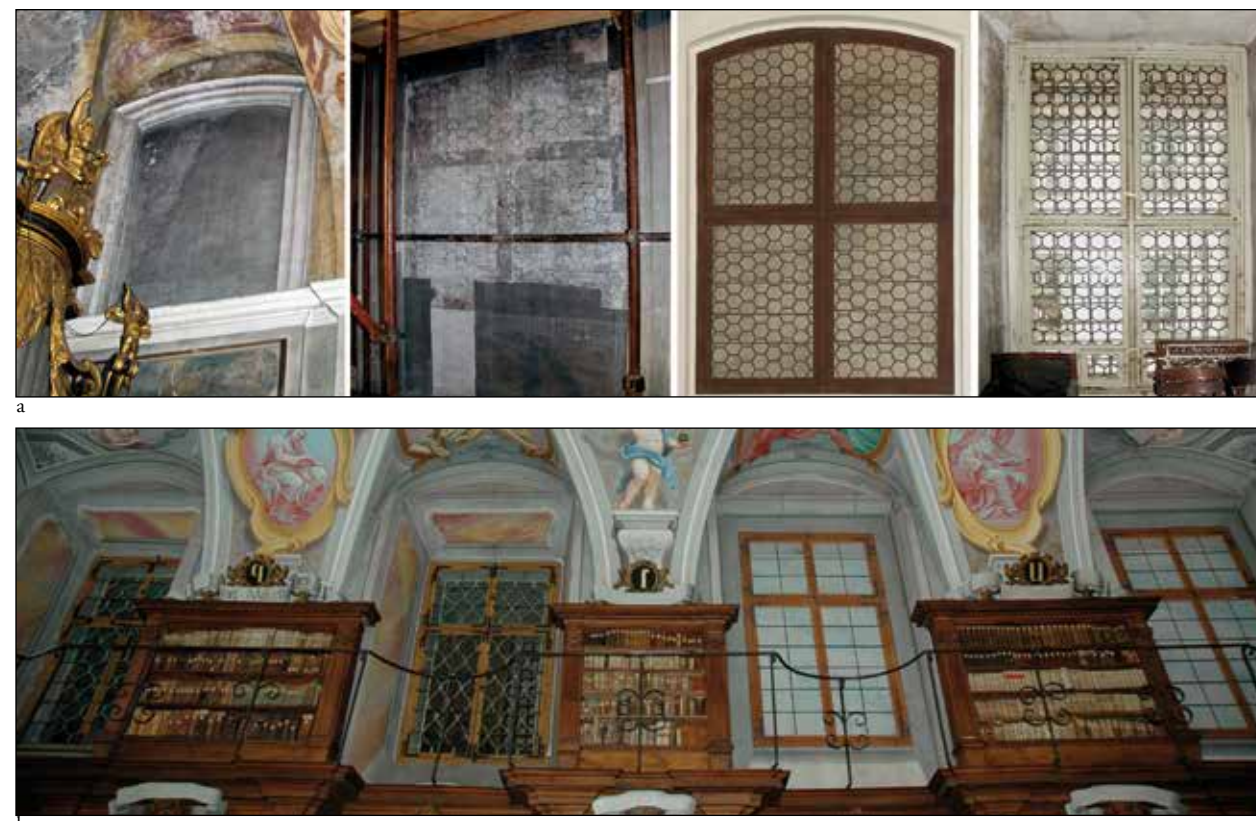
Figures 17a and 17b: The blind window in 2002 before the last restoration, in 2003 during it and in 2006 after the restoration, in comparison with the original Baroque window in the room above the cathedral sacristy: 17a and with the blind windows in the Seminary Library in Ljubljana: 17b.

the main wall garland below the lunettes, which cut directly into the barrel vault and the large window in the western wall. The fourth “window” on both the north side and south side of the nave just by the western wall is blind. During the last restoration (2002–2006) the windows were renovated as the non-original glazing was worn and damaged. Originally the basilica-like windows were also Baroque, in a honeycomb pattern; the glass was inserted into lead frames as can still be seen in the only preserved Baroque window in the upper floor of the north sacristy, which was of help to us in the reconstruction of the new glazing, copying the original Baroque style.²²²

The restoration project included the two blind windows typical of the Baroque artistic habit of playing with illusion and tricks, which had been, like all the other undecorated interior surfaces, whitewashed in grey. We removed the whitewash and presented Quaglio’s original fresco,²²³ an illusionistic window with a honeycomb pattern, imitating the original Baroque windows (figure 17a). But on old pho-

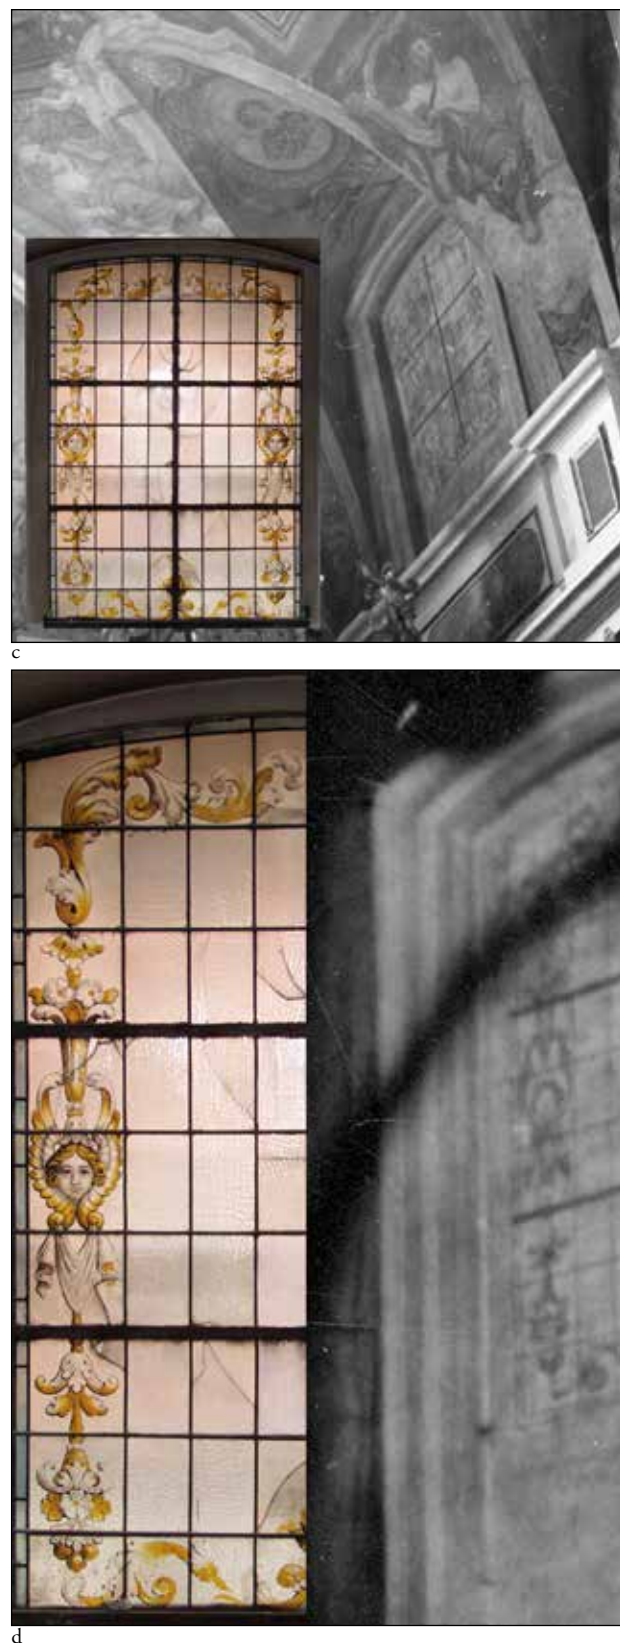
Figure 17c: Comparison of the decorative pattern from the stained glass of the old southern window: **17c left** with the painting of the north blind window from Šumi's photograph dated 1952: **17c right**. **Figure 17d:** Comparison of a detail from the stained glass of the old southern window: **17d left** with a detail: **17d right** from Stele's photograph (figure 14a). The same blind window was most likely whitewashed after 1959/60 (figure 14d).

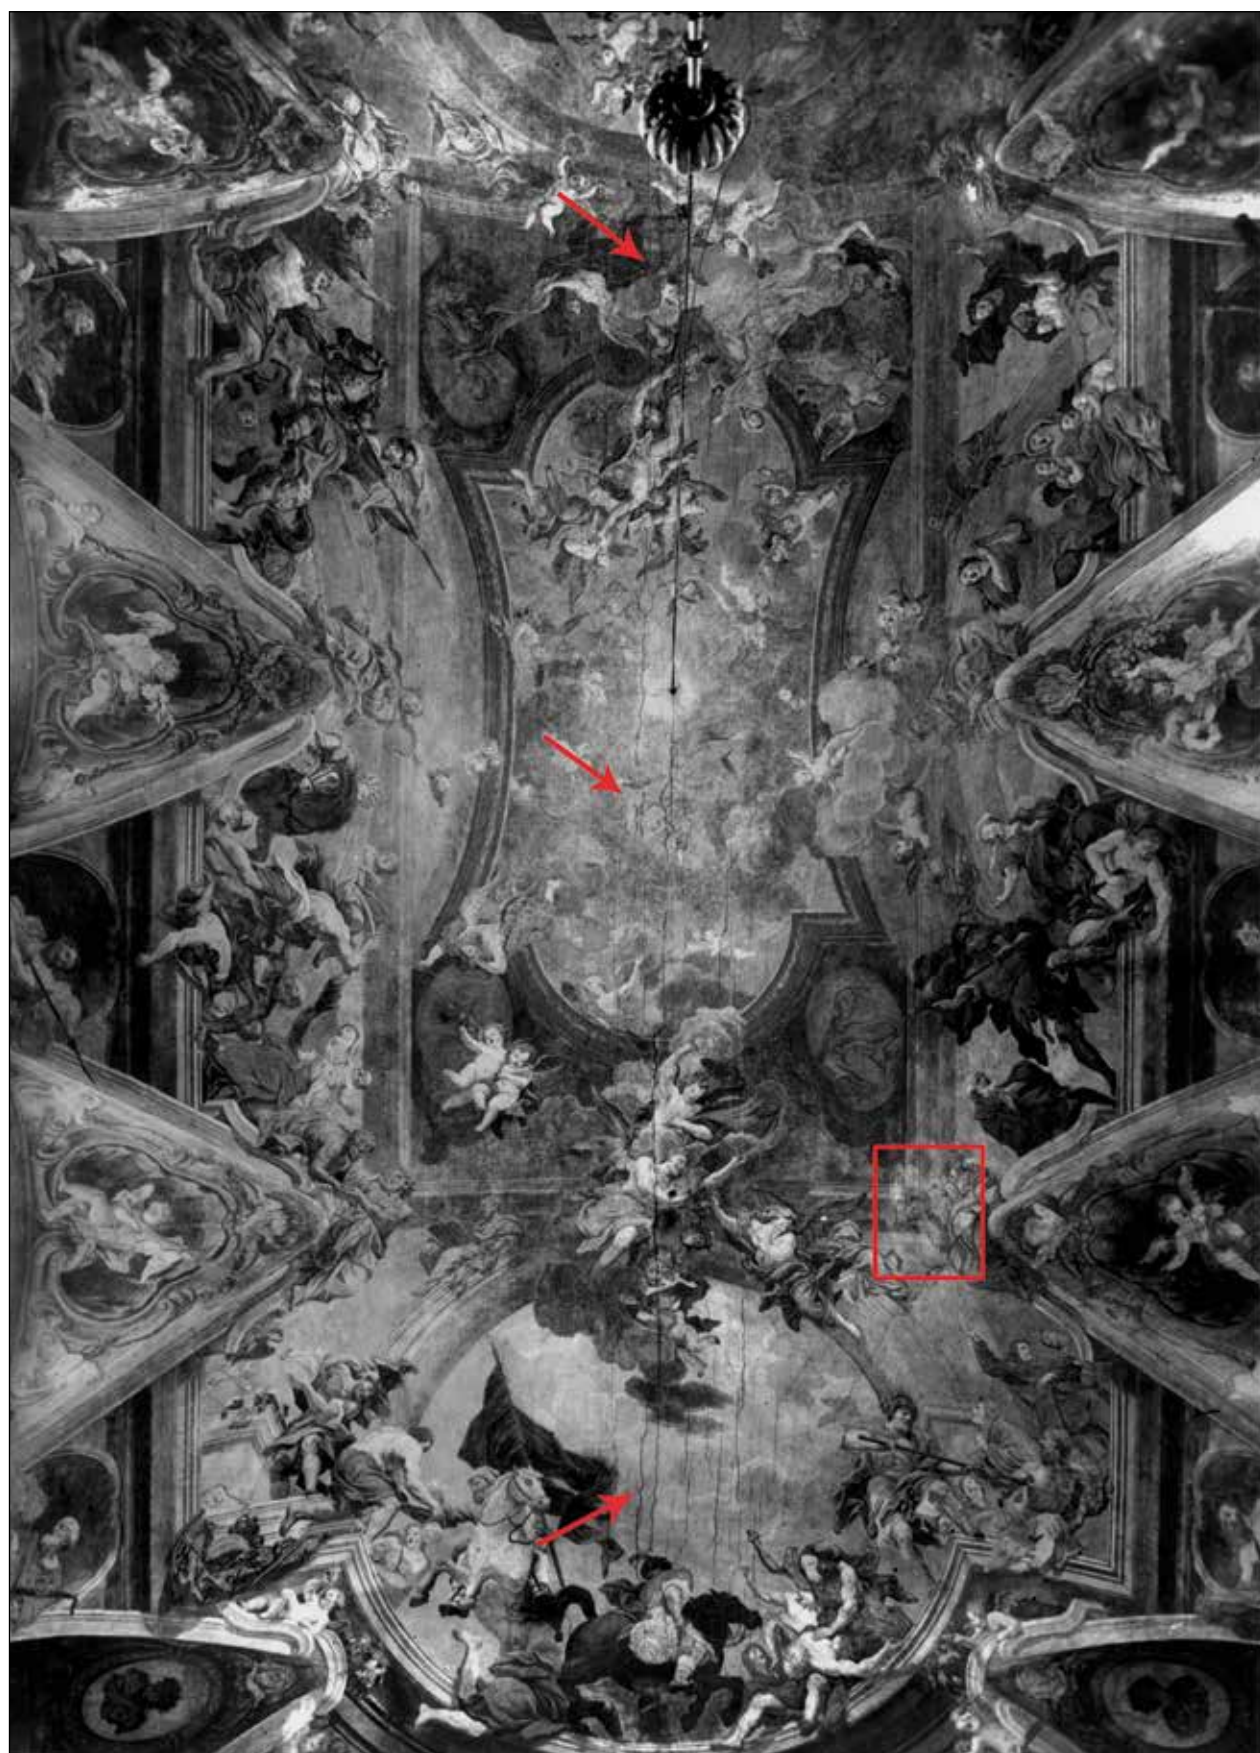
Figure 18a: The painting on a photograph of the nave vault, photographer and date unknown, with visible cracks and dirt gives the impression of not having been restored.

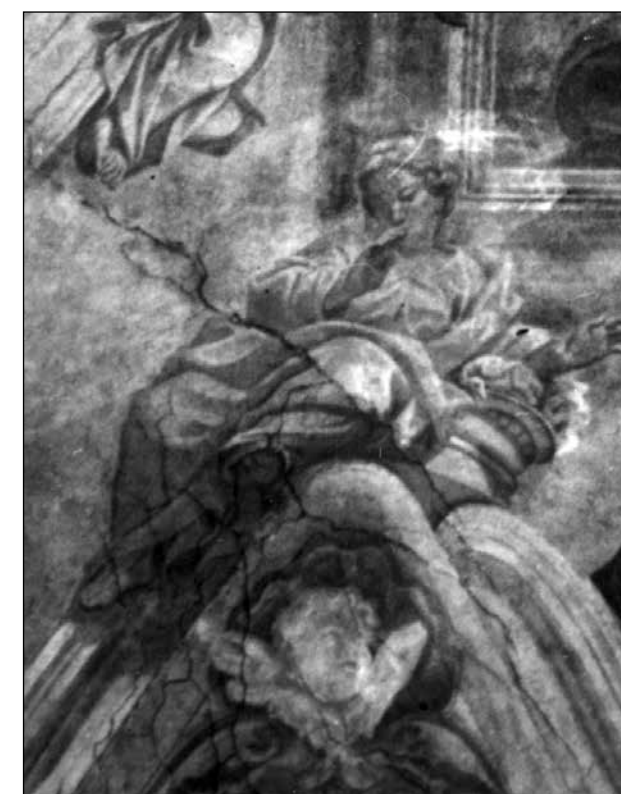
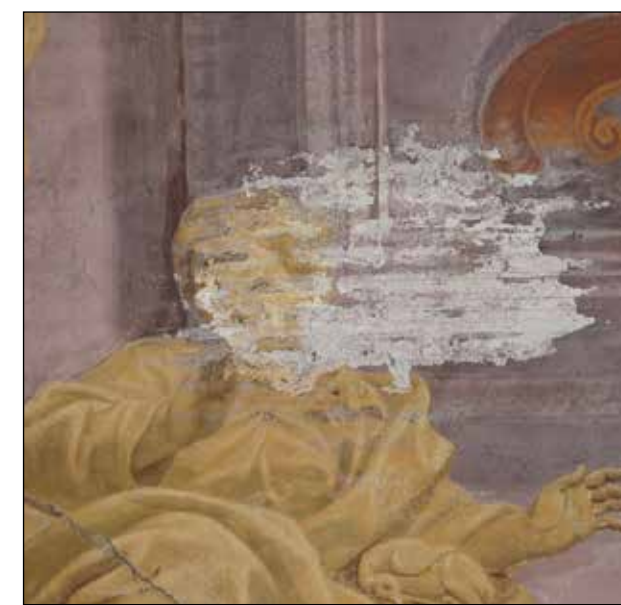
Figures 18b and 18c: In an enlargement of detail 18b from the whole (18a) a trace of long-term damp is visible around the head of the first northern virtue *Bonitas*, which caused destruction: 18c – the condition in 2004.

and climatic changes, the darkened consolidation layer on the surface). As an example of damage caused by damp let us mention the following sections: H8, H9 – the head of the first virtue – *Bonitas* on the west side, and H19, H20 – the head of the third virtue *Humilitas* on the east side, on the northern lunettes. During the restoration of the two heads we were helped by one of the most important finds made – a photograph of the nave vault, photographer and time unknown (figure 18a)²³³ – which was of great value during the reconstruction. This exceptionally high quality shot very clearly shows the state of affairs before the two heads were damaged by long-term leaks. When and for how long these areas suffered from damp is difficult to prove. Perhaps the destruction was caused by the leaks written about in the complaint by the cathedral administration against the Ljubljana Town Internal Affairs Commission in connection with the punishment of the cathedral's head administrator Venčeslas Snoj for collecting voluntary contributions that were prohibited in those politically delicate times. Among other things, the following was said of 1950: "Last winter the roof leaked so badly that the vault was soaked through, as it was impossible to obtain the material necessary for repairs."²³⁴ During the 2002-2006 restoration we were able to reconstruct the head of *Bonitas* successfully on the basis of an enlargement of a detail on this photograph (figures 18b, 18c).

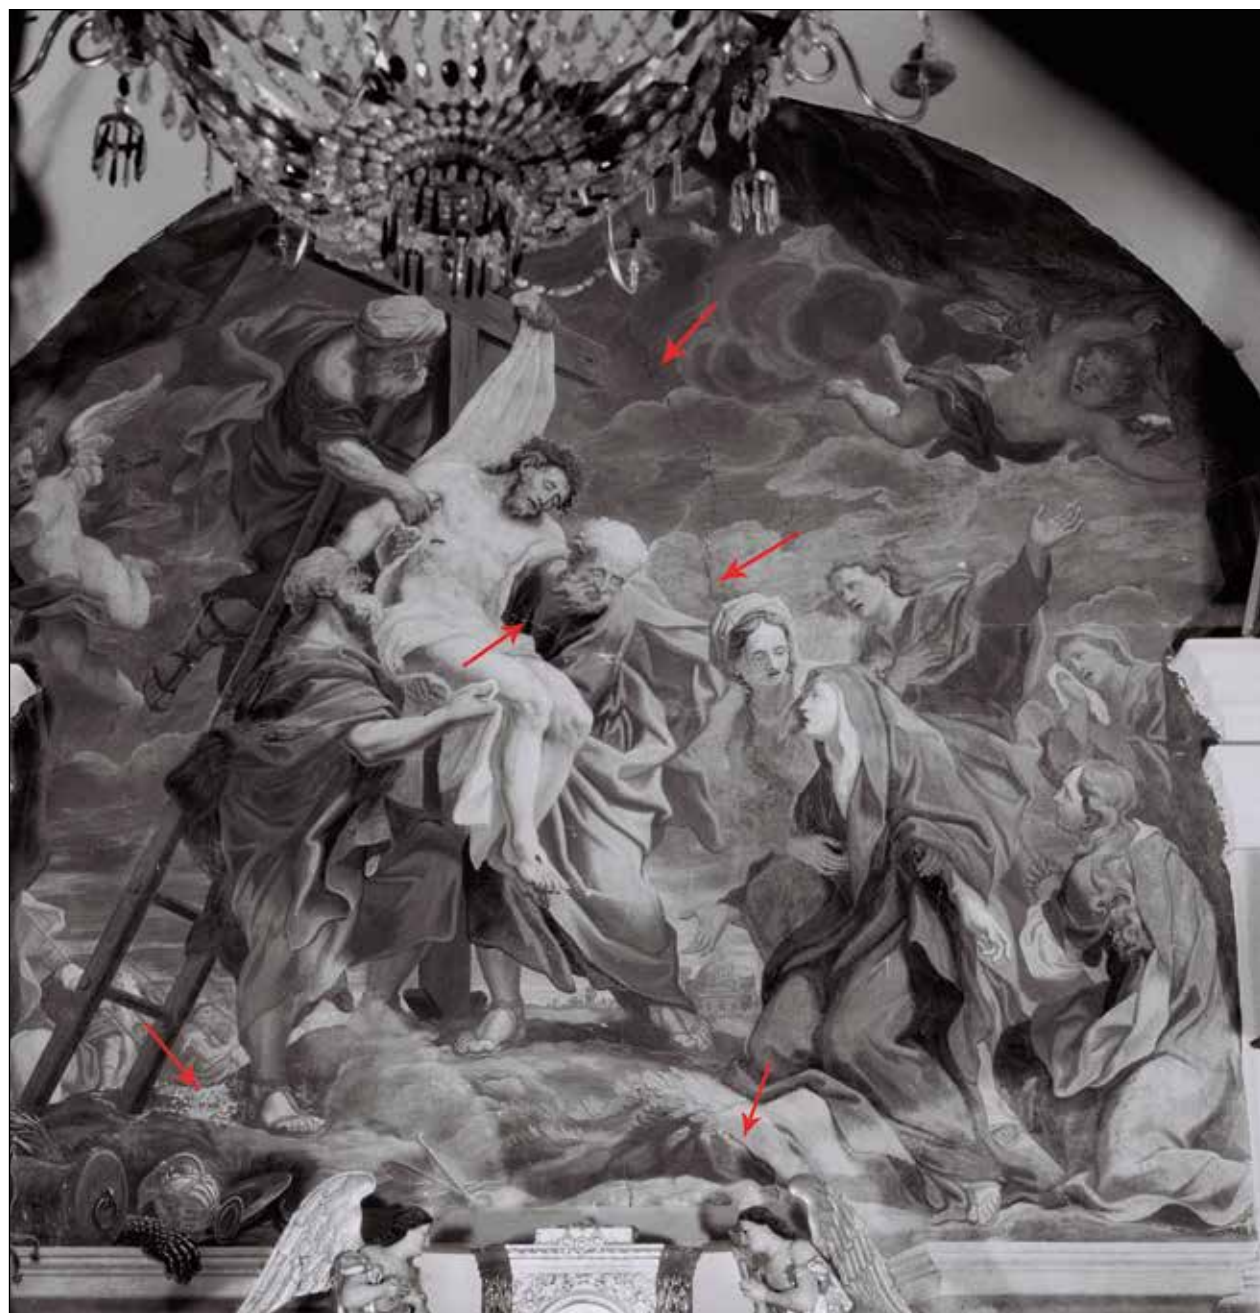
Figures 18d and 18e: Two photographs of the *Deposition from the Cross* from Puštal: 18d: (unknown photographer and date), prior to restoration, with visible cracks and: 18e after the restoration, the condition in 2005.

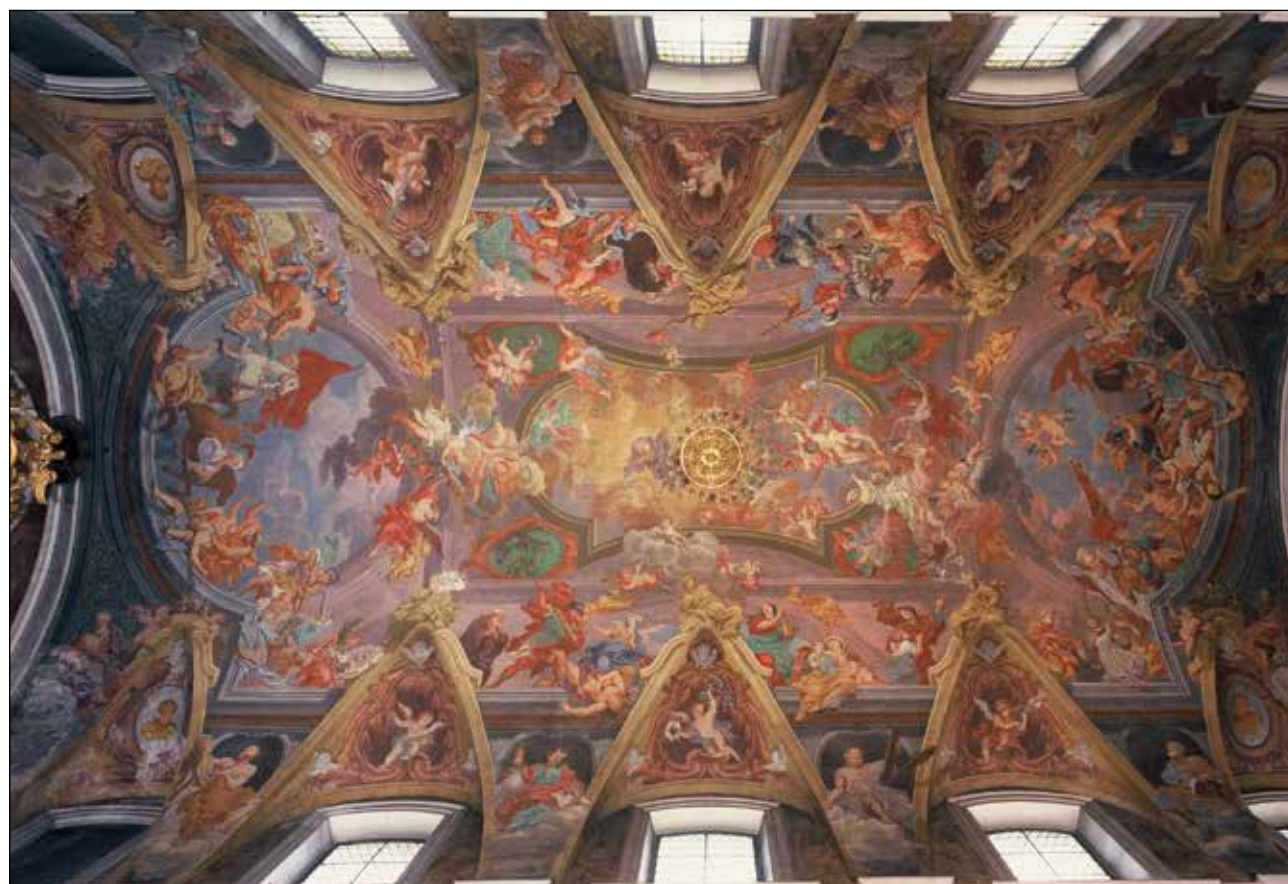
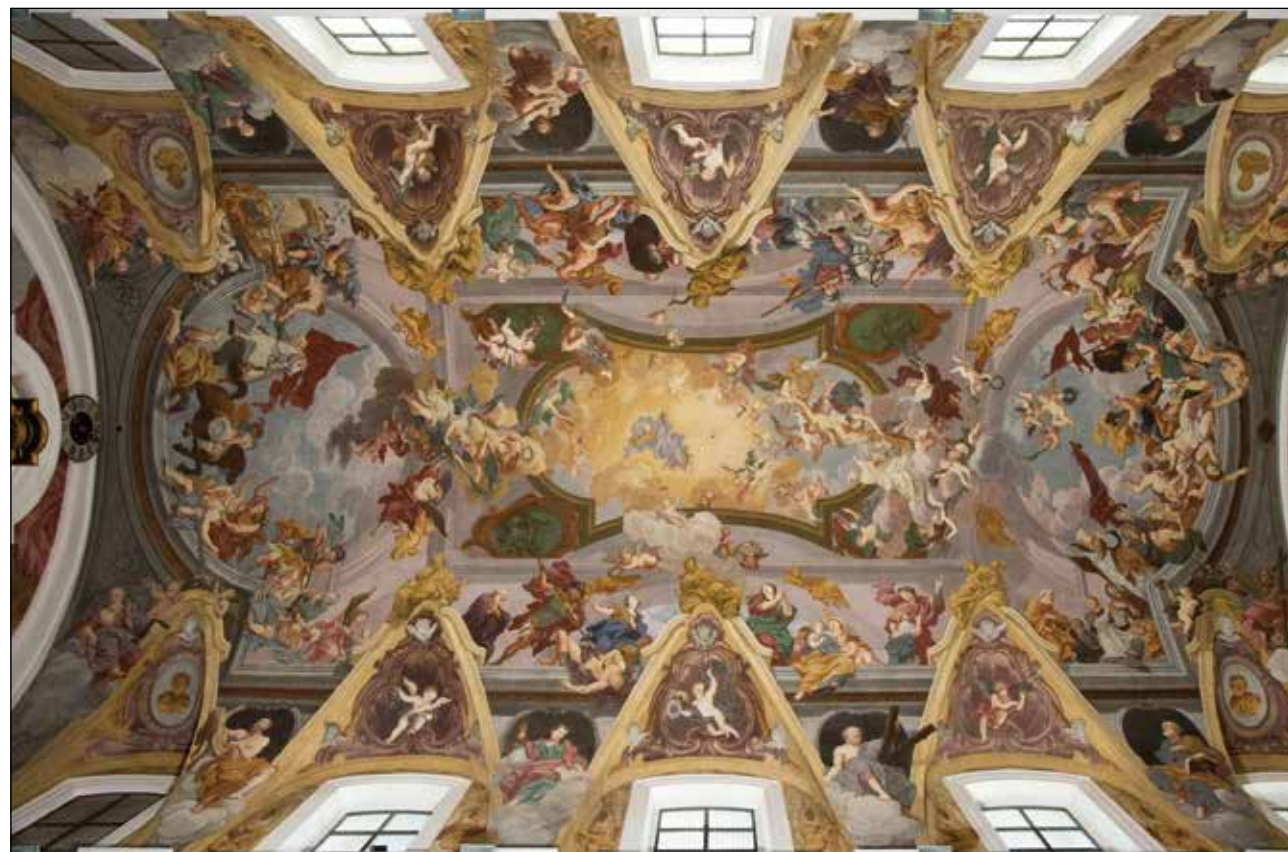
Figures 18f and 18g: The nave vault prior to restoration in 1996: 18f and after it in 2007: 18g.

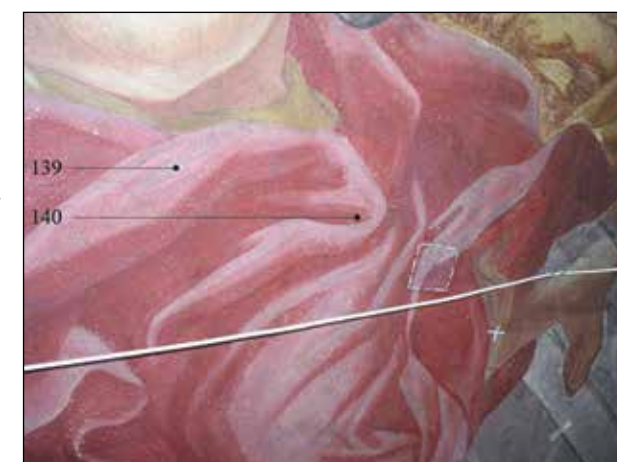
Figure 1: Example of the locations of sample removal on the red drapery (no. 139 and 140).

To determine the state of the colour layers¹, micro samples were taken from 25 different parts on surfaces of the wall and ceiling paintings on the nave vault (figure 1). For examination using an optical microscope and SEM/EDS (scanning electron microscopy / energy dispersive spectroscopy) analysis and a Raman spectrometer attached to an optical microscope, samples were embedded in polyester resin and hardened in a dryer at 50°C. The hardened embedded samples were then ground to obtain sample cross-sections (figure 2) and the surfaces of the cross-sections were additionally polished.

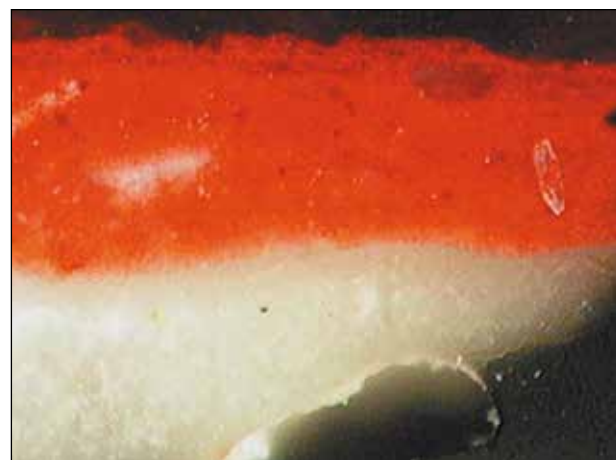
Figure 2: Photomicrograph of the cross-section of sample no. 140. Red colour layer on lime ground. Magnification 400x.

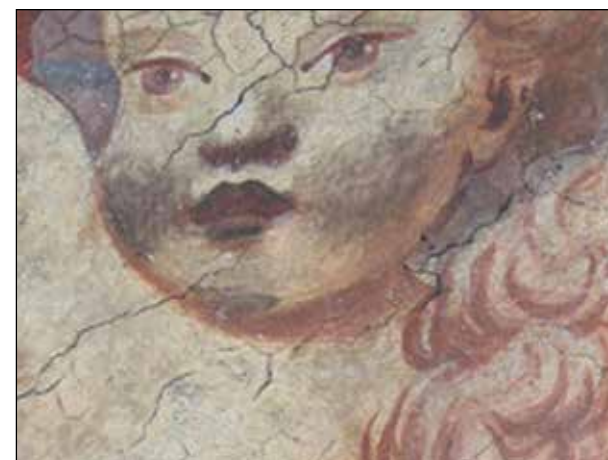
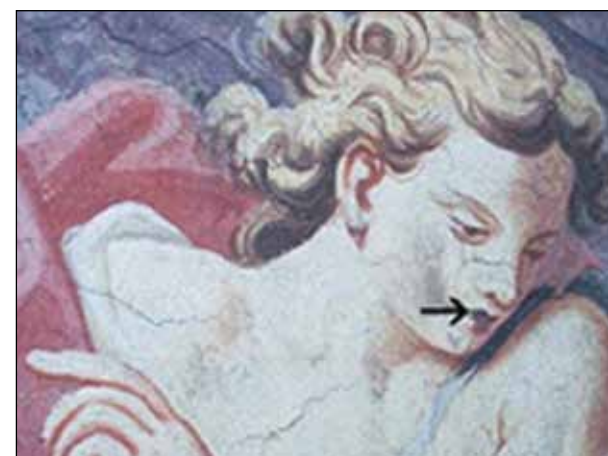
Figure 4: a) Detail of darkening in the angel's face. b) Location of sample removal (no. 119).

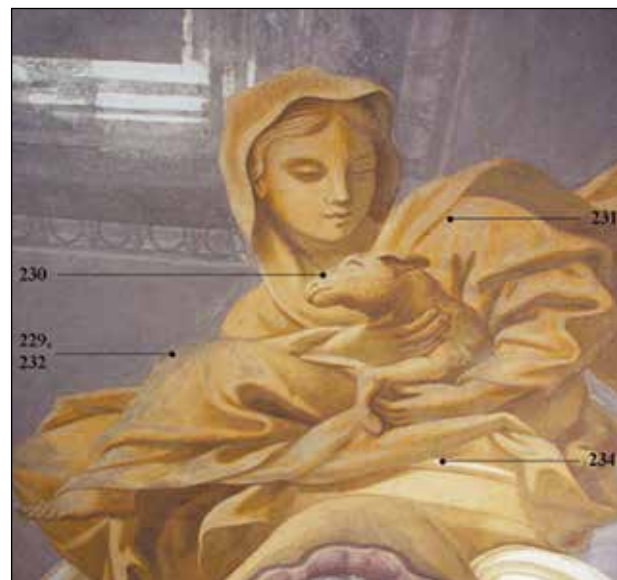
Figure 19: Locations of removal of samples SNL 229 – 234.

Figure 19 illustrates the darkening of the ochre colour layer in the overpainted areas of the figure.

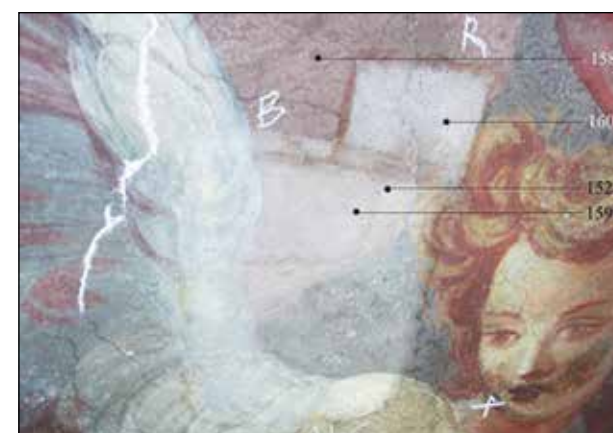
Figure 7: Locations of samples no. 158 – before cleaning, and 159 – after cleaning.

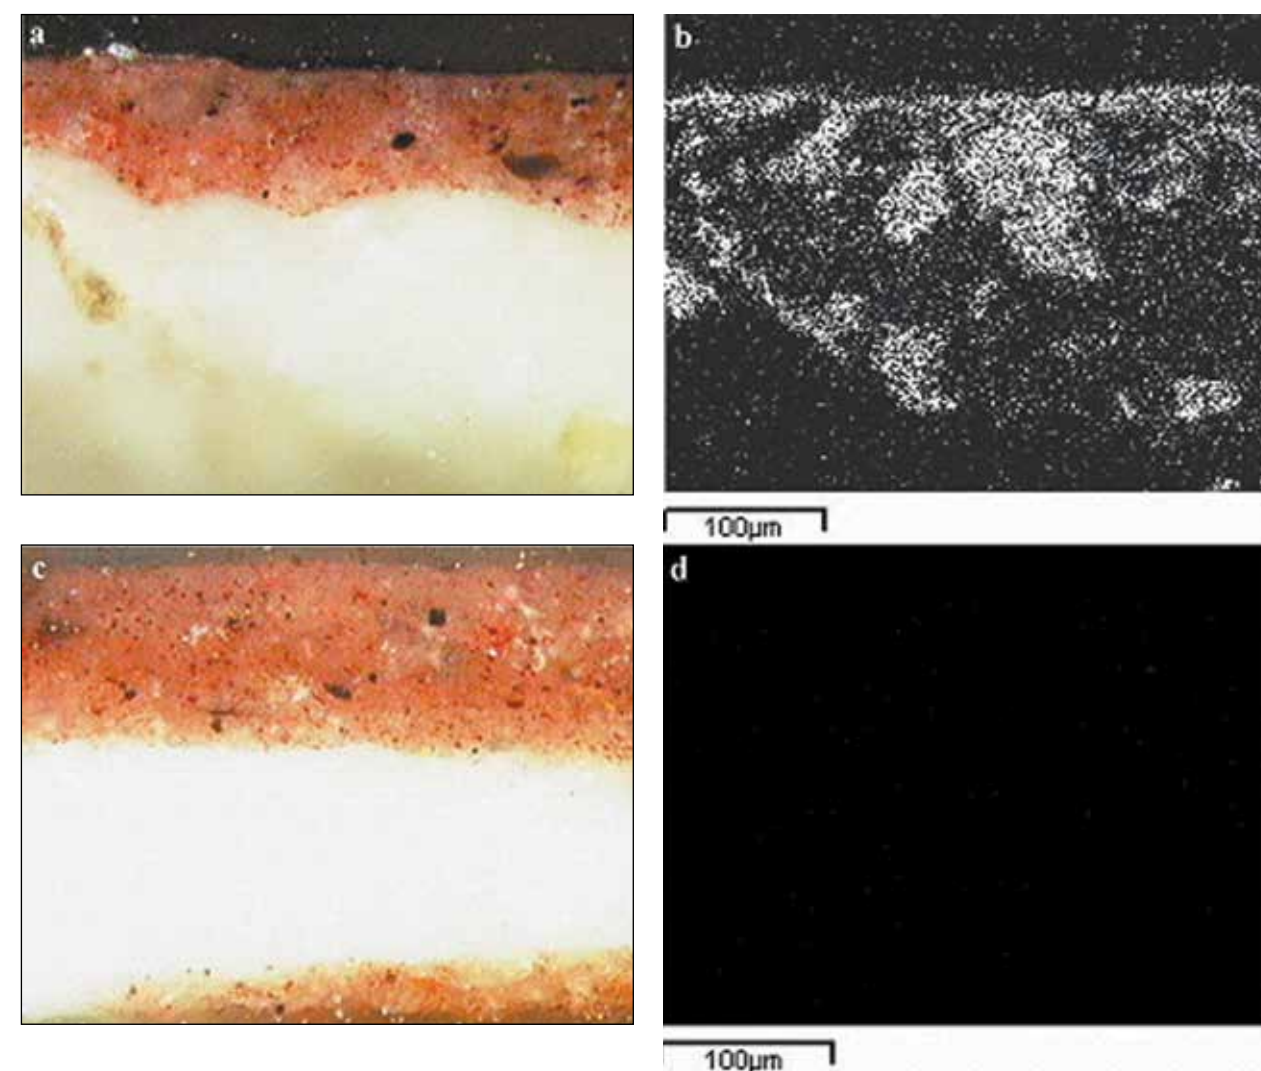
Figure 8: a) Cross-section of sample no. 158. b) EDS distribution of sulphur on the cross-section of sample no. 158 ($w_s = 2.87\%$). c) Image of the cross-section of sample no. 159. d) EDS distribution of sulphur on the cross-section of sample no. 159 ($w_s = 0.21\%$).

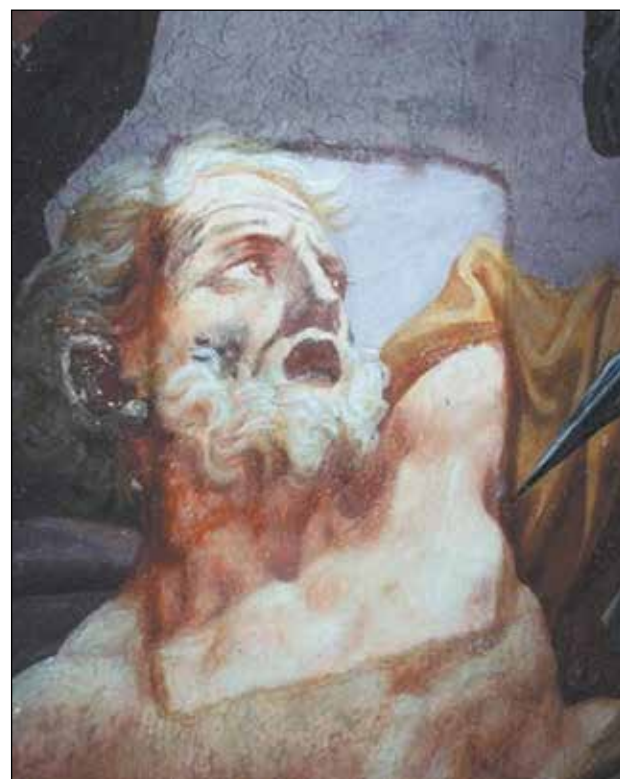
Figure 13: Successful example of cleaning on a larger surface area.

Given the results of test cleaning procedures, the ammonium carbonate and bicarbonate method was used on the whole of the surface (600 m²) of the nave. The areas of application were much larger after determining the appropriate procedure, ca. 1 m². Figure 13 shows an example of cleaning performed on a large area, where the original colour contrast can also be seen.

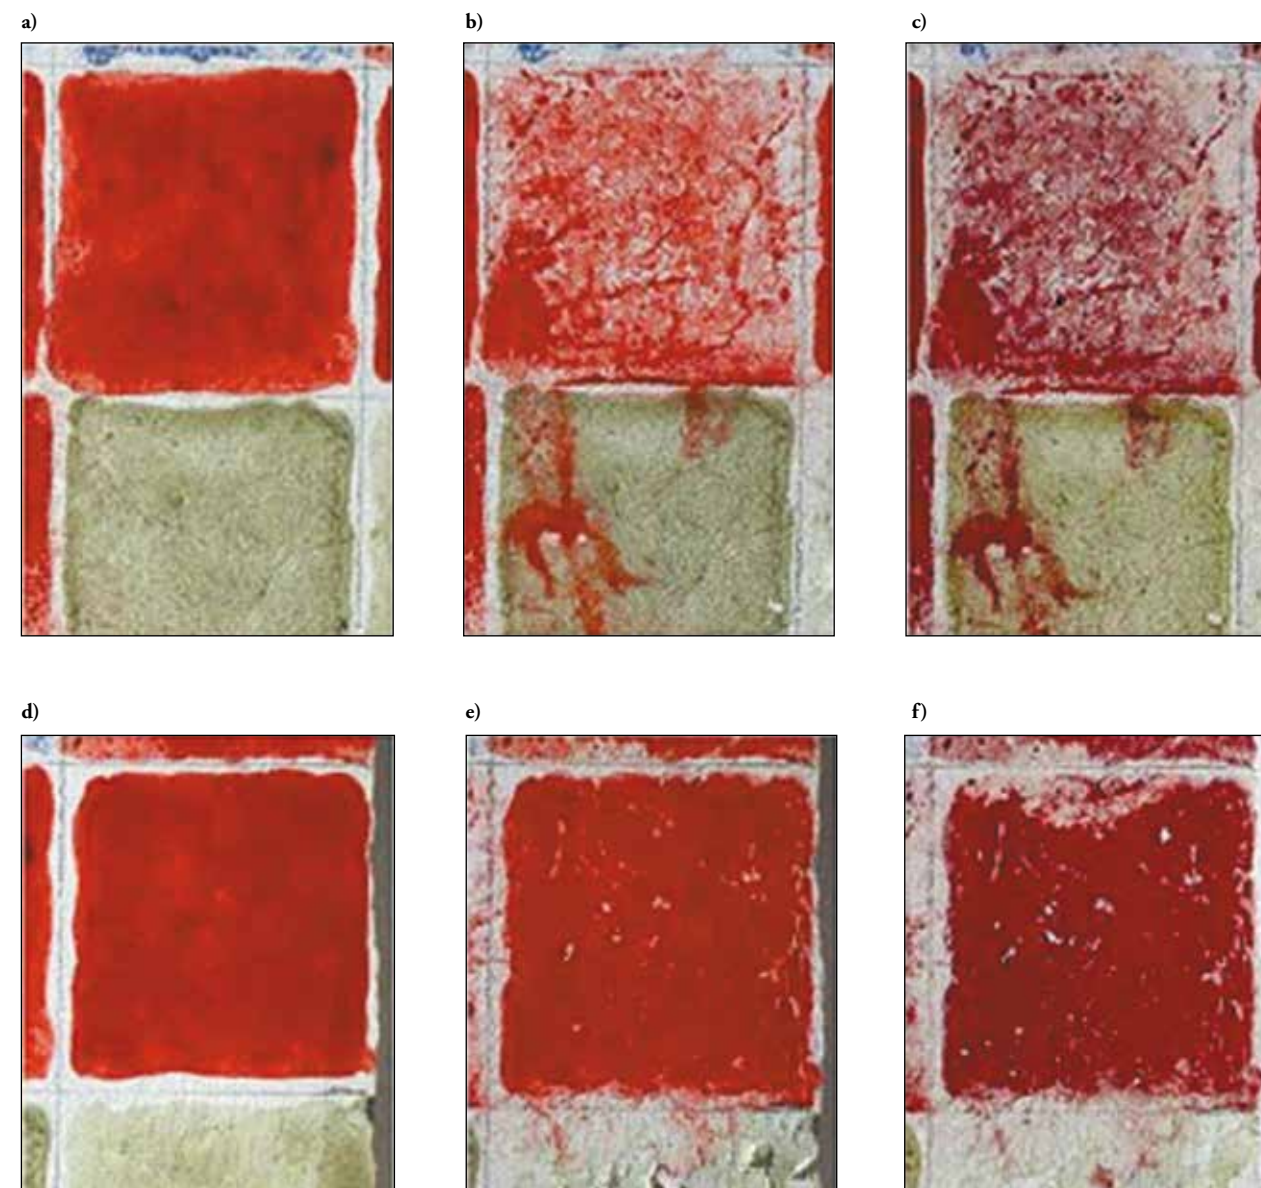
Figure 2: Effect of temperature fluctuations, relative humidity and UV-VIS radiation on the colour layers of cinnabar in combination with Klucel EF and Tylose MH: a) Klucel EF – cinnabar before exposure, b) Klucel EF – cinnabar after effect of T, RH, c) Klucel EF – cinnabar after effect of UV-VIS radiation, d) Tylose MH – cinnabar before exposure, e) Tylose MH – cinnabar after effect of T, RH, f) Tylose MH – cinnabar after effect of UV-VIS radiation.

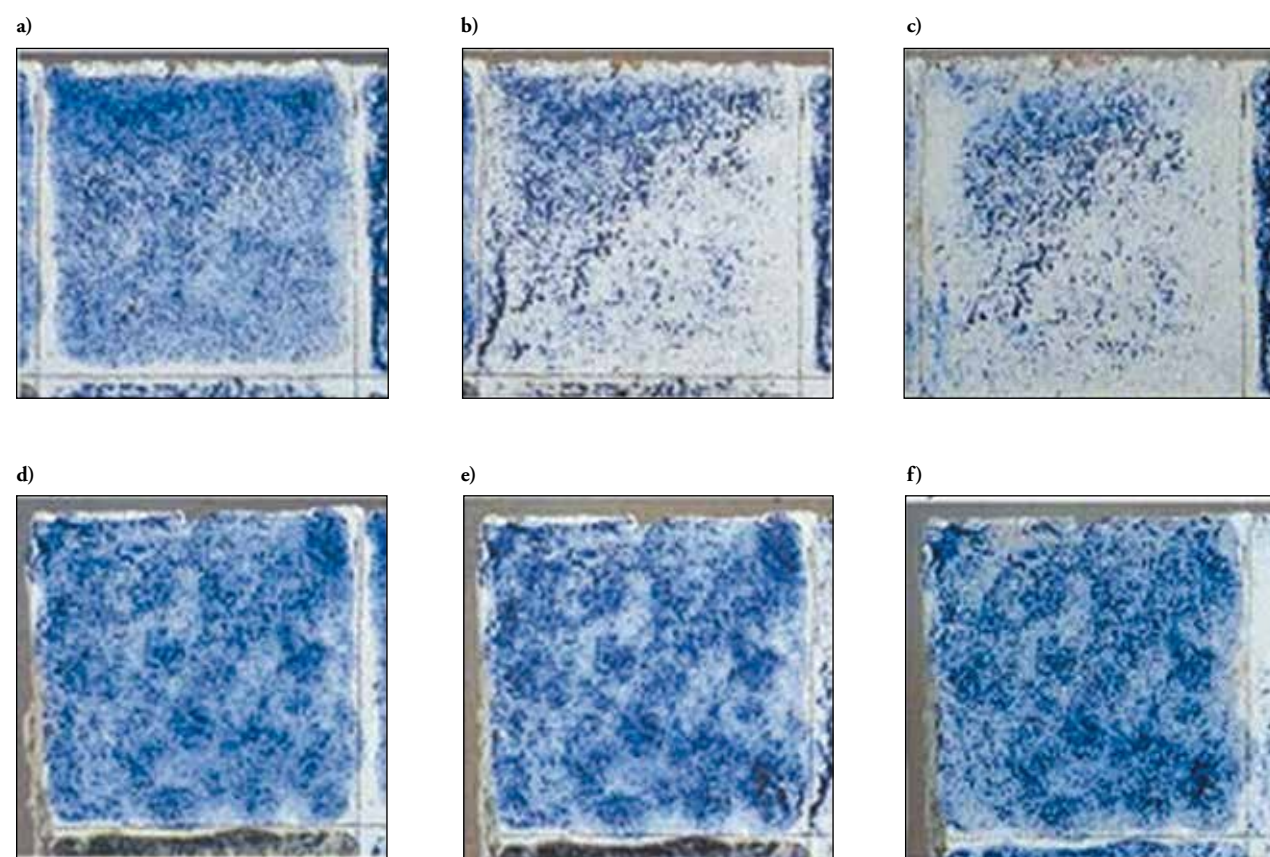
Figure 3: Effect of temperature fluctuations, relative humidity and UV-VIS radiation on the colour layers of smalt in combination with Klucel EF and Tylose MH: a) Klucel EF – smalt before exposure, b) Klucel EF – smalt after effect of T, RH, c) Klucel EF – smalt after effect of UV-VIS radiation, d) Tylose MH – smalt before exposure, e) Tylose MH – smalt after effect of T, RH, f) Tylose MH – smalt after effect of UV-VIS.

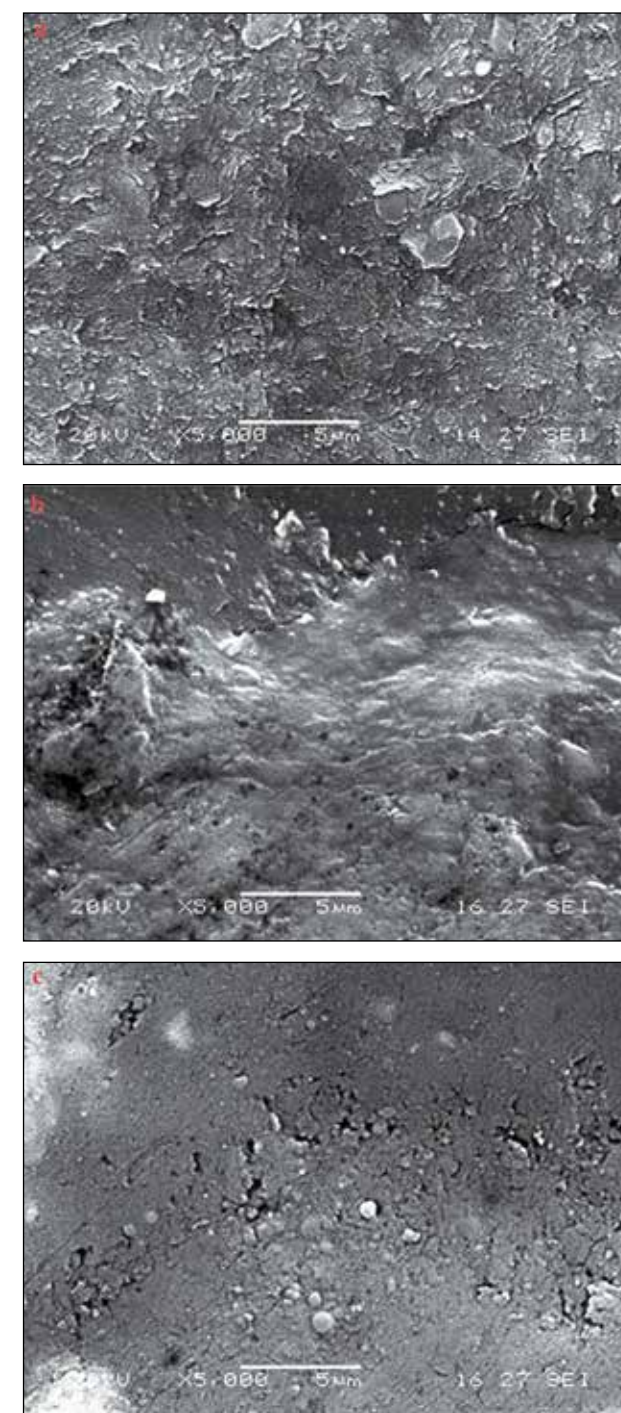
Figure 5: Scanning electron micrograph of the colour layer with Primal AC33: a) before exposure, b) after treatment in the T, RH chamber, and c) after treatment in the UV-VIS chamber.

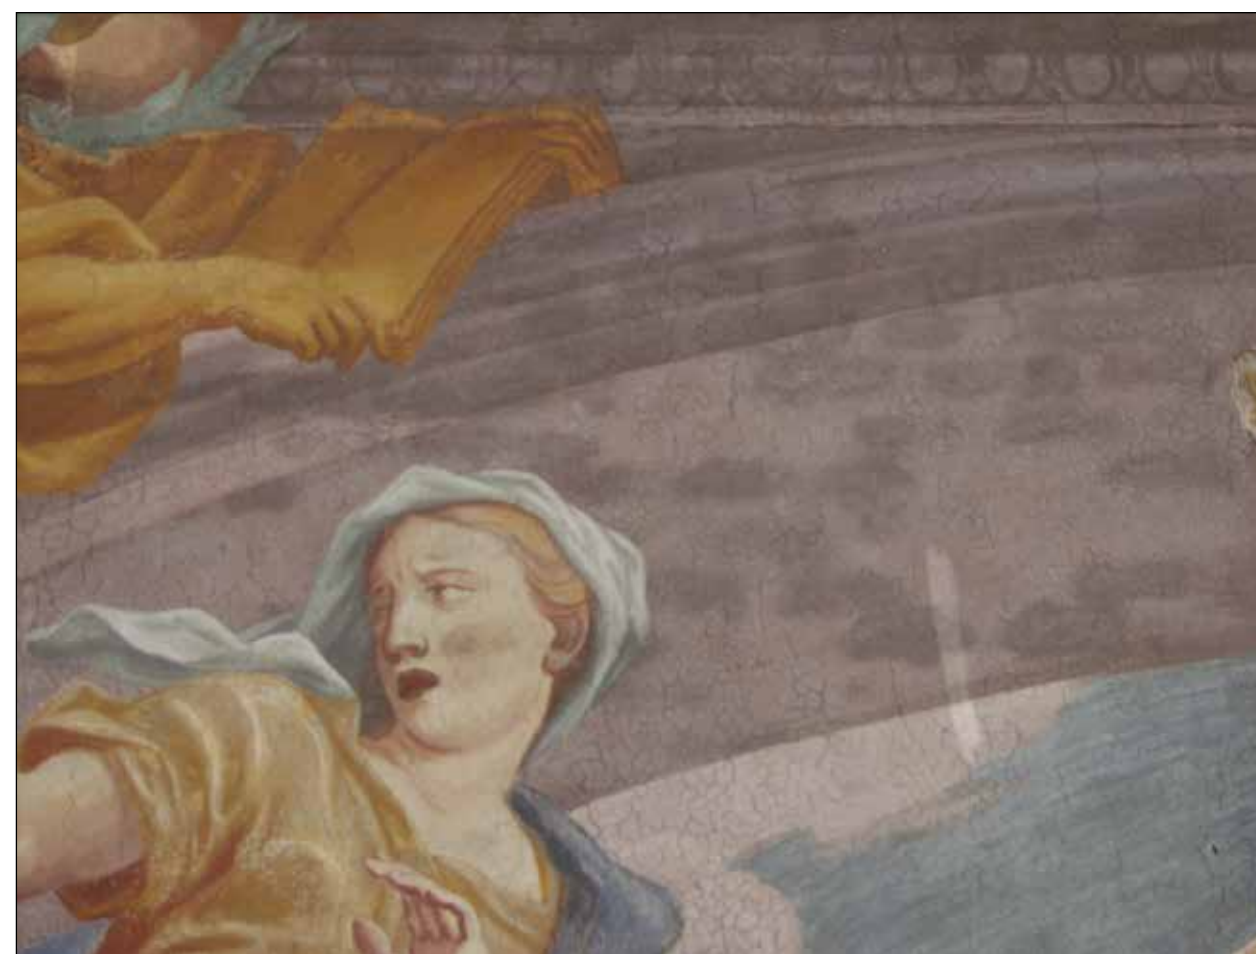
Figure 1: Quadrant G12, 13 – the darkened surface with the marked rectangular stains on the architectural background above the spot corresponding to the position of bricks in the nave vault.

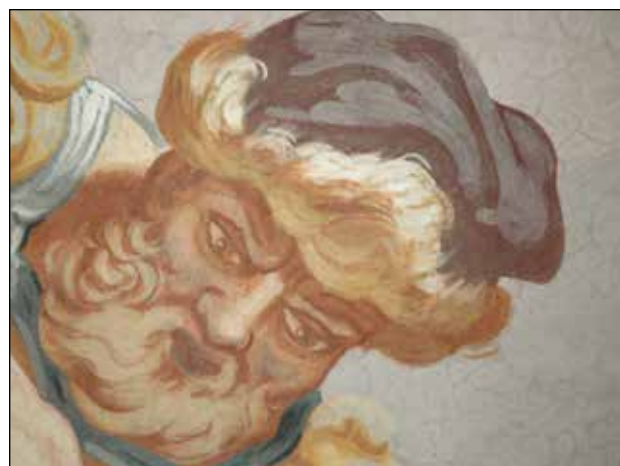
Figure 3: Quadrant O22 - after cleaning and retouching.

check whether the colour had faded. Let us stress that the painting here was well preserved, which made the procedure easier and facilitated a greater measure of control. We were very pleased with the results, especially with regard to the purple colour, which regained the glow we have observed in other well-preserved wall paintings by Quaglio (figures 4 and 5). We then increased the testing area to approximately one square metre. For this, we chose section NO22, 23 and achieved equally good results (figures 2 and 3).

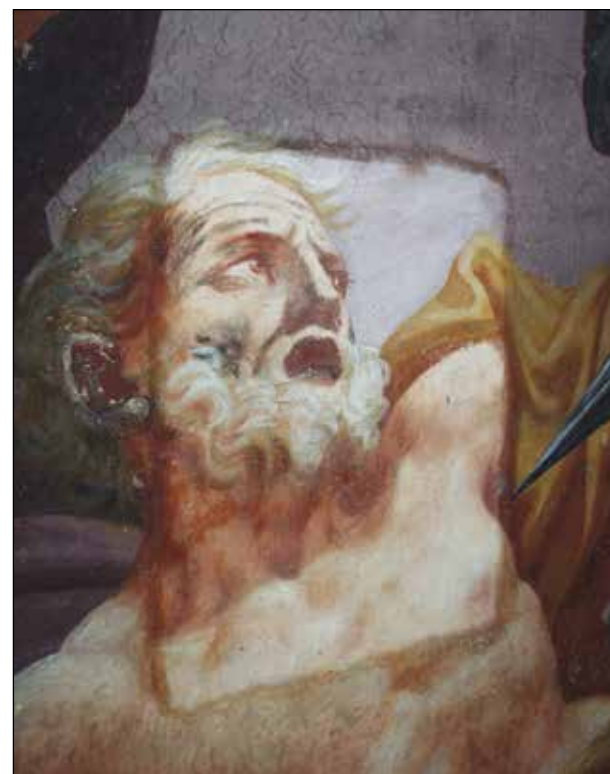
Figure 4: Quadrant N18 - the cleaned test surface, measuring approximately 20 x 20 centimetres. There is a noticeable difference in the colour before and after the treatment.

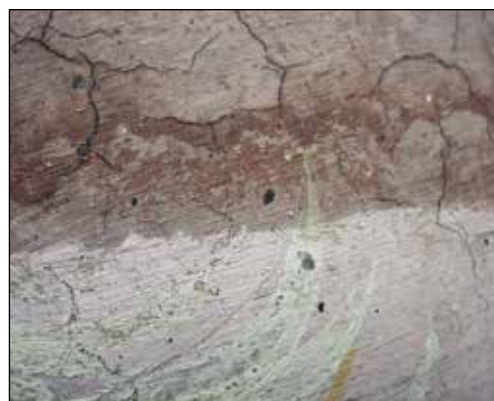
Figure 5: Quadrant N18 – a magnification of figure 4 –above the scalp: it was possible to almost completely remove the darkened casein coating from the original support after the application of compresses with ammonium carbonate.

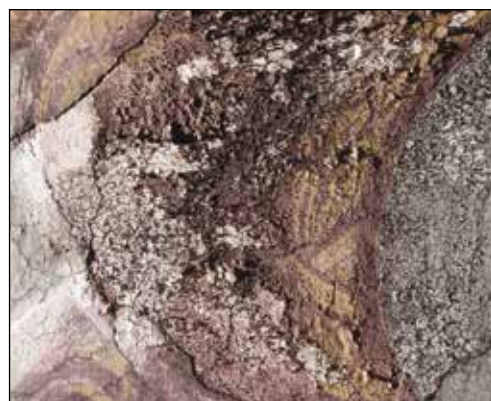
Figure 6: Quadrant F3 – the condition of some of the worst damaged sections of the painting in the vicinity of the north-western bell tower.

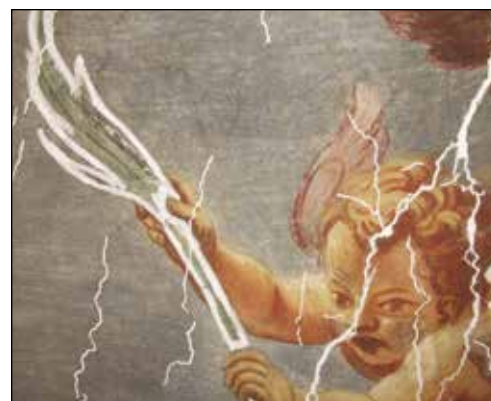
Figure 7: Quadrant J21 – temporary protection of the edges of damaged areas on green sections using Cyclododecan prior to cleaning with compresses.

¹⁶ It is possible that the painter himself used a small amount of lime when painting in order to achieve a darker, more velvety tone which, however, disappeared completely due to sulphatisation. For a temporary protection of border areas during the application of ammonium compresses in these cases we used Cyclododecan dissolved in white spirit (figure 7). During the attempts at consolidation the surface by using 3% Klucel and alcohol, carried out with a prior application of two layers of Japanese restoration paper, we achieved fairly good results. We continued the procedure with gentle rinses through Japanese paper with water and natural sea sponges, and when the surface was completely dry, we applied a thin layer of ethyl silicate.

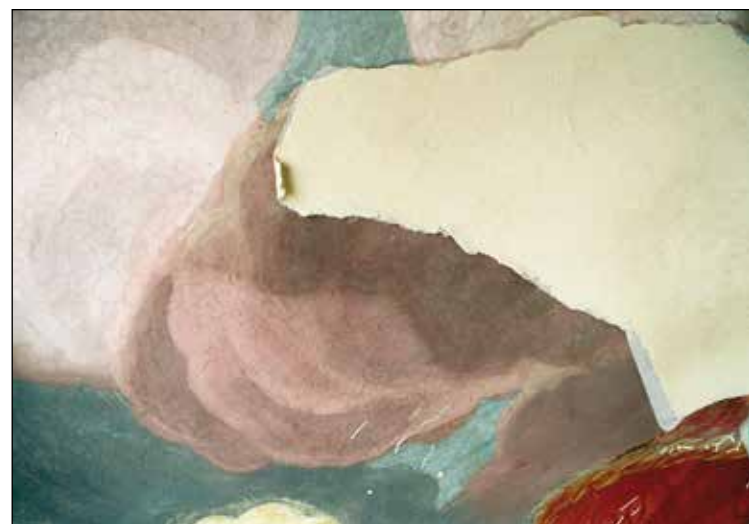
Figure 1: The removal of the cleaning compress: the layer of dirt that has yet not been successfully removed with water rinses using natural sea sponges is clearly visible.

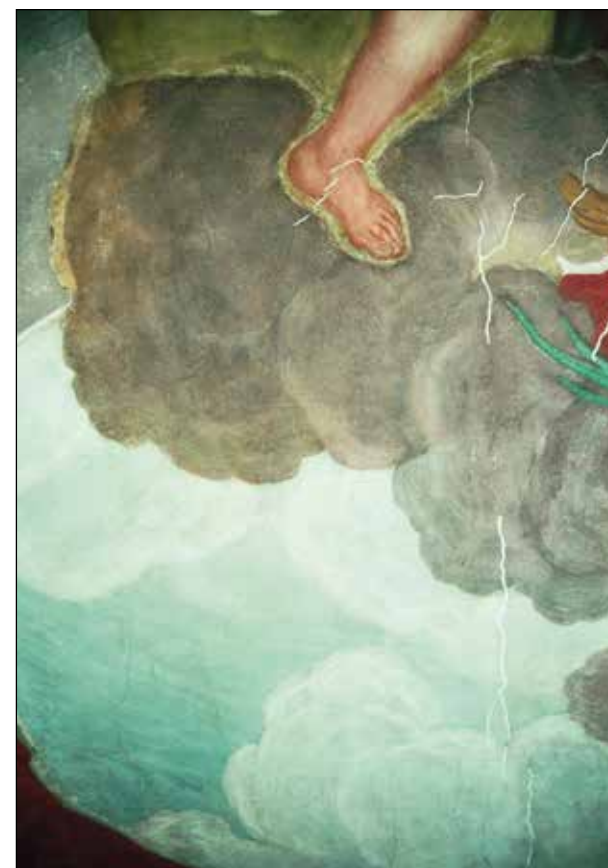
Figure 3: A detail from the perspective section of the painting, with clouds that have yet not been cleaned in the forefront.

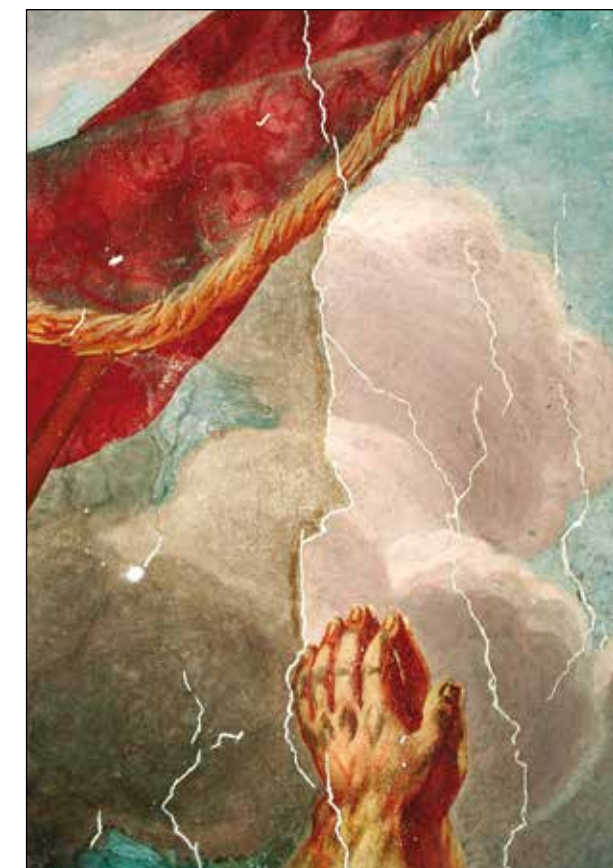
Figure 4: The cleaned clouds on the sky of the right half of the perspective section of the painting.
