THE RESTORATION OF QUAGLIO'S WALL PAINTINGS
IN LJUBLJANA CATHEDRAL

The Restoration of Quaglio's Wall Paintings in Ljubljana Cathedral

A conservation-restoration project involving the wall paintings created by Giulio Quaglio (1668–1751)

on the nave vault and the western wall of the Cathedral of St Nicholas in Ljubljana, IPCHS Restoration Centre (2002–2006)

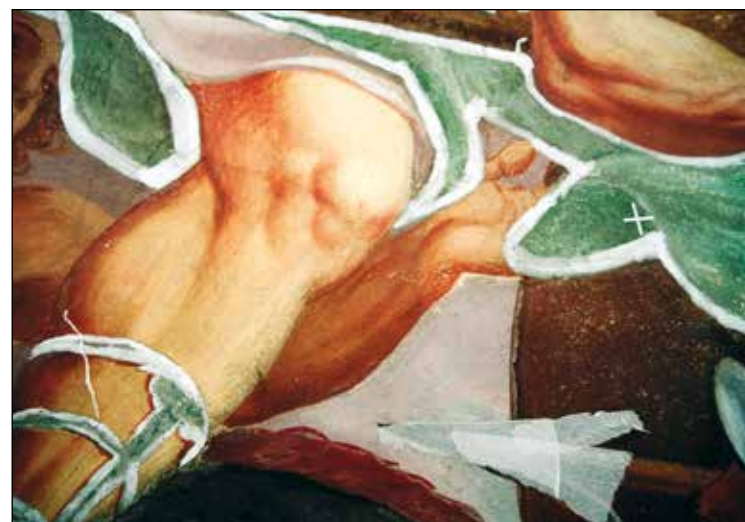
Figure 5: The application of Cyclododecan for the protection of the green pigment.

The few green paints that were used, such as, in the palm branches held by the figures, or the four monochrome medallions, are an example of an original pigment with poor cohesive properties. We found that the green pigment was made from green earth with a non-homogenous lime base and with no organic binder,⁷ which seemed to be confirmed by crystallographic analyses. Thus we approached the cleaning of the green paint with extreme caution. We decided on rinsing with natural sea sponges soaked in water. The green paint was protected with a special coating in order to temporarily isolate the paint prior to the cleaning of adjacent surfaces.

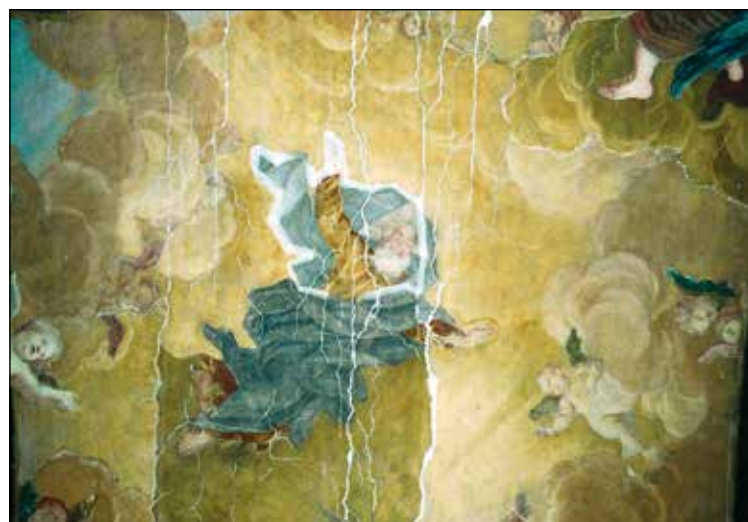
Figure 6: The central part of the vault painting with the image of God the Father during cleaning.

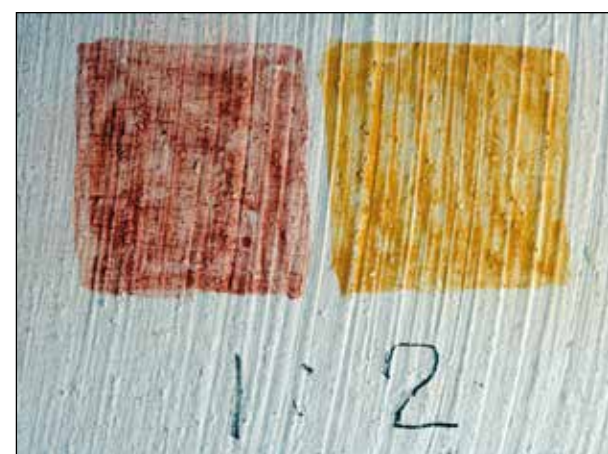
Figure 1: Testing binders in practice – lime whitewash on a cardboard support (also figure 3 and 4).

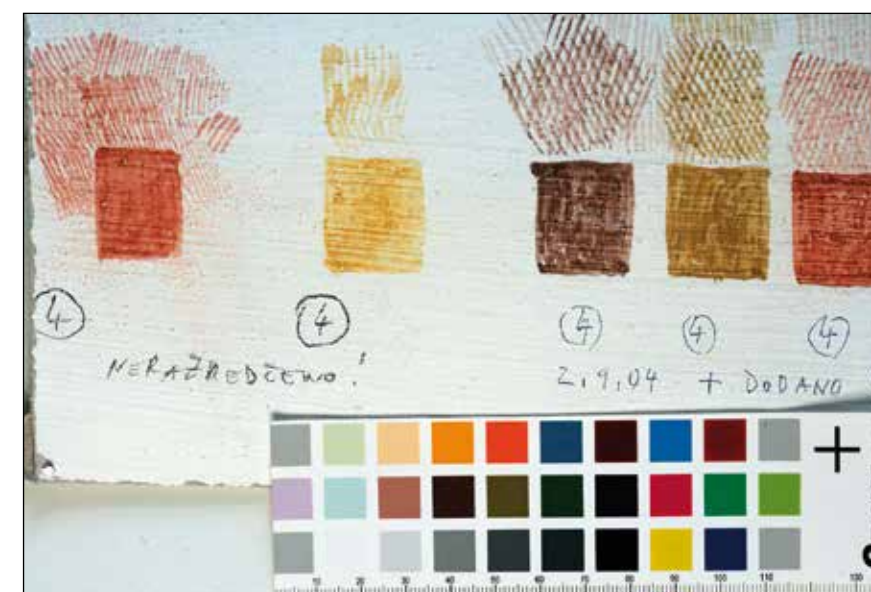
Figure 3: Experimentation with colours using various percentages of added binder.

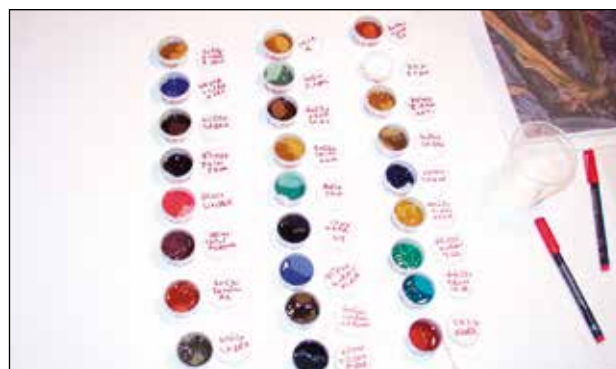
Figure 5: Preparing pots of pigments and binders in the form of tablets, which need to be diluted with water.

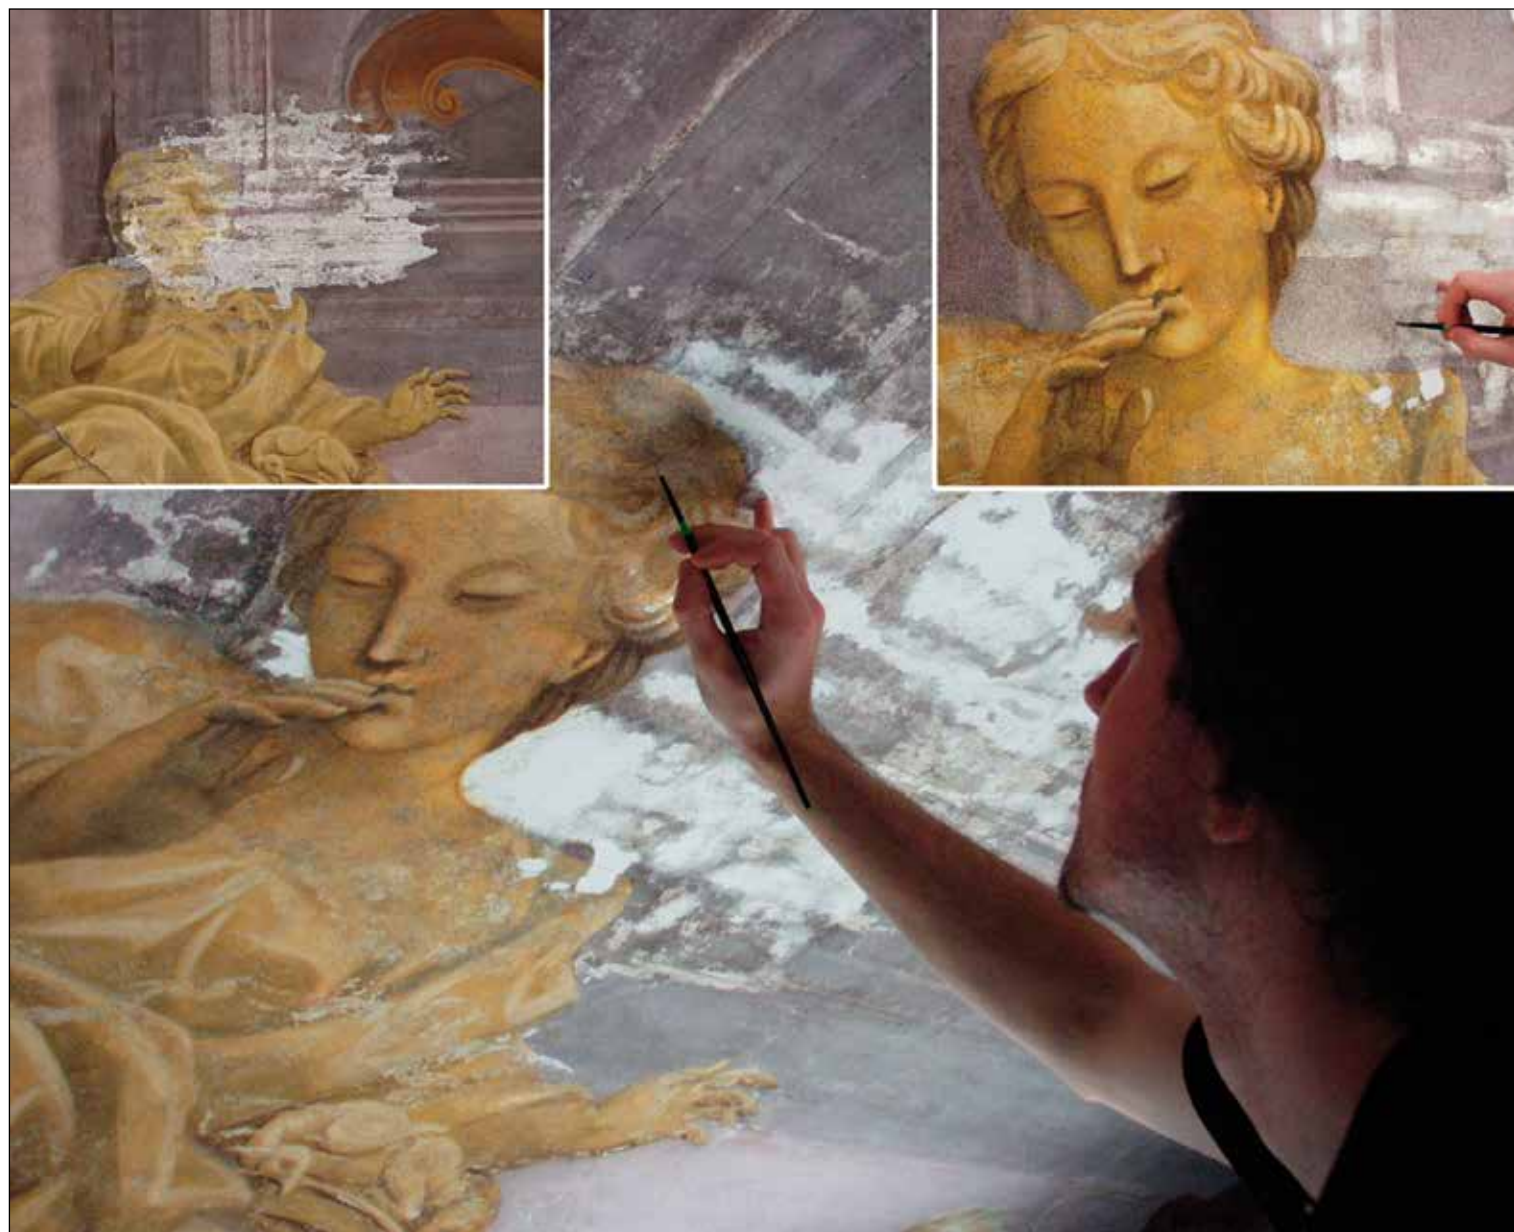
Figure 7: The only larger reconstruction of the nave vault painting – the head of the personified virtue at the crossing of quadrants G, H and 8, 9 before, during and after retouching.

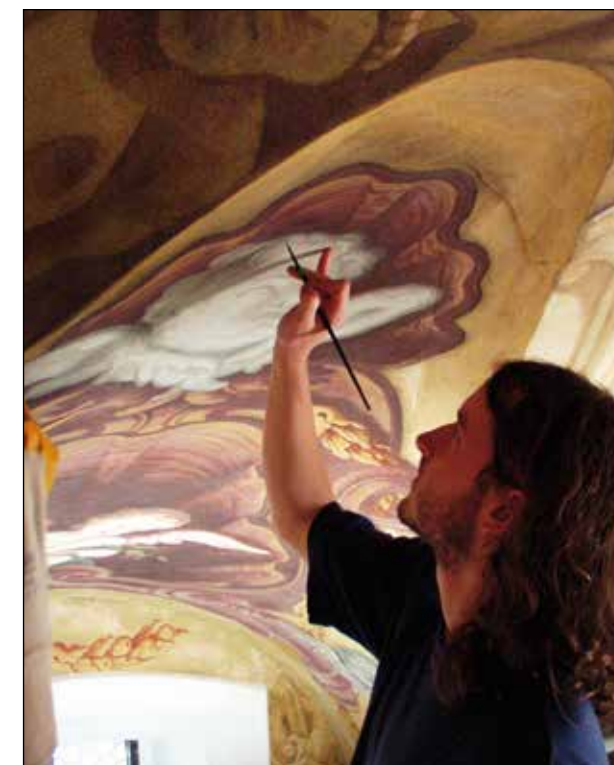
Figure 9: Retouching the angel's head in quadrant F8.

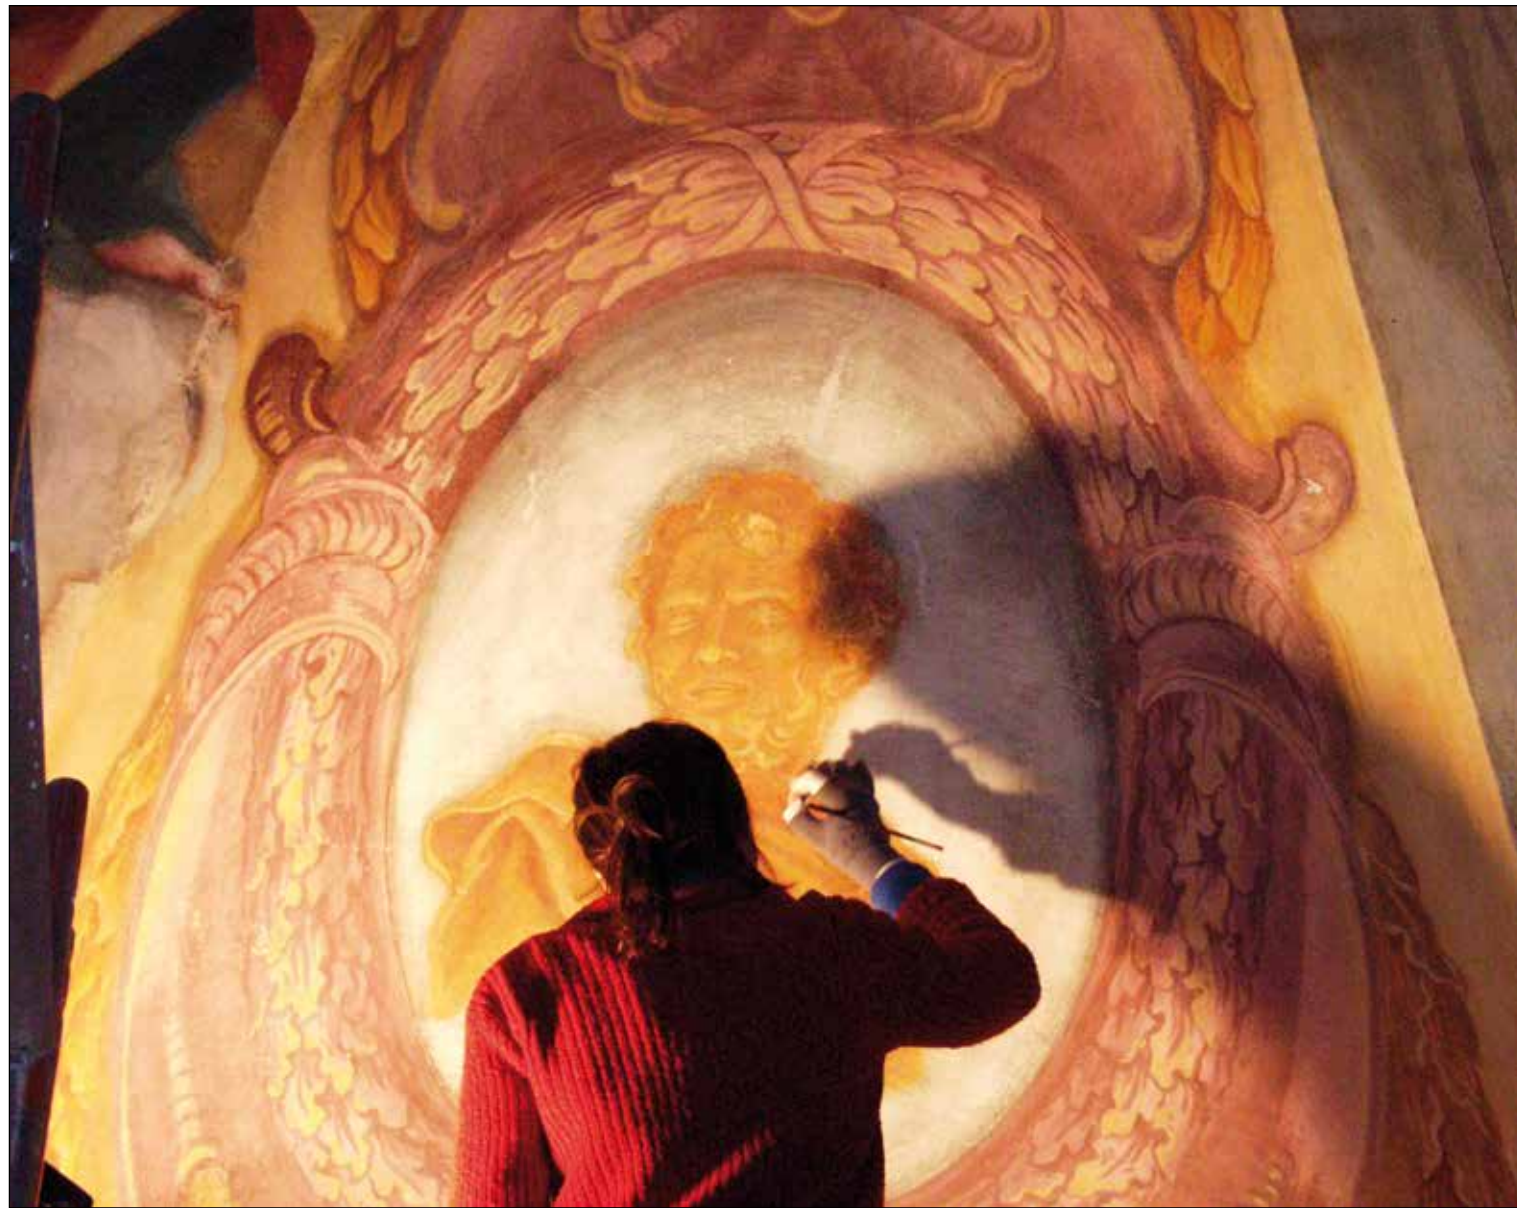
Figure 10: Retouching the antique bust – quadrant P25.

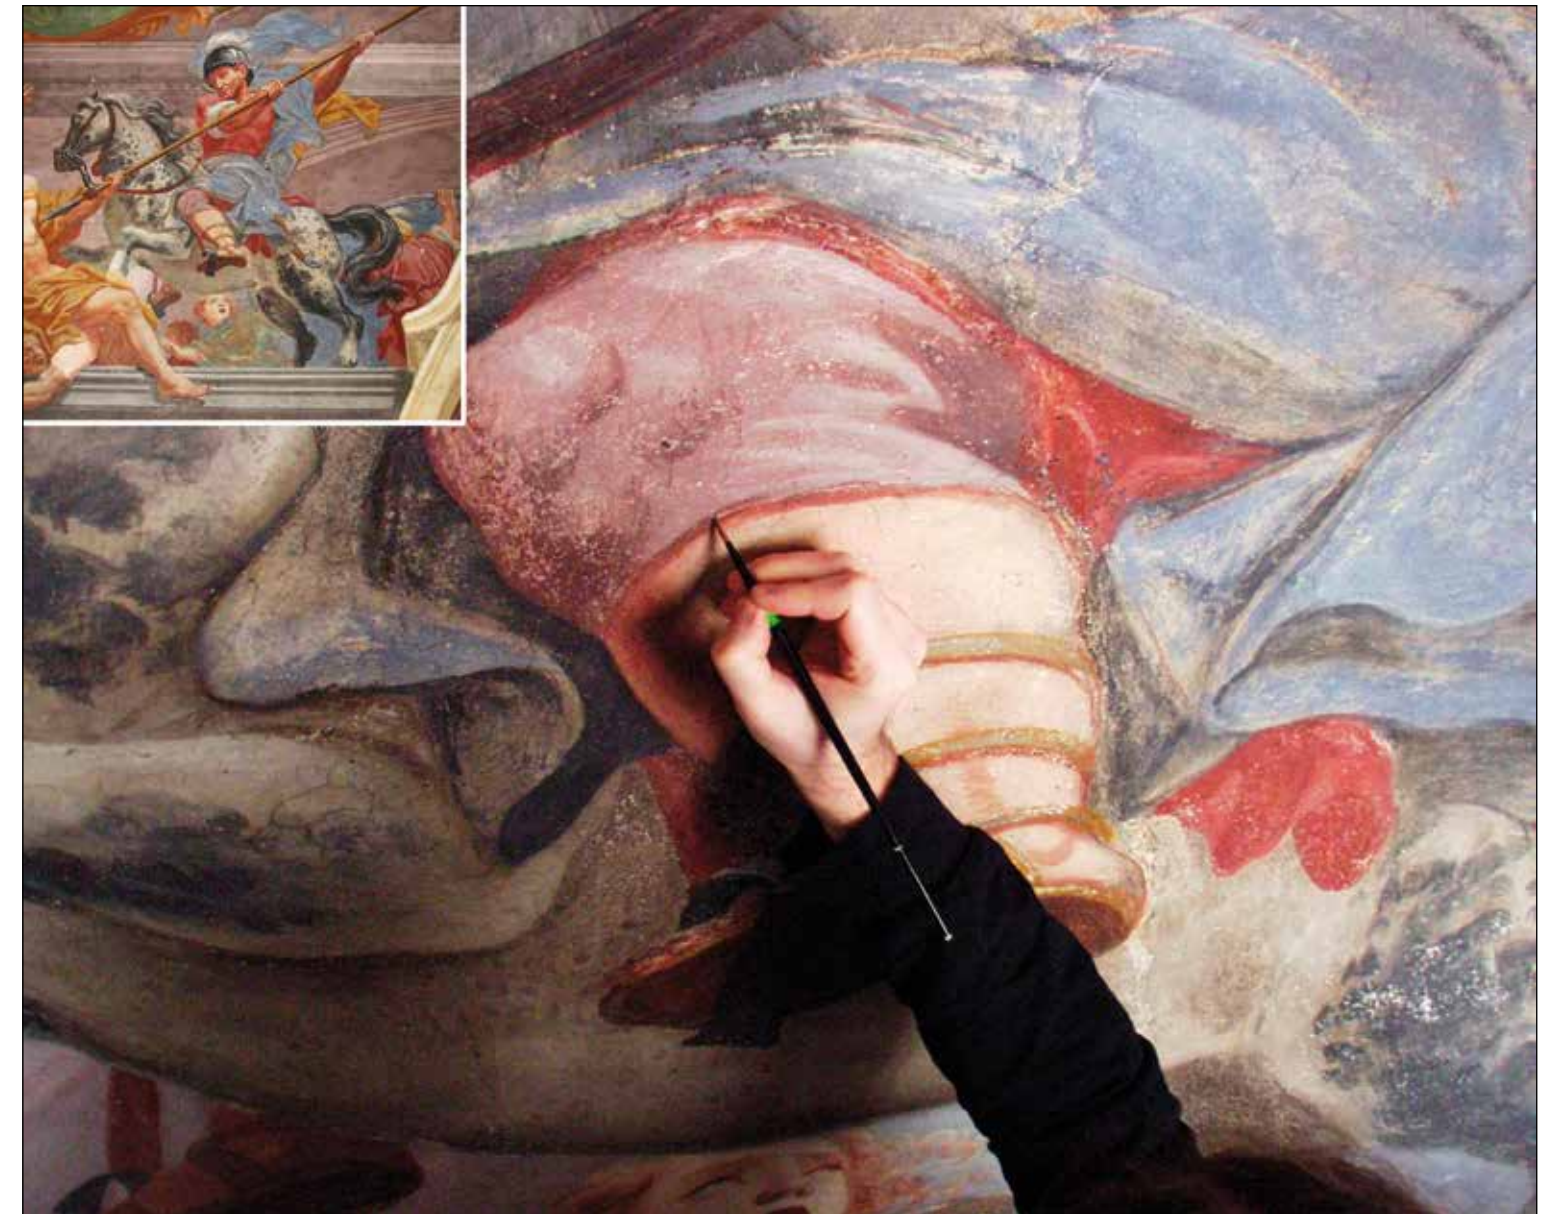
Figure 11: Retouching a detail in the area of quadrant N17.

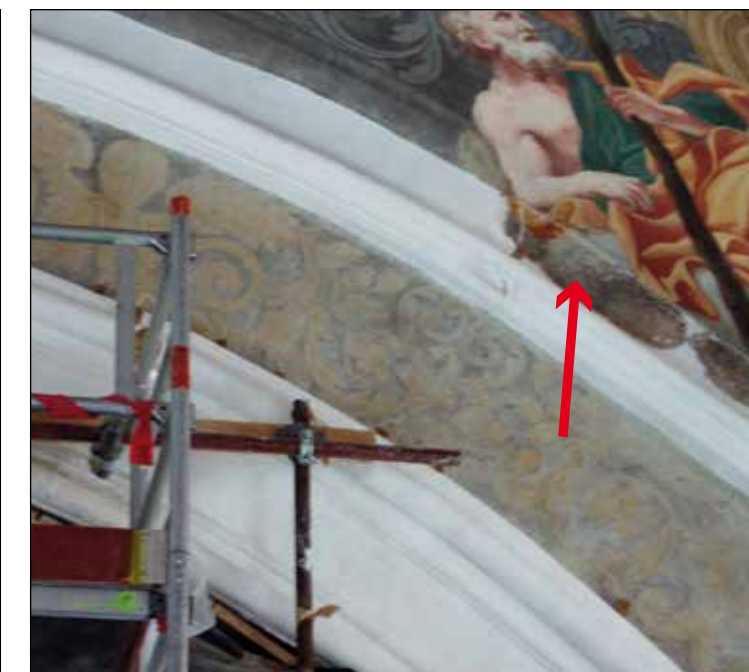
Figure 6: A part of Quaglio's wall painting underneath the whitewashes on the triumphal arch wall.

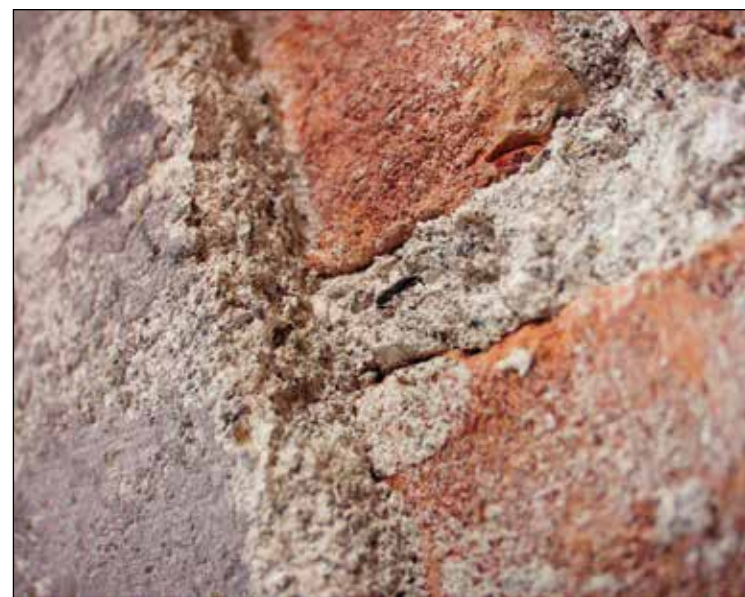
Figure 16: A detail from a probe of the vault, located within quadrant H19

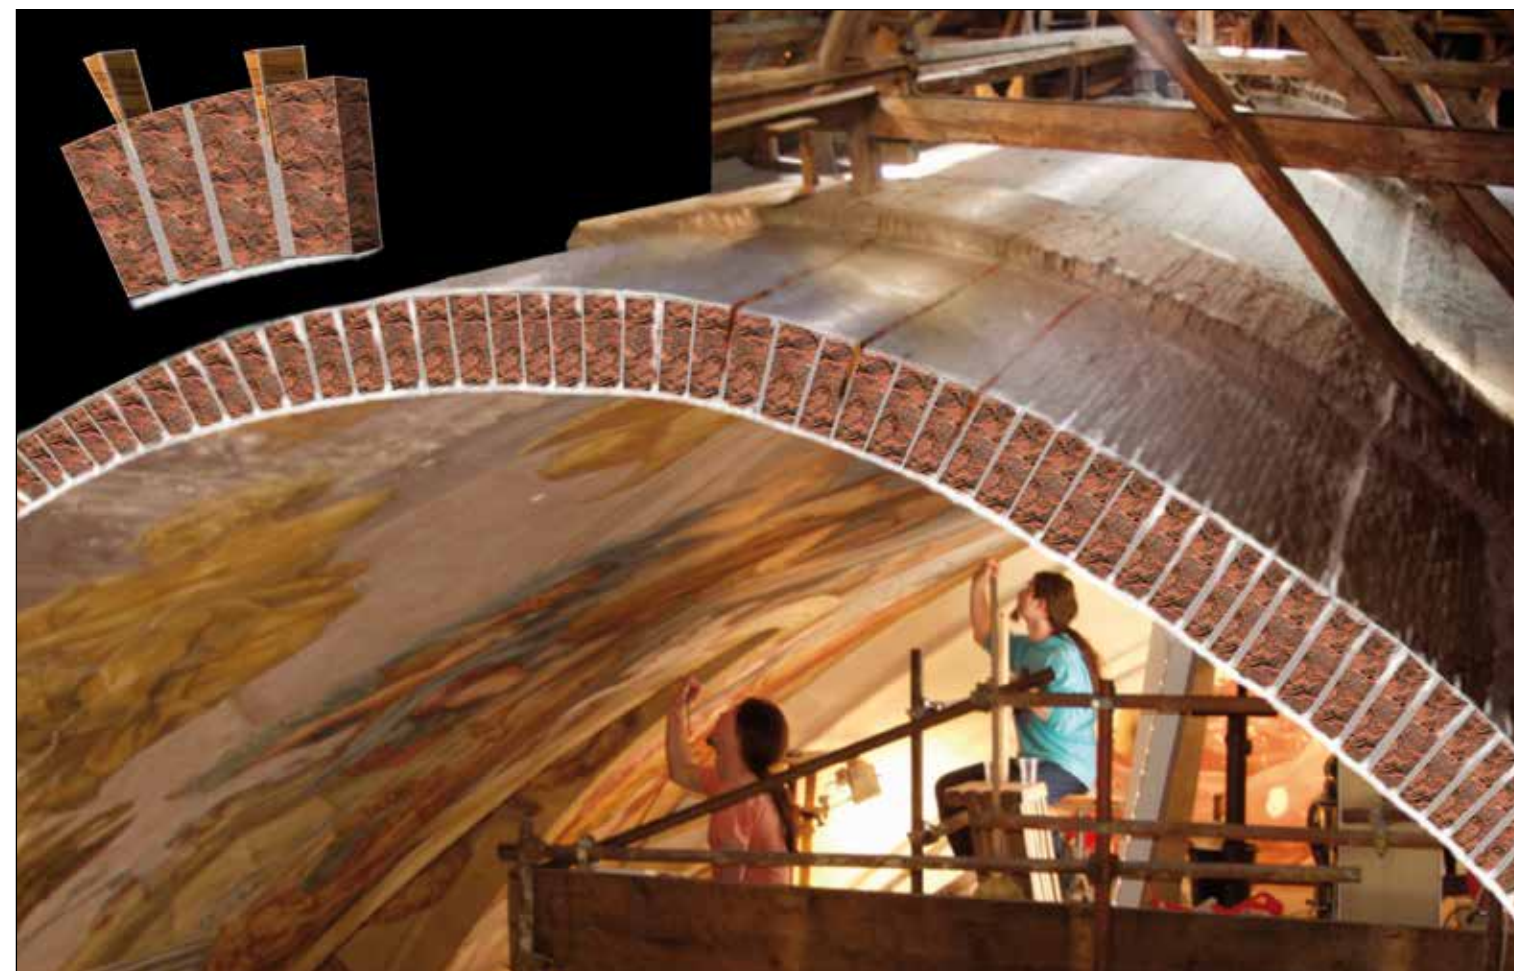
A section through the brick vault clearly illustrates the construction of the vault with arched supports upon whose sides the roofing con-

Figure 18: A cross-section of the vault's brick construction.

struction rests. A series of wedges has been inserted lengthwise into the brickwork every few rows (figure 18, detail top left). In figure 20, the top of the lunette can be seen well, where the bricks have been laid at a right angle in the direction of the brickwork of the large vault. The abutment reaches almost to the top of the structure of the lunette. In figure 21, the anchoring of the roofing construction can be seen well, directed towards the springing of the vault.

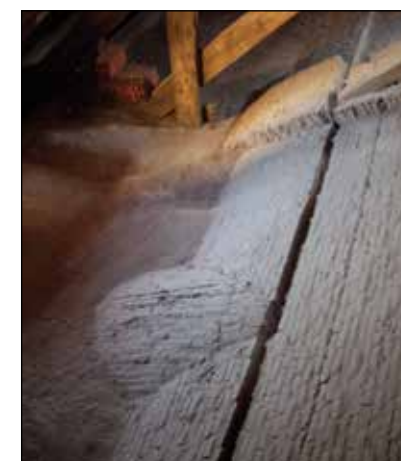
Figure 20: The arch of a lunette.

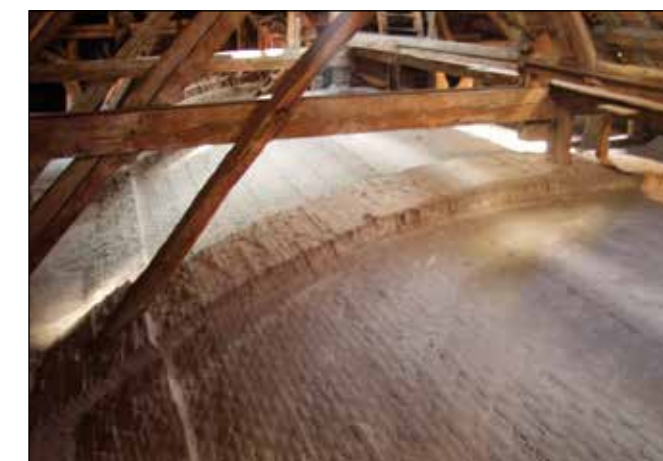
Figure 21: The anchoring system of the roofing proceeds tangentially towards the springing of the vault.

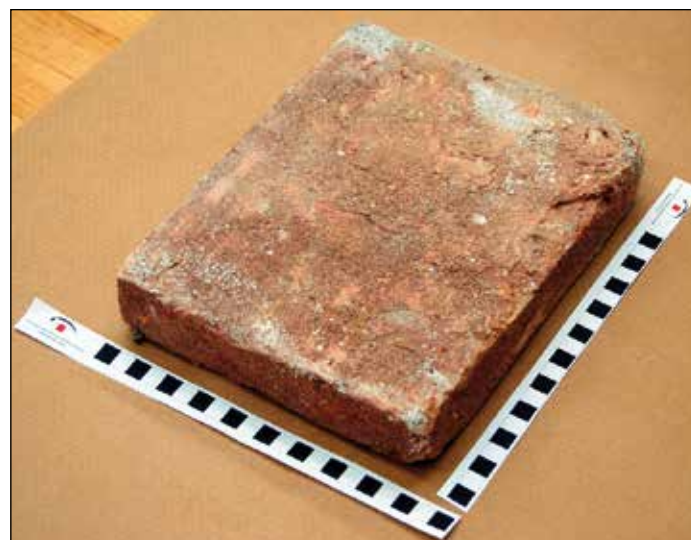
Figure 22: Hand-made brick.

The vault is made from bricks, apart from the bottom starting point (the springing of the vault), where stone slabs were used due to greater anticipated pressure (figure 41). In the attic, hand-made bricks were found in the abutment, which measured approximately 19 cm in width, 24 cm in length and 4.5 cm in height (figure 22). The same bricks were used in the construction of reinforcing arched brick supports. The plaster on the damaged surface of the painted vault (location H19 – figure 23) was removed in the form of a square probe up to the brick construction. The lime plaster in the thickness of 1.5 cm is composed of two layers (figures 24, 25), which are the top layer of the 3 to 5 mm thick intonaco (skim coat), and the 10 to 12 mm thick arriccio (brown coat). In the area of the lower plaster inside the probe, a mark was discovered (a small cross made in charcoal – figure 26), which was used to mark one of the points in the junction of the surface before the intonaco was laid down. Bricks were also used as the main construction material in forming profiles, cornices and pilasters (figure 27). Besides conservation-restoration work on the painted surfaces, also all crumbled off, cracked and otherwise damaged areas on the profiles, cornices and other ornamental elements had to be renovated (figures 29, 33). In preparing the bearings for anchoring the supports of the restoration

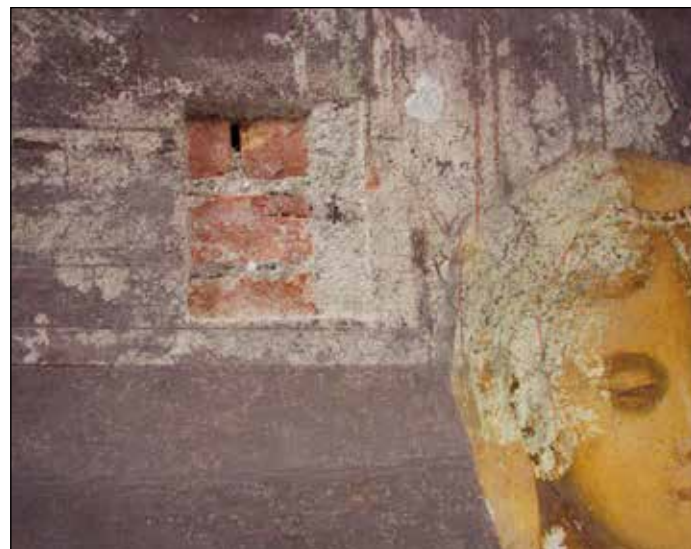
Figure 23: Damaged surface of the vault painting (location H19).

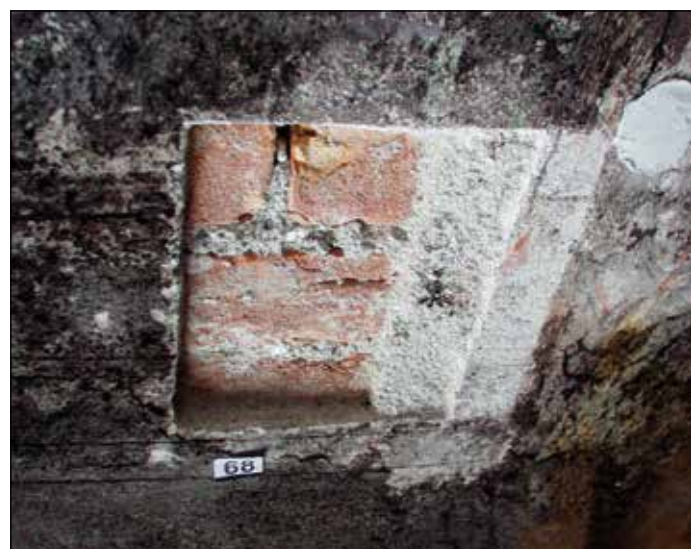
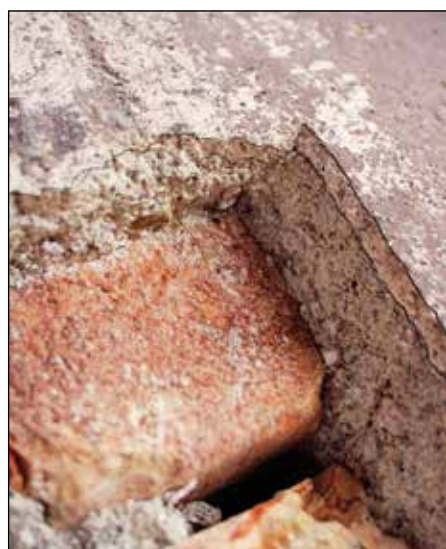
Figures 24, 25: The lime plaster is composed of two layers.

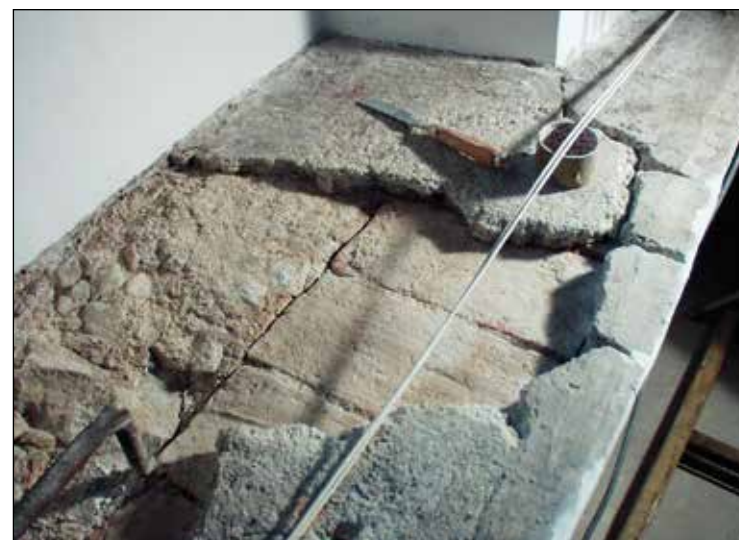
Figure 27: The window sill beneath the vault window where the brick construction of the profiles is visible.

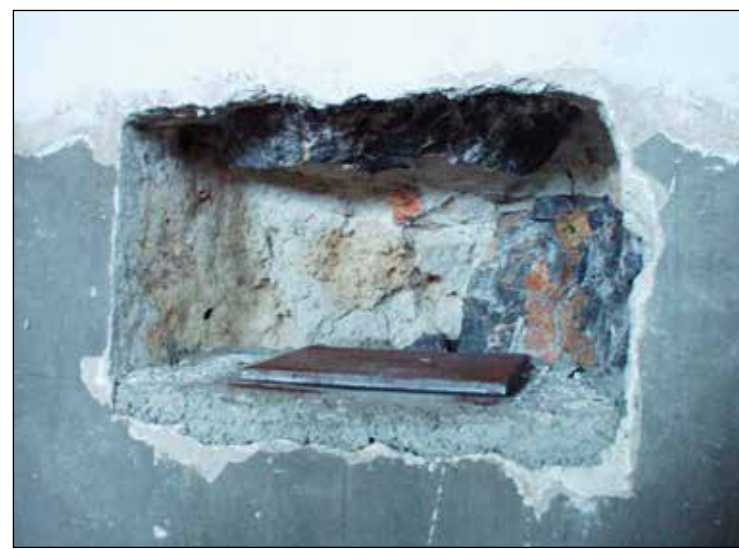
Figure 28: Damage occurred with the anchoring of the restoration platform.

platform, certain damage occurred to the walls (figure 28) and profiles of the painted medallions. Inside these niches, which could also have been probes, we had the opportunity to observe what kind of material was used in the construction of the more than one-meter thick walls. As can be seen from the shot, the material is composed of stone and probably constructed using quicklime, finally slaked on the wall itself. An exhaustive report was produced about the composition of the collected sample (SNL 228, figures 30, 31) of plasterwork from the square probe from location H19 and collected samples of the profile ornamentation on the cornices.⁹

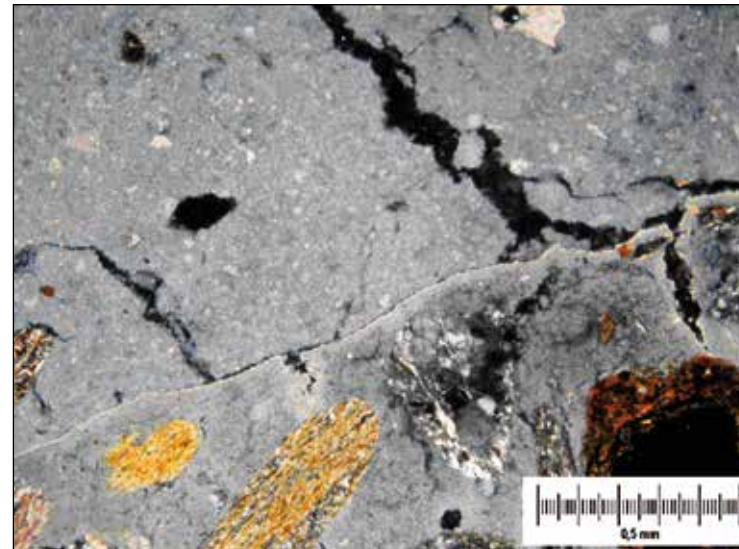
Figure 30: Limit between upper and lower plaster – sample: SNL 228; conditions: transmission light, crossed polars.

⁹ KRAMAR 2007. Photographs 30 and 31 are from the mentioned report (5 and 6).

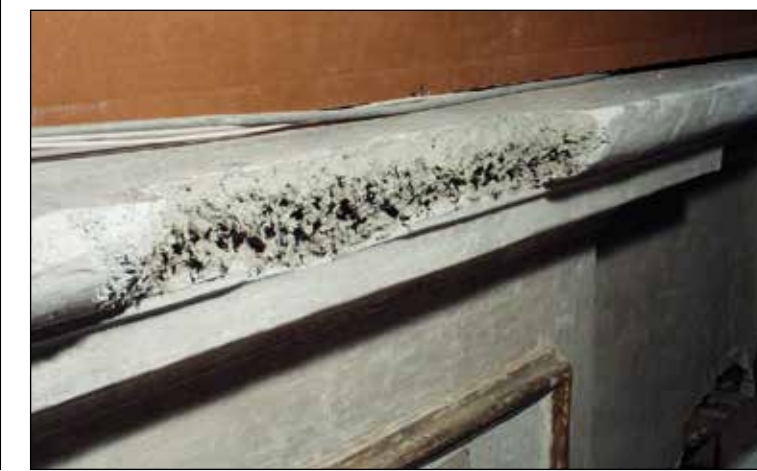
Figure 29: The application of a new binding mortar at the beginning of the reconstruction of the cornice.

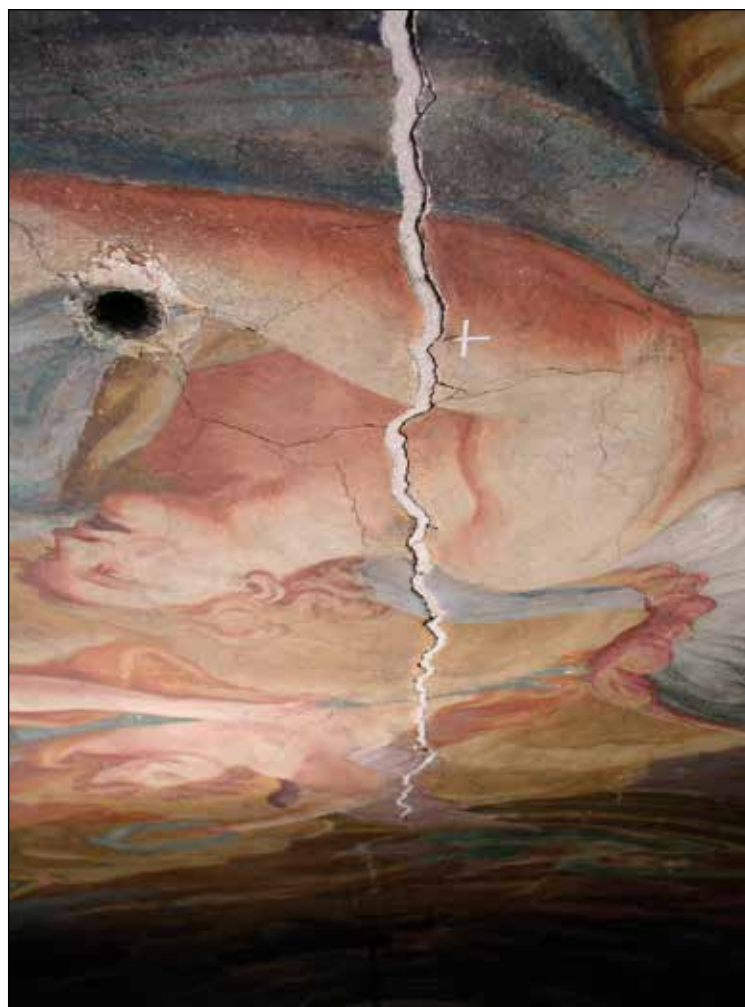
Figure 32: Condition before treatment – a new crack, next to another, once already filled crack, runs along one side and then the other.

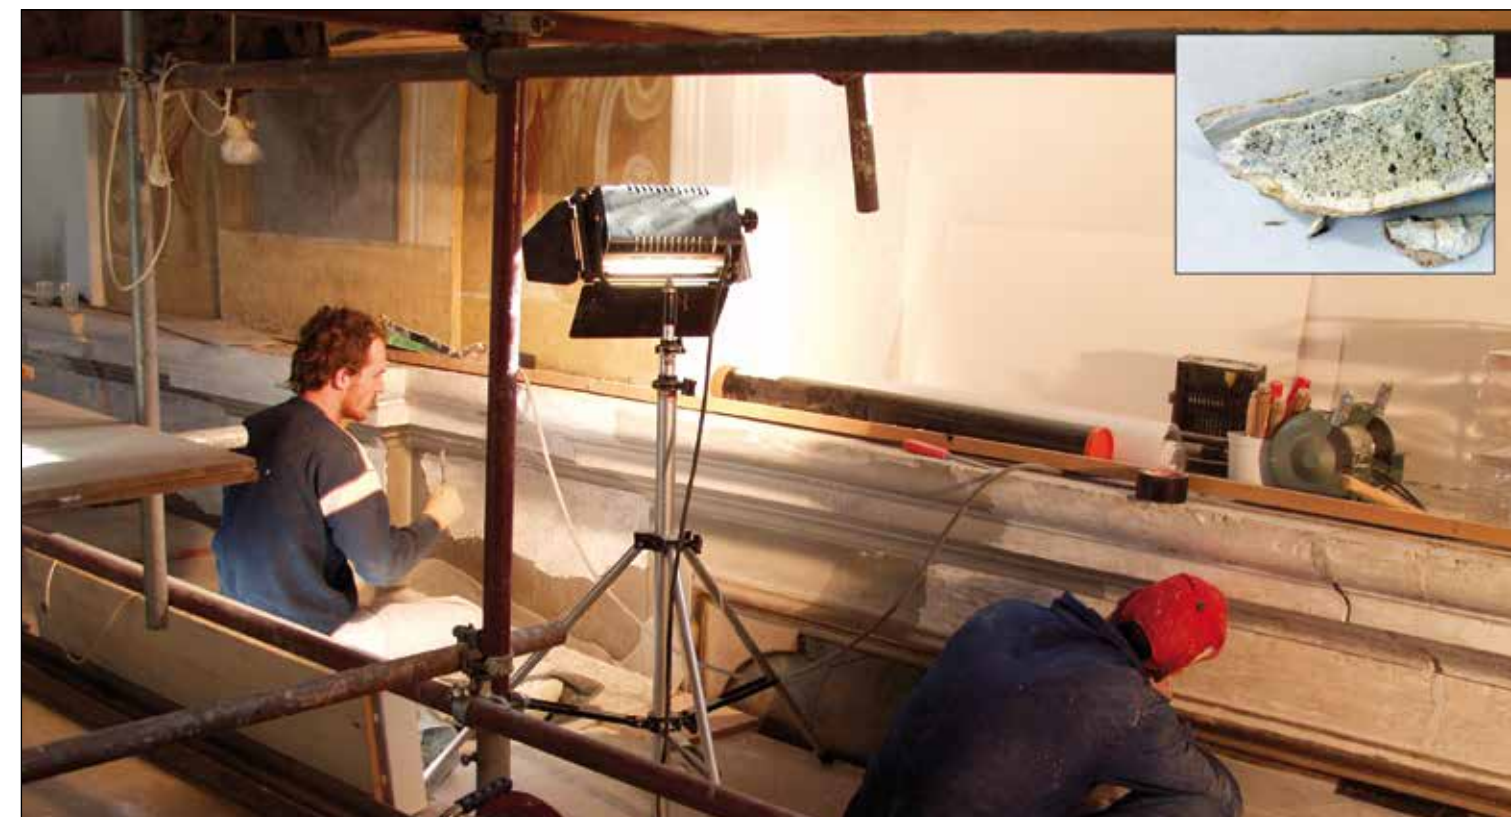
Figure 33: Removal of darkened whitewashes from the cornice profile under Quaglio's mural. The smaller image shows the layers of the stucco plaster on the profile of the cornice.

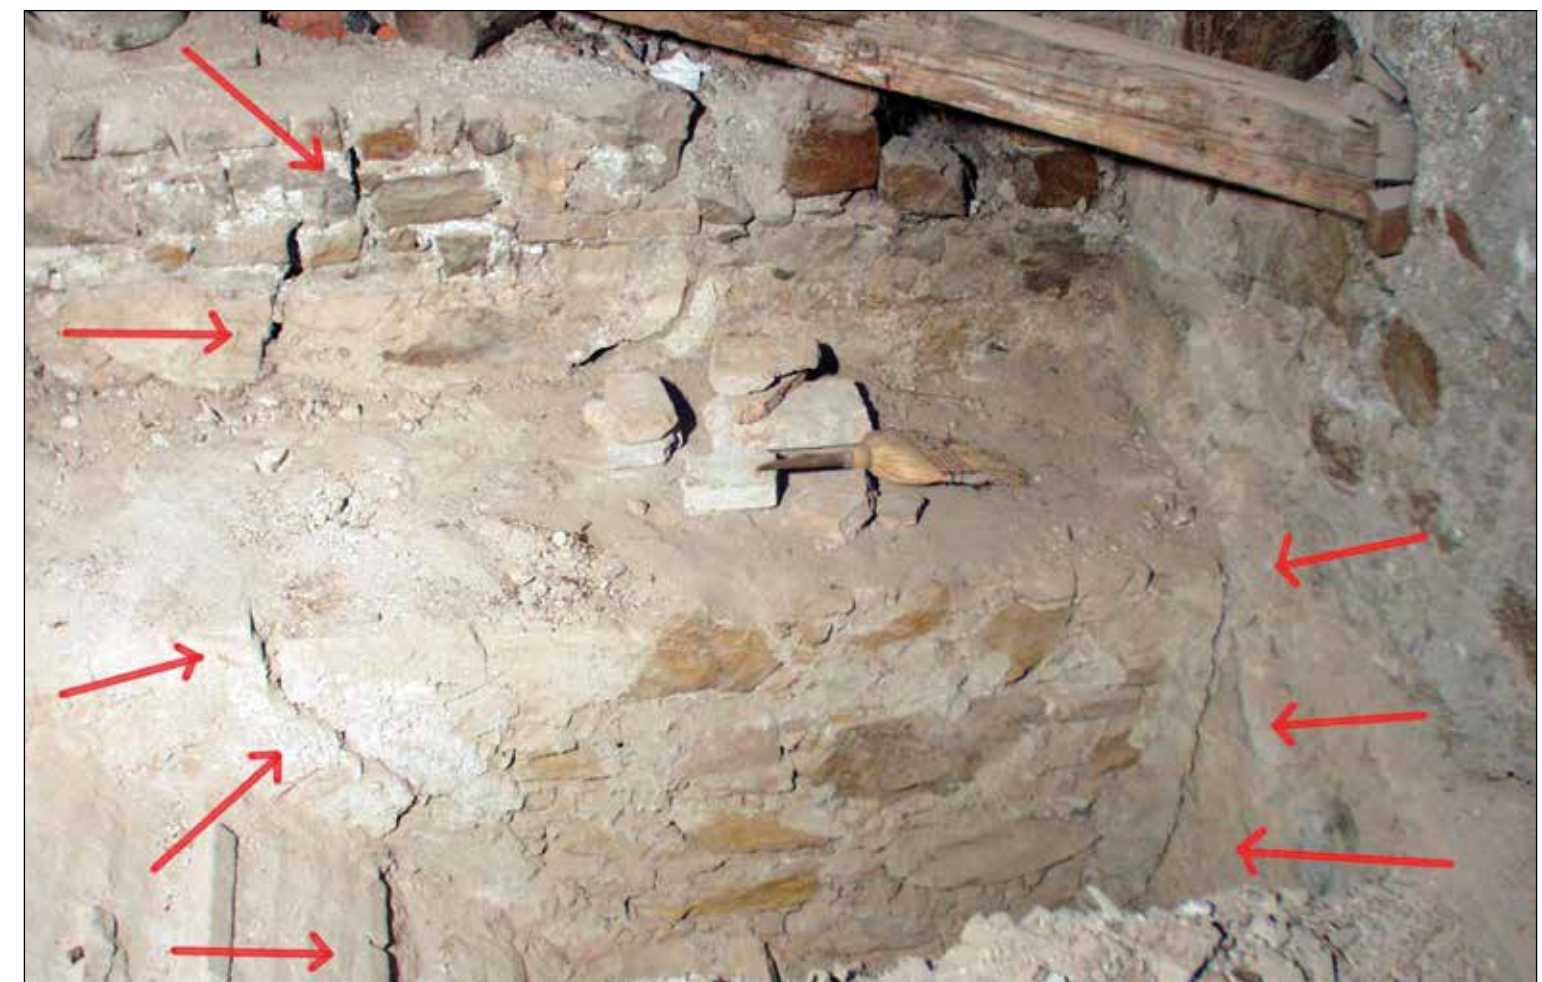
Figure 38: Testing probe in the north-western corner of the attic with marked arrows indicating a large crack on the left and detachment of the masonry.

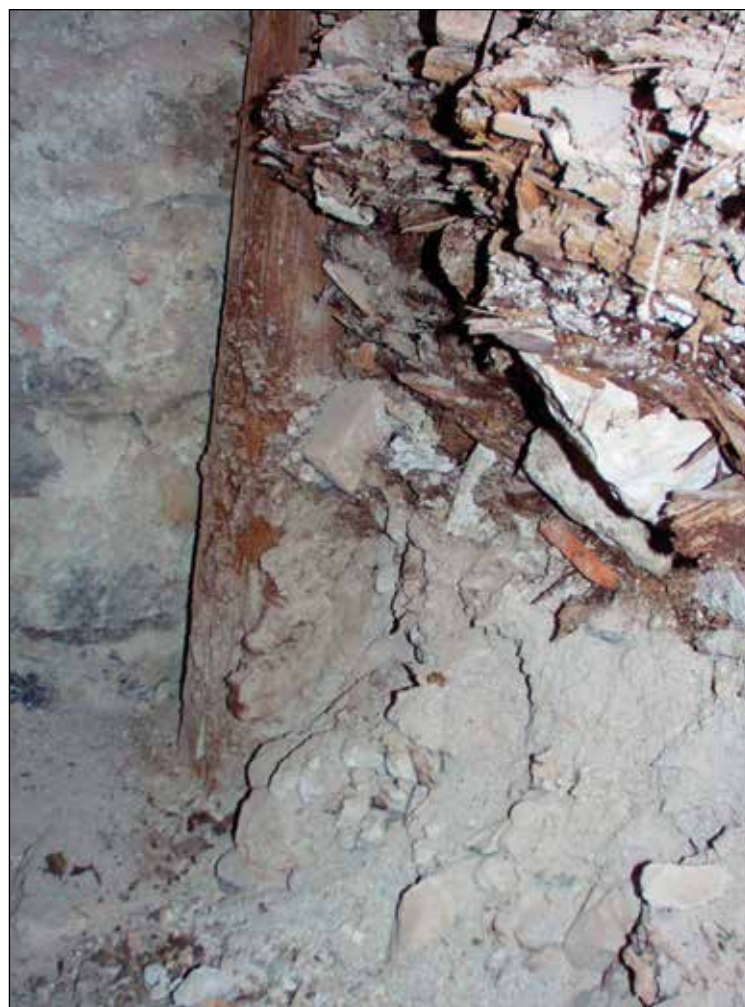
Figure 39: Probing of the abutment.

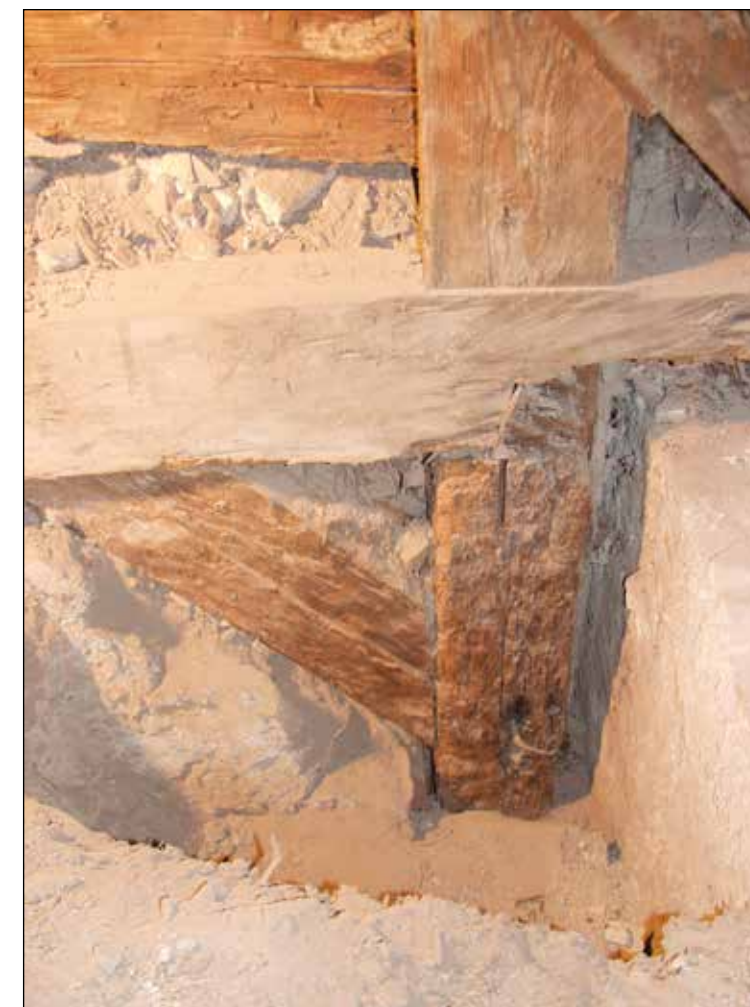
Figure 42: The anchoring in the roofing construction.

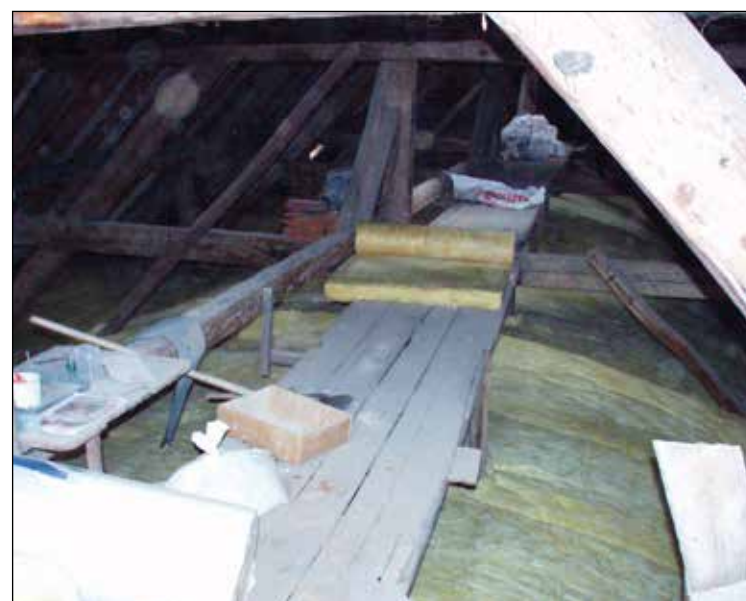
Figure 44: Applying thermal insulation to the vault.

These supporting points, together with the marked arched reinforcing supports, are of great help when investigating the causes and consequences of any water leakage. The thermographic record in figure 43 shows the central part of the vault after being heated with warm air. The red colour denotes areas (thicker walls) that accumulated heat, whereas the blue colour shows the surfaces that are thinner in construction and therefore lose heat more quickly. There is only a difference of 1.1°C between the warmest (red – 13.2°C) and the coldest areas (blue – 12.1°C). From this example it can be seen that the surfaces of the vault respond differently to changes in temperature, causing the materials to constrict and expand, therefore producing cracks. A layer of thermal insulation was placed onto the vault in order to minimise these differences in temperature (February 2006; figure 44).
