THE RESTORATION OF QUAGLIO'S WALL PAINTINGS
IN LJUBLJANA CATHEDRAL

The Restoration of Quaglio's Wall Paintings in Ljubljana Cathedral

A conservation-restoration project involving the wall paintings created by Giulio Quaglio (1668–1751)

on the nave vault and the western wall of the Cathedral of St Nicholas in Ljubljana, IPCHS Restoration Centre (2002–2006)

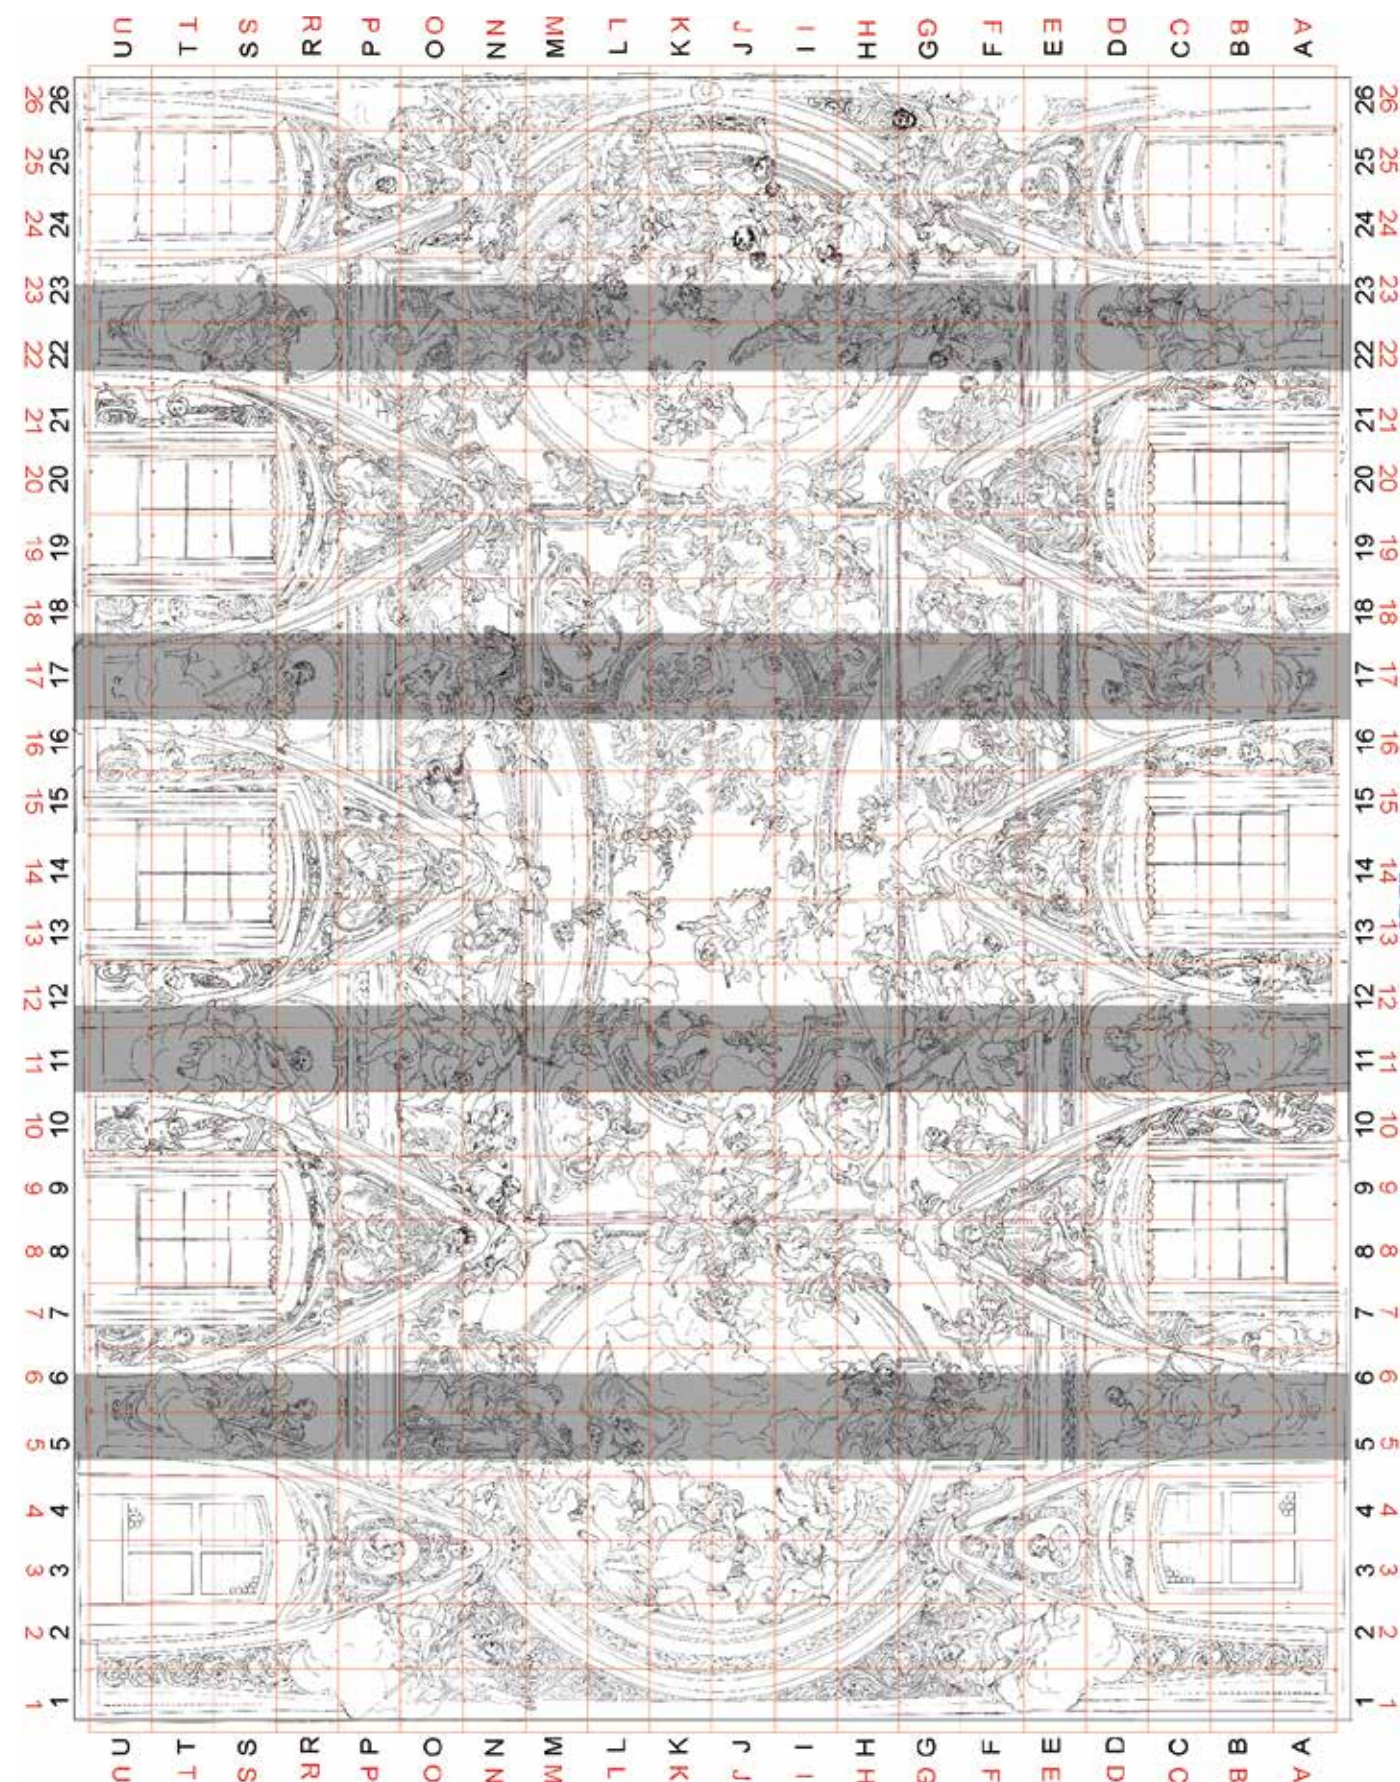
Figure 45: Marked position of the reinforcing arches in the vault construction. The drawing is important for the analysis of the locations of damage on the wall and ceiling paintings.

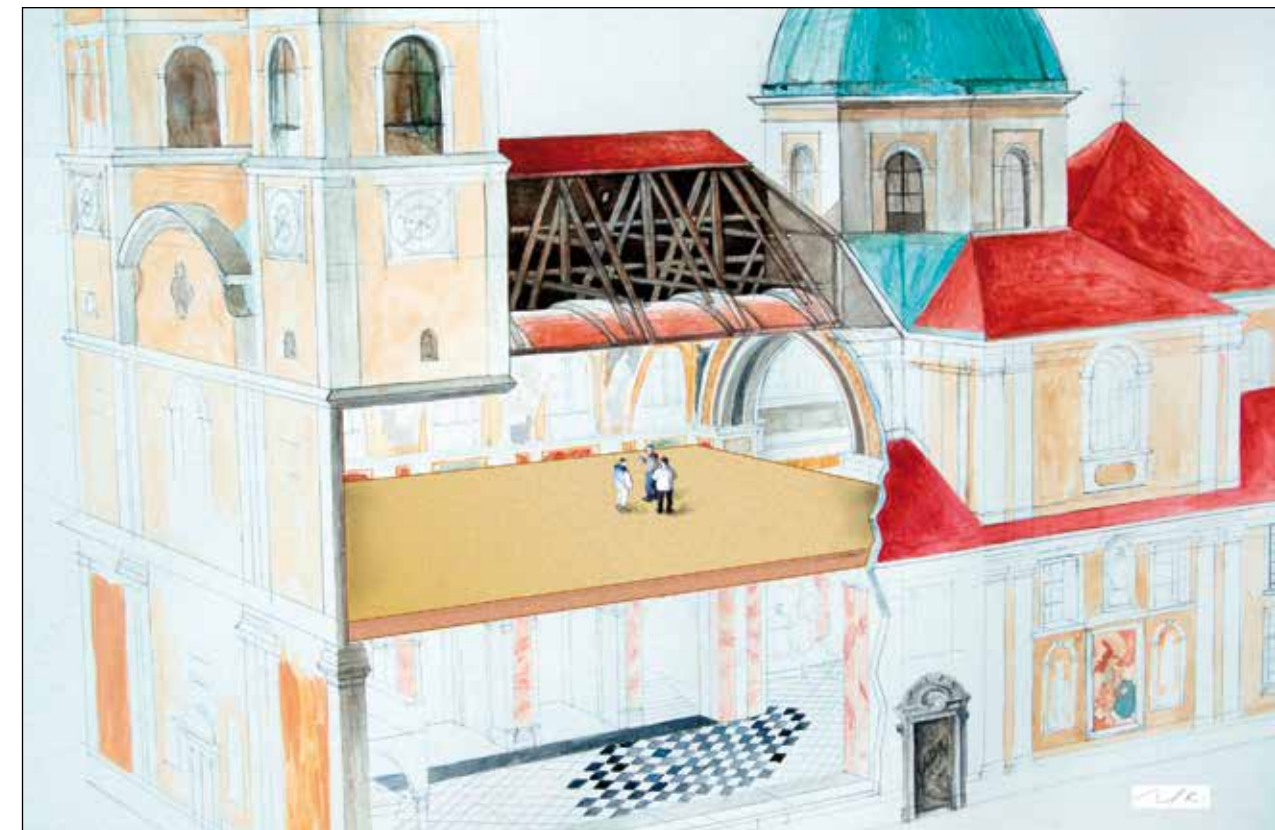
Figure 51b

Figures 51a and 51b: The position of the restoration platform at a height of 13 metres.

In order for the restorers to reach every single painted surface area (figure 47), at a height of 20 m, measuring 25 m in length, a restoration platform was set up at a height of 13 m (figure 51a – red line, and figure 51b). In order for the structure of the platform to withstand additional scaffolds and equipment, wall bearings were prepared (figure 48) into which strong anchors were placed (figure 49). Walking boards with sound and dust protection were attached onto the upper side of the anchors, whereas plaster boards (figure 50) were fixed to the underside so that visitors to the church were spared the sight of the platform construc-

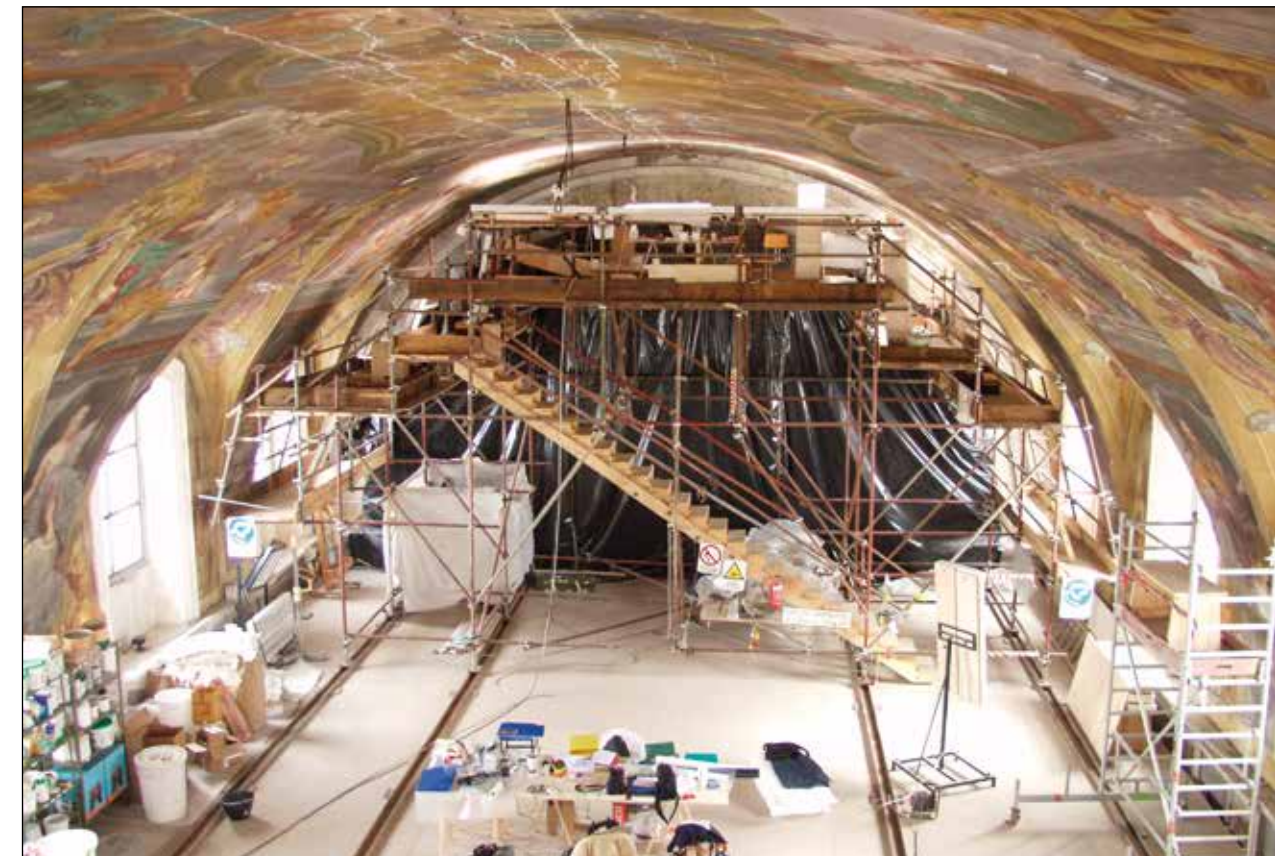
Figure 52: View towards the east: the moveable scaffold on the restoration platform.

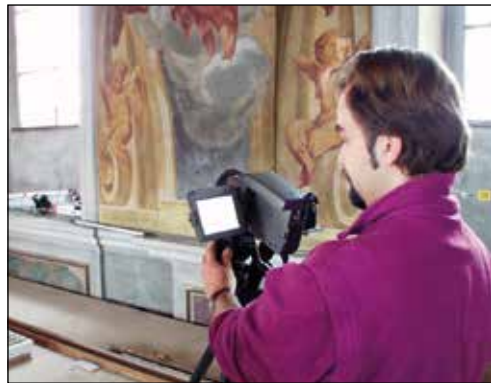
Figure 53

Non-destructive investigations of the vault and western wall of the Church of St Nicholas were already carried out in 1997 by means of photogrammetric drafts and thermographic investigations, which were supplemented by results obtained from measurements using a more modern thermographic camera in 2003 (figure 53). In Figure 54, the detection of the wide central crack on the vault can be seen, whereas figure 55 shows all thermographic records of the vault and western wall. To aid comparison Figures 56 and 57 have been added, which illustrate the region of the reconstructed and fallen off wall and ceiling painting on the junction between the vault and western wall. To monitor the stability of the building construction and perception of eventual changes, a system of measurement points was implemented by using sensors to measure the micro-stretching of the cracks of the nave vault (figures 58). In order to monitor micro-climatic conditions, sensors were implemented to measure humidity, temperature and temperature-related expansion (figure 59). The locations of individual sensors are denoted in figures 60, 61 and 62. To monitor temperature changes between the interior and the attic, the exterior side of the vault, measurements were taken of relative air humidity under the vault, air temperature under the vault and the surface temperature of the interior side of the vault before installation of thermal insulation and after, on the attic side. It can be seen from the measurements that the difference in the temperature measured on the surface of the vault in the interior and the attic was substantially reduced, which would certainly reduce the likelihood of new cracks forming due to expansion of material caused by big temperature fluctuations.¹³ Before thermal insulation was installed, we ourselves experienced the transfer of temperature across the vault into the interior

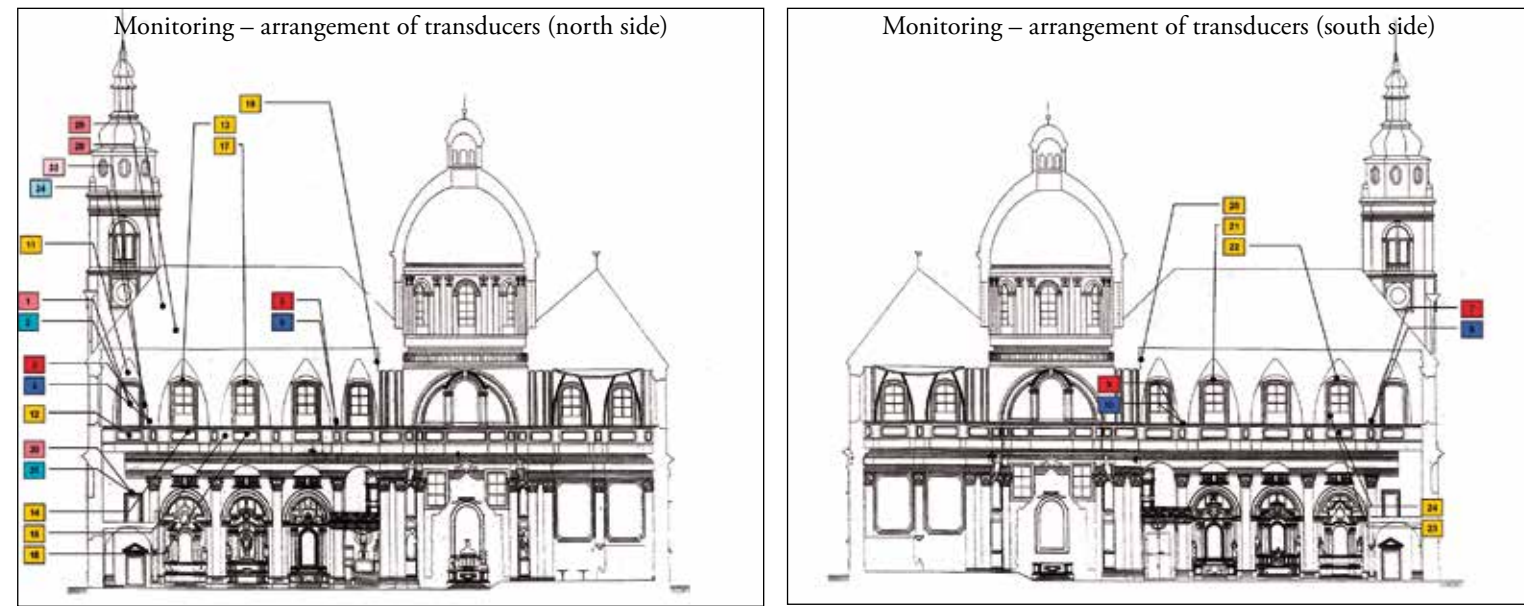
Figure 60: Key
 Fissurometer (yellow square)
 Wall temperature (red square)
 Wall moisture (blue square)
 Space temperature (pink square)
 Space moisture (cyan square)
 Surface temperature (red vertical lines)
 Surface moisture (blue vertical lines)

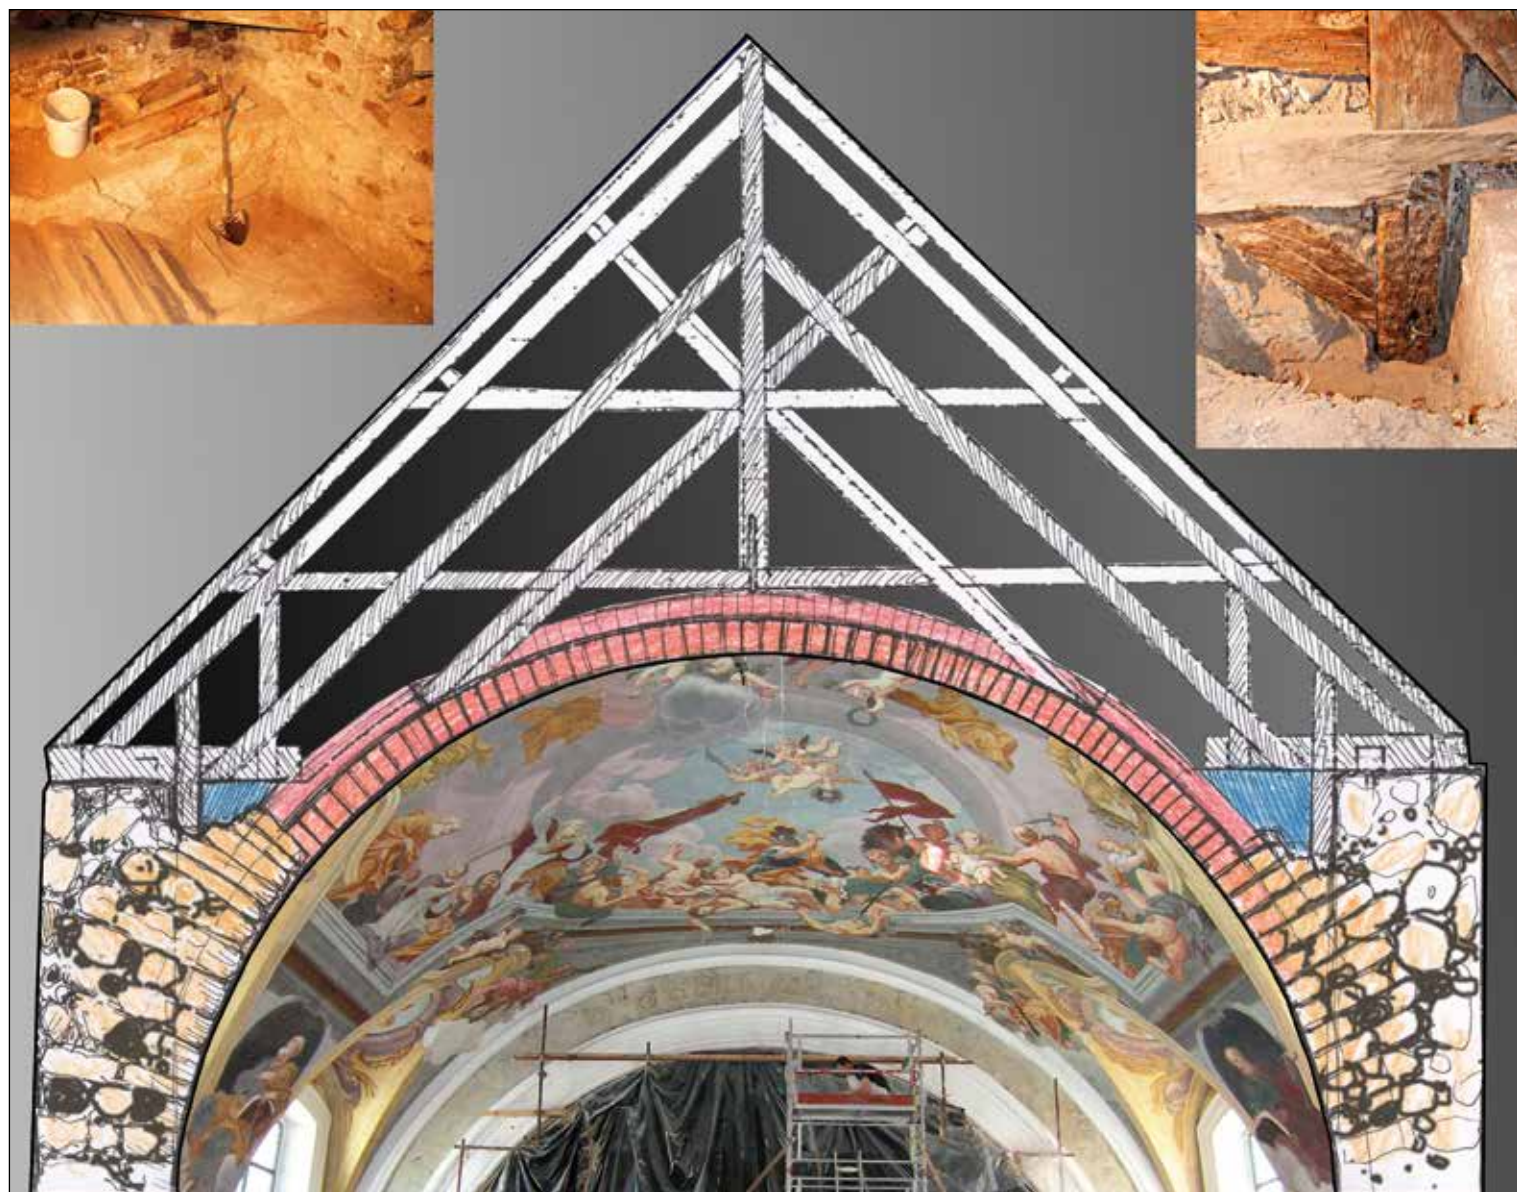
Figure 73: The cross-section of the vault and roof: most of the vault is constructed from bricks, only in the region resting onto the wall of the nave were stone slabs added to the springing, which we discovered after the temporary removal of the abutment (image top left). The abutment in the illustration is denoted by the blue colour. The majority of the weight of the wooden roofing construction is spread onto both loadbearing walls, exerting pressure onto the vault only tangentially across the arched supports, thus decreasing the splaying out of the vault. The image above shows a part of the roofing which is anchored into a part of the abutment, thus forming a kind of horizontal bond. Due to the repeated contractions and expansions of the inbuilt material over many years, as well as movements caused by earthquakes, deep longitudinal cracks formed at the top of the vault across the whole length of the nave (figure 74).

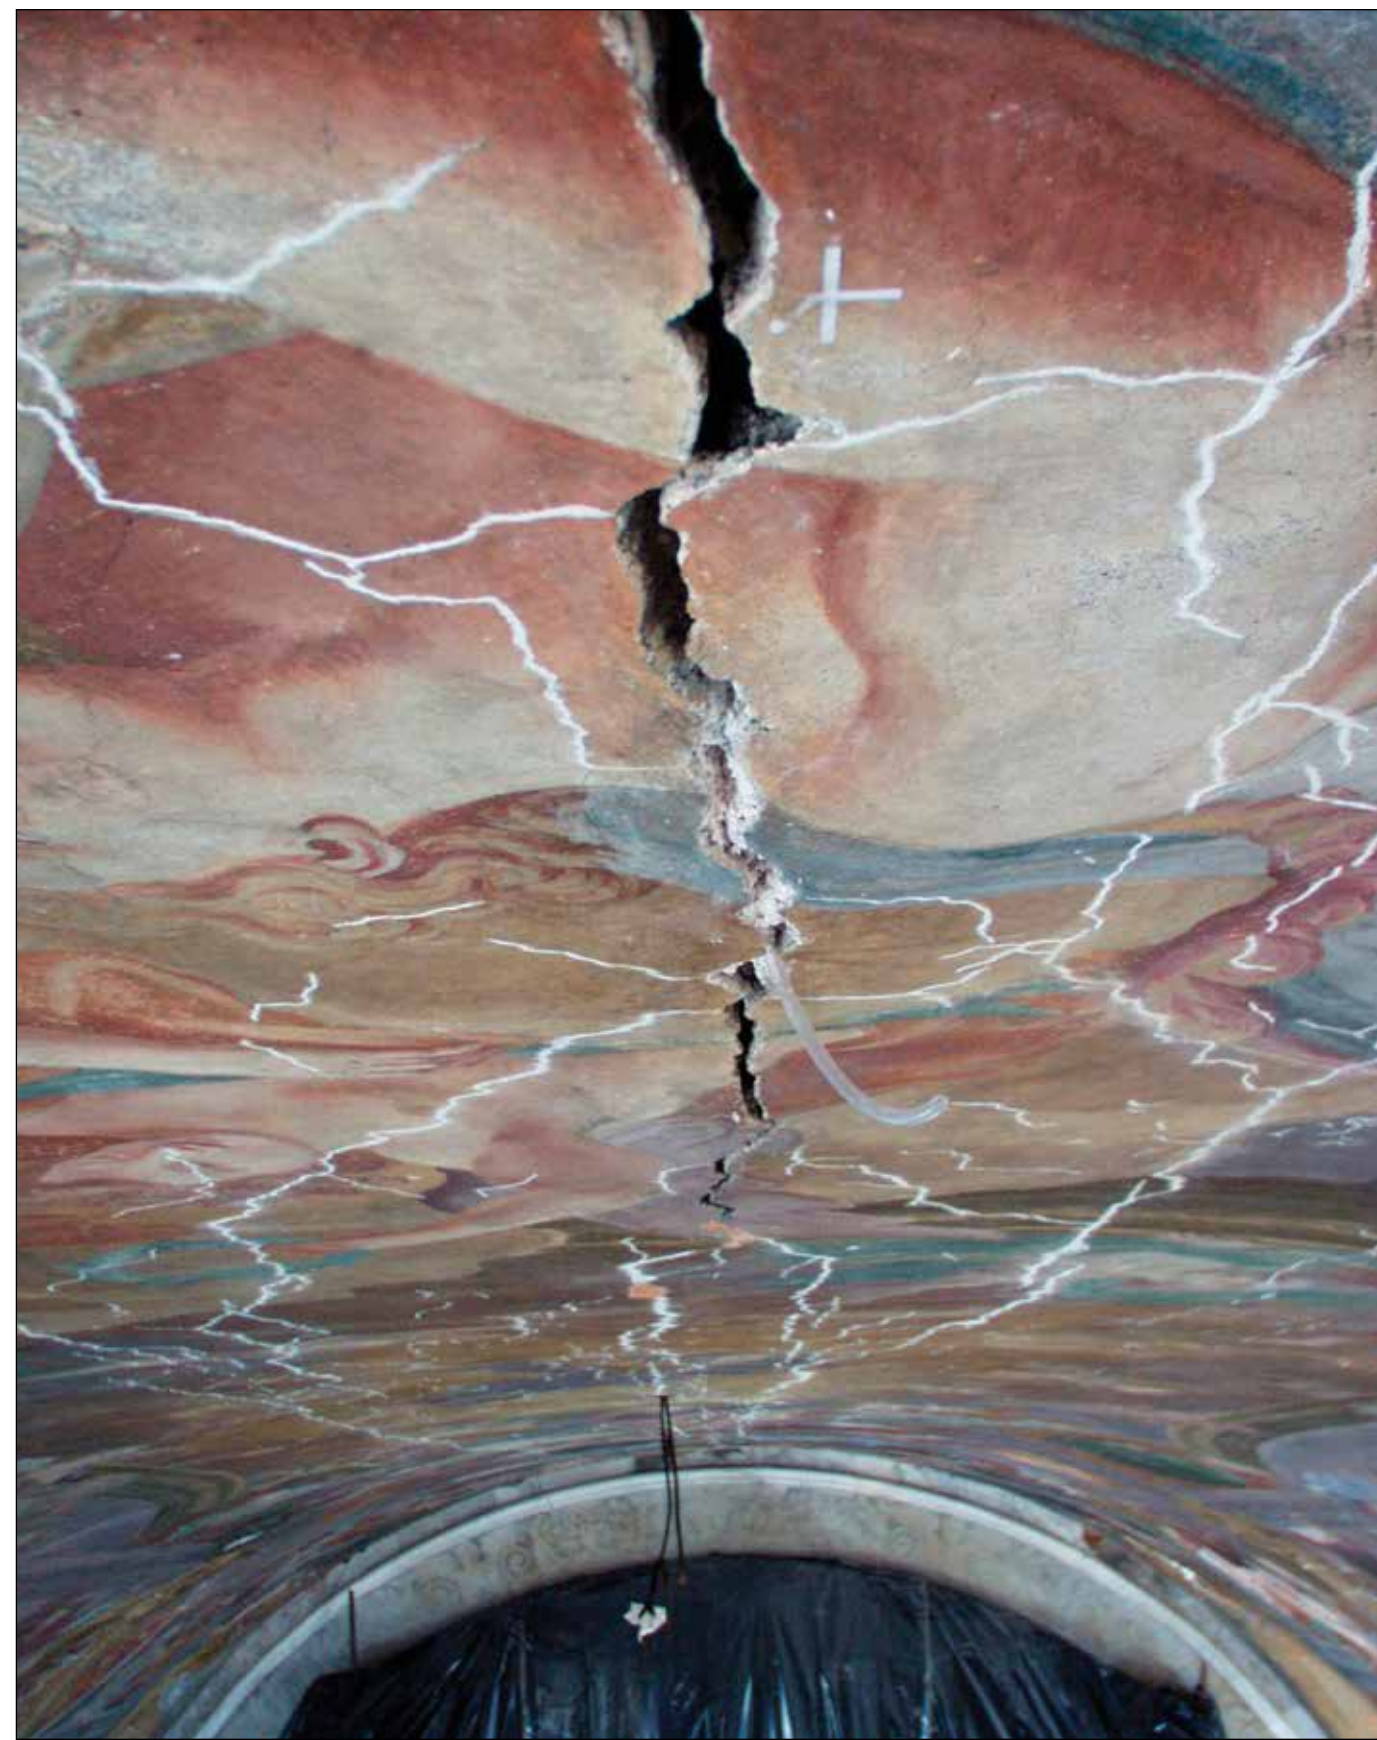
Figure 74: Wide longitudinal cracks on the apex of the vault.

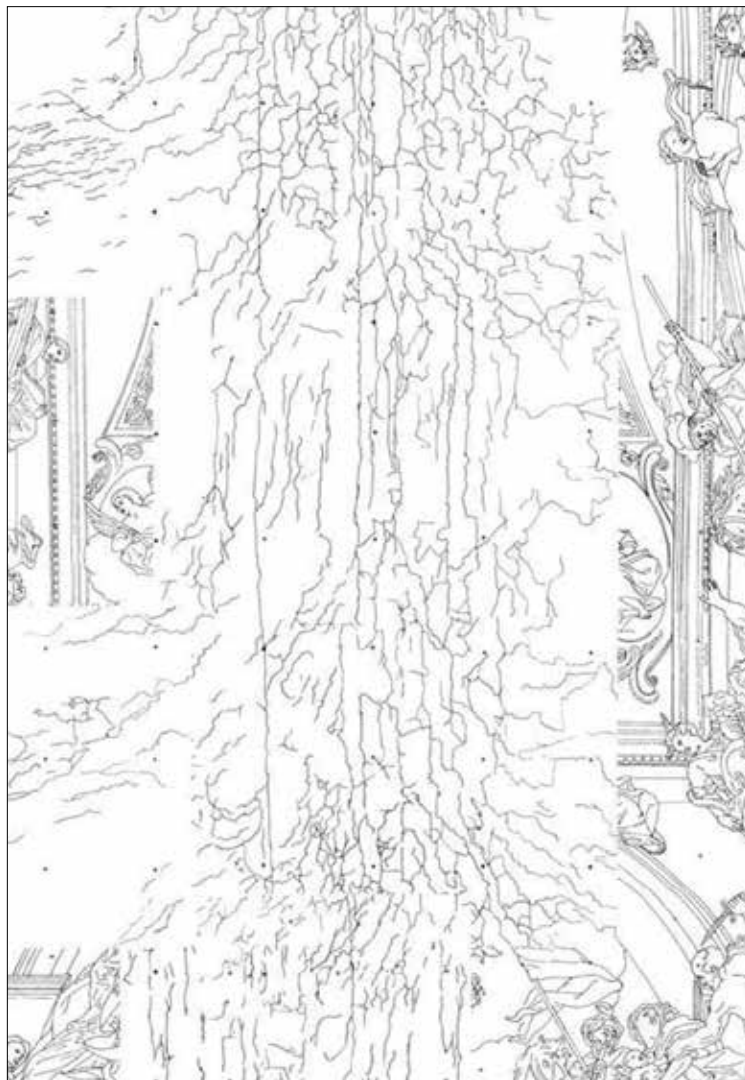
Figure 75: Graphic illustration of the course of the cracks on the vault.

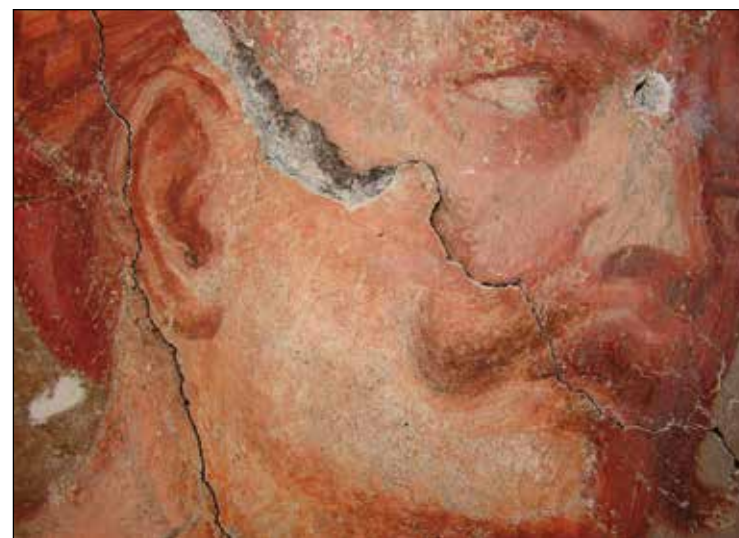
Figure 76

There are many causes for the damage occurred on the wall and ceiling paintings on the vault and western wall of the Cathedral of St Nicholas, and these interlace. The natural disaster, such as the earthquake of 1895, produced numerous great, as well as small areas of damage, throughout the construction of the church. If the earthquake caused the heavy cracks on the western wall, as can be seen in figures 76 and 77, then it is quite possible that some roof tiles were moved or even fell off. Whether the church building was fixed immediately or at a later date, can only be guessed at. The fact remains that some of the greater damaged areas occurred precisely due to the evident disintegration of the lime binding exposed to the continuous effects of moisture. The two cracks in figures 76 and 77 are shown after removal of the old, unsuitable fill material.

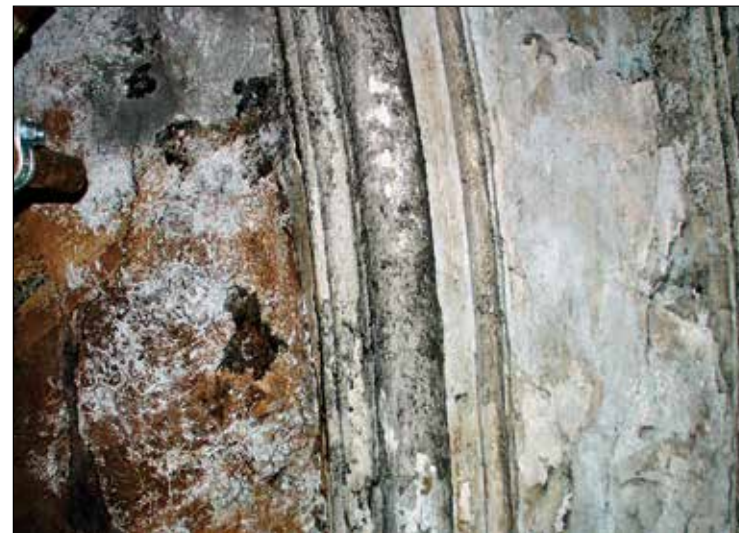
Figure 78

The formation of salt crystals on the surface of the murals made the otherwise relatively smooth ground much coarser in structure, on which dust, soot and other impurities had begun to collect (figures 78, 79). The extensive lifting of the colour layer together with the plasterwork underneath in the region of the northern walled-in window (figure 80) demonstrate the persistent trickling of meteoric water at the junction of the roof and the northern belfower. The crack (figure 81) is filled with soot, which indicates air currents through the vault.

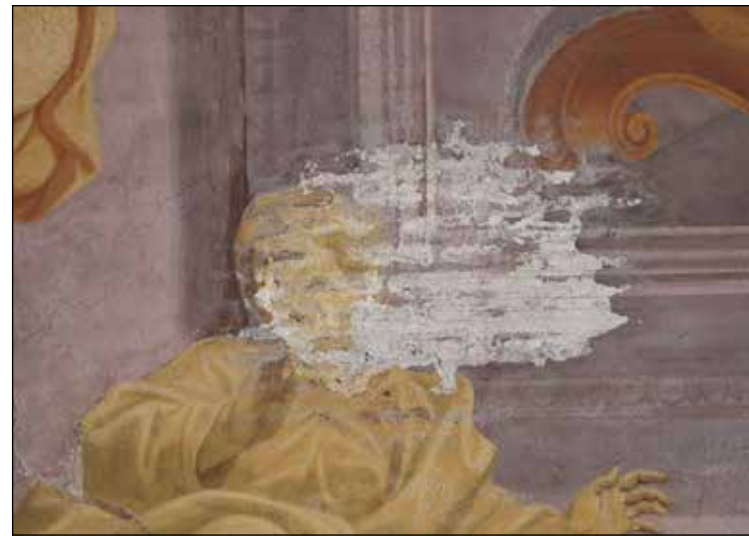
Figure 82/1

The most typical type of damage to the plasterwork and murals, which could be seen by an attentive observer from the ground of the nave and from a distance of twenty metres are presented in figures 82/1–87/6. Their actual locations within the grid are shown in figure 88. The first four images (82/1–85/4) lie on the northern side, whereas the last two (86/5 and 87/6) can be found on the southern side of the vault. In figure (7) – inside figure 88 – a severe crack is denoted in red. This is the only large transverse crack on the vault and is a continuation of a crack that runs across the whole of the exterior as well as in the interior, in the direction of N-S. No special points were uncovered by measuring the expansions on this crack, however, the experts drew attention to it nevertheless.

The damage in the first three images was caused by leakage of meteoric waters over an extended period of time. Here, besides the colour layer, also the plasterwork underneath began to fall off. The fourth (figure 85/4), which is less damaged, shows the typical darker traces of moisture seeping in due to different levels of conductivity in the construction of the vault and consequential efflorescences and deposits of dissolved matter on the surface of the wall and ceiling paintings.²¹ The fifth and sixth images lie on the opposite, southern side of the vault and at first glance seem less damaged than the previous ones. In figure 87/6 a similar pattern of filtering through the brick construction can be noted as in figure 85/4, although in this case the plasterwork with the mural has also begun to flake off. In figure 86/5, the figure of the virtue is almost in its entirety rimmed in white, which is caused by the flaking of the fragile, poorly carbonised particles on the edge of the giornata, and is not so much a product of leakage. From this rim outwards, however, the consequences of leakage can be seen in the form of a darker border, from behind which water has clearly trickled out, coloured by a dissolved mixture of matter which it accumulated along its course across the wooden roofing. The flaking of colour particles is pronounced in the lower third of the depicted figure.

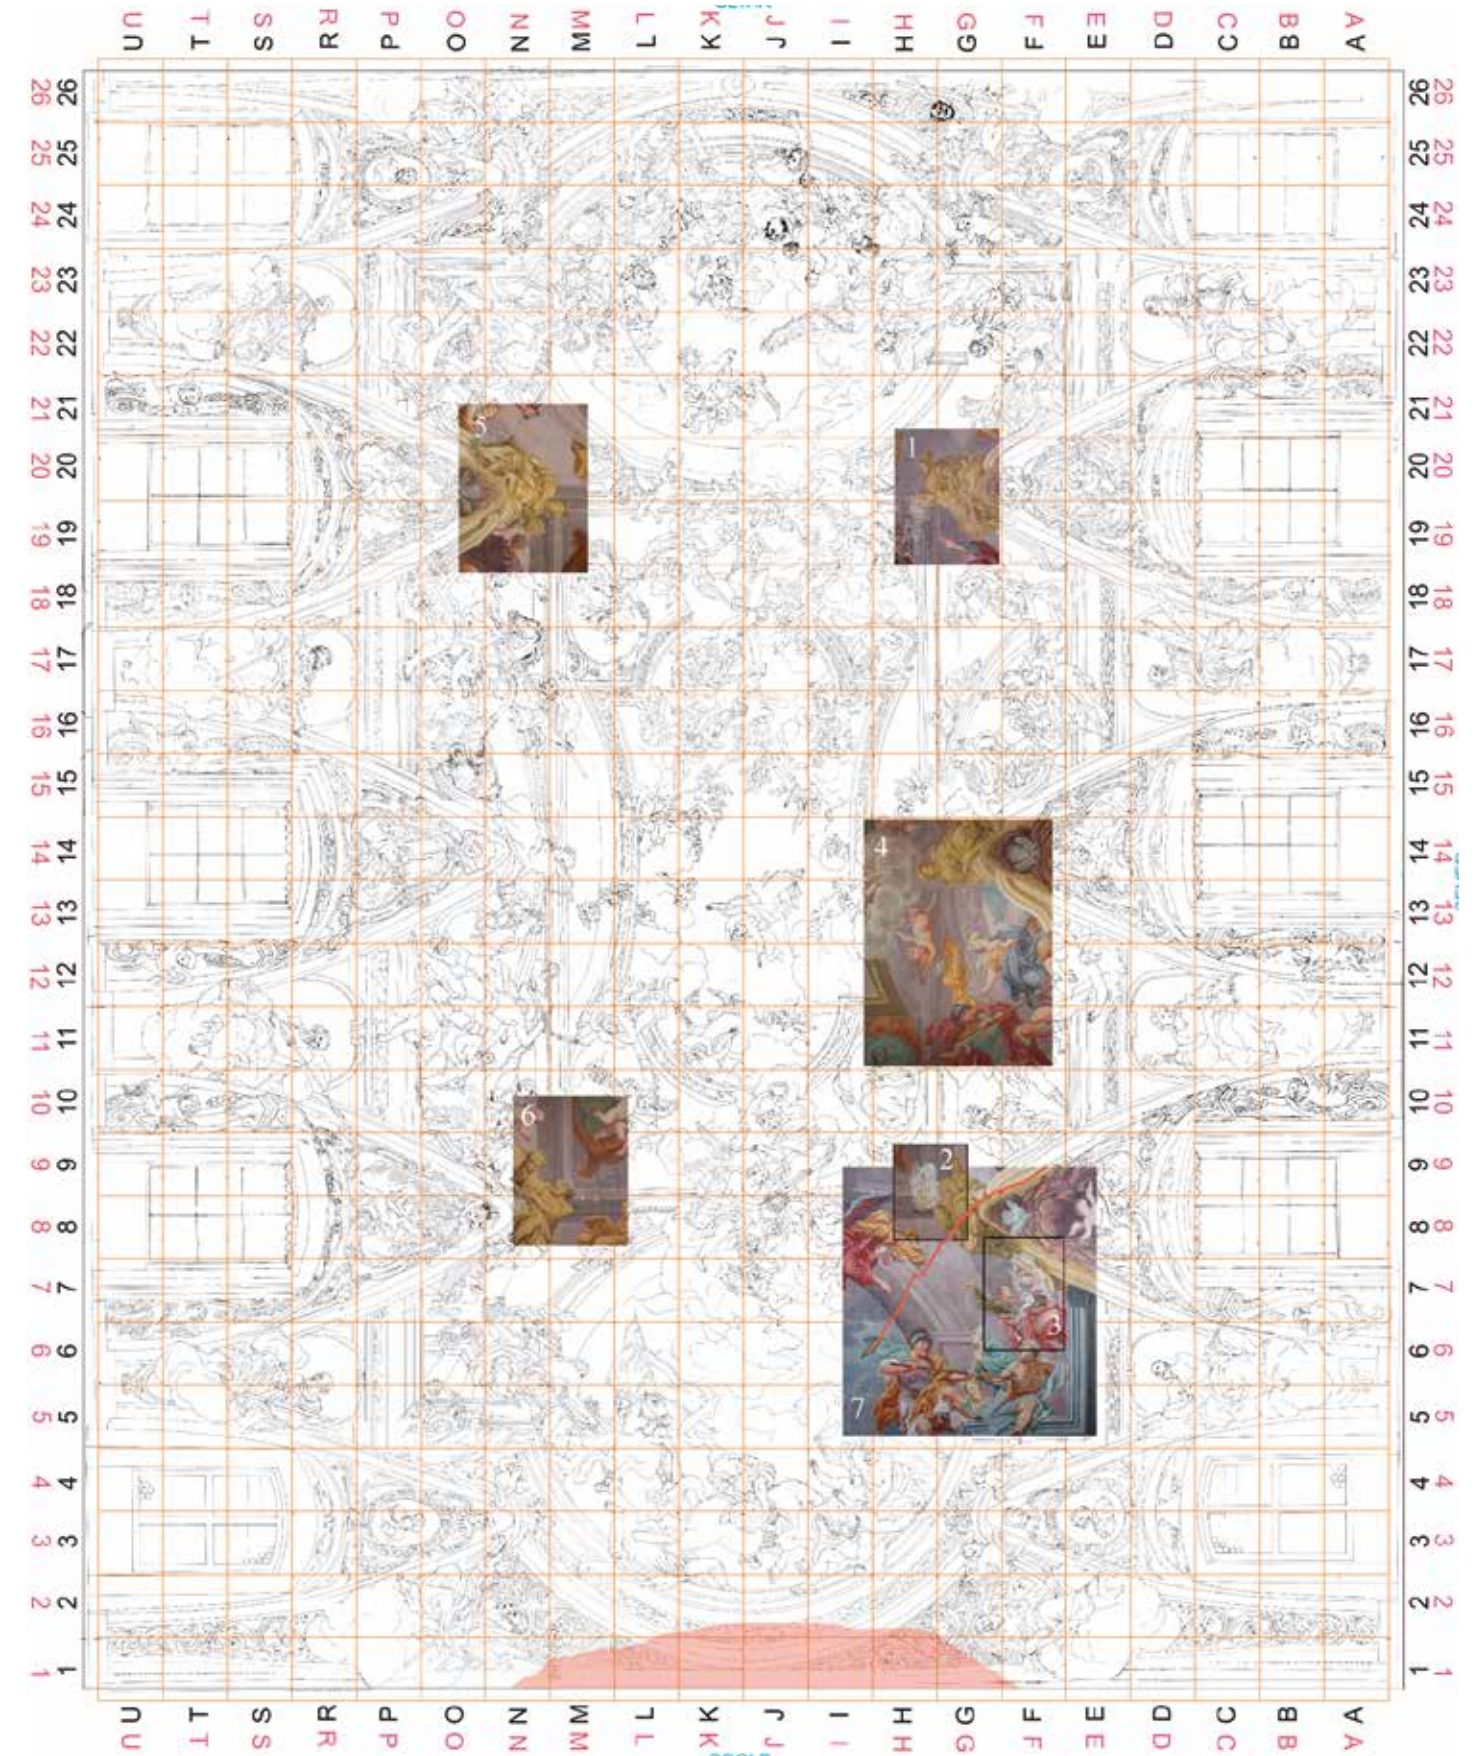
Figure 88: Locations of the most damaged areas of the vault painting.
 The coloured part denotes the fallen off area of Quaglio's original mural, most probably after the earthquake of 1895. Before treatment the plaster in this region was exchanged for a plaster of a coarser structure. The colours in this fragment are darker, probably due to the change in the binder used.

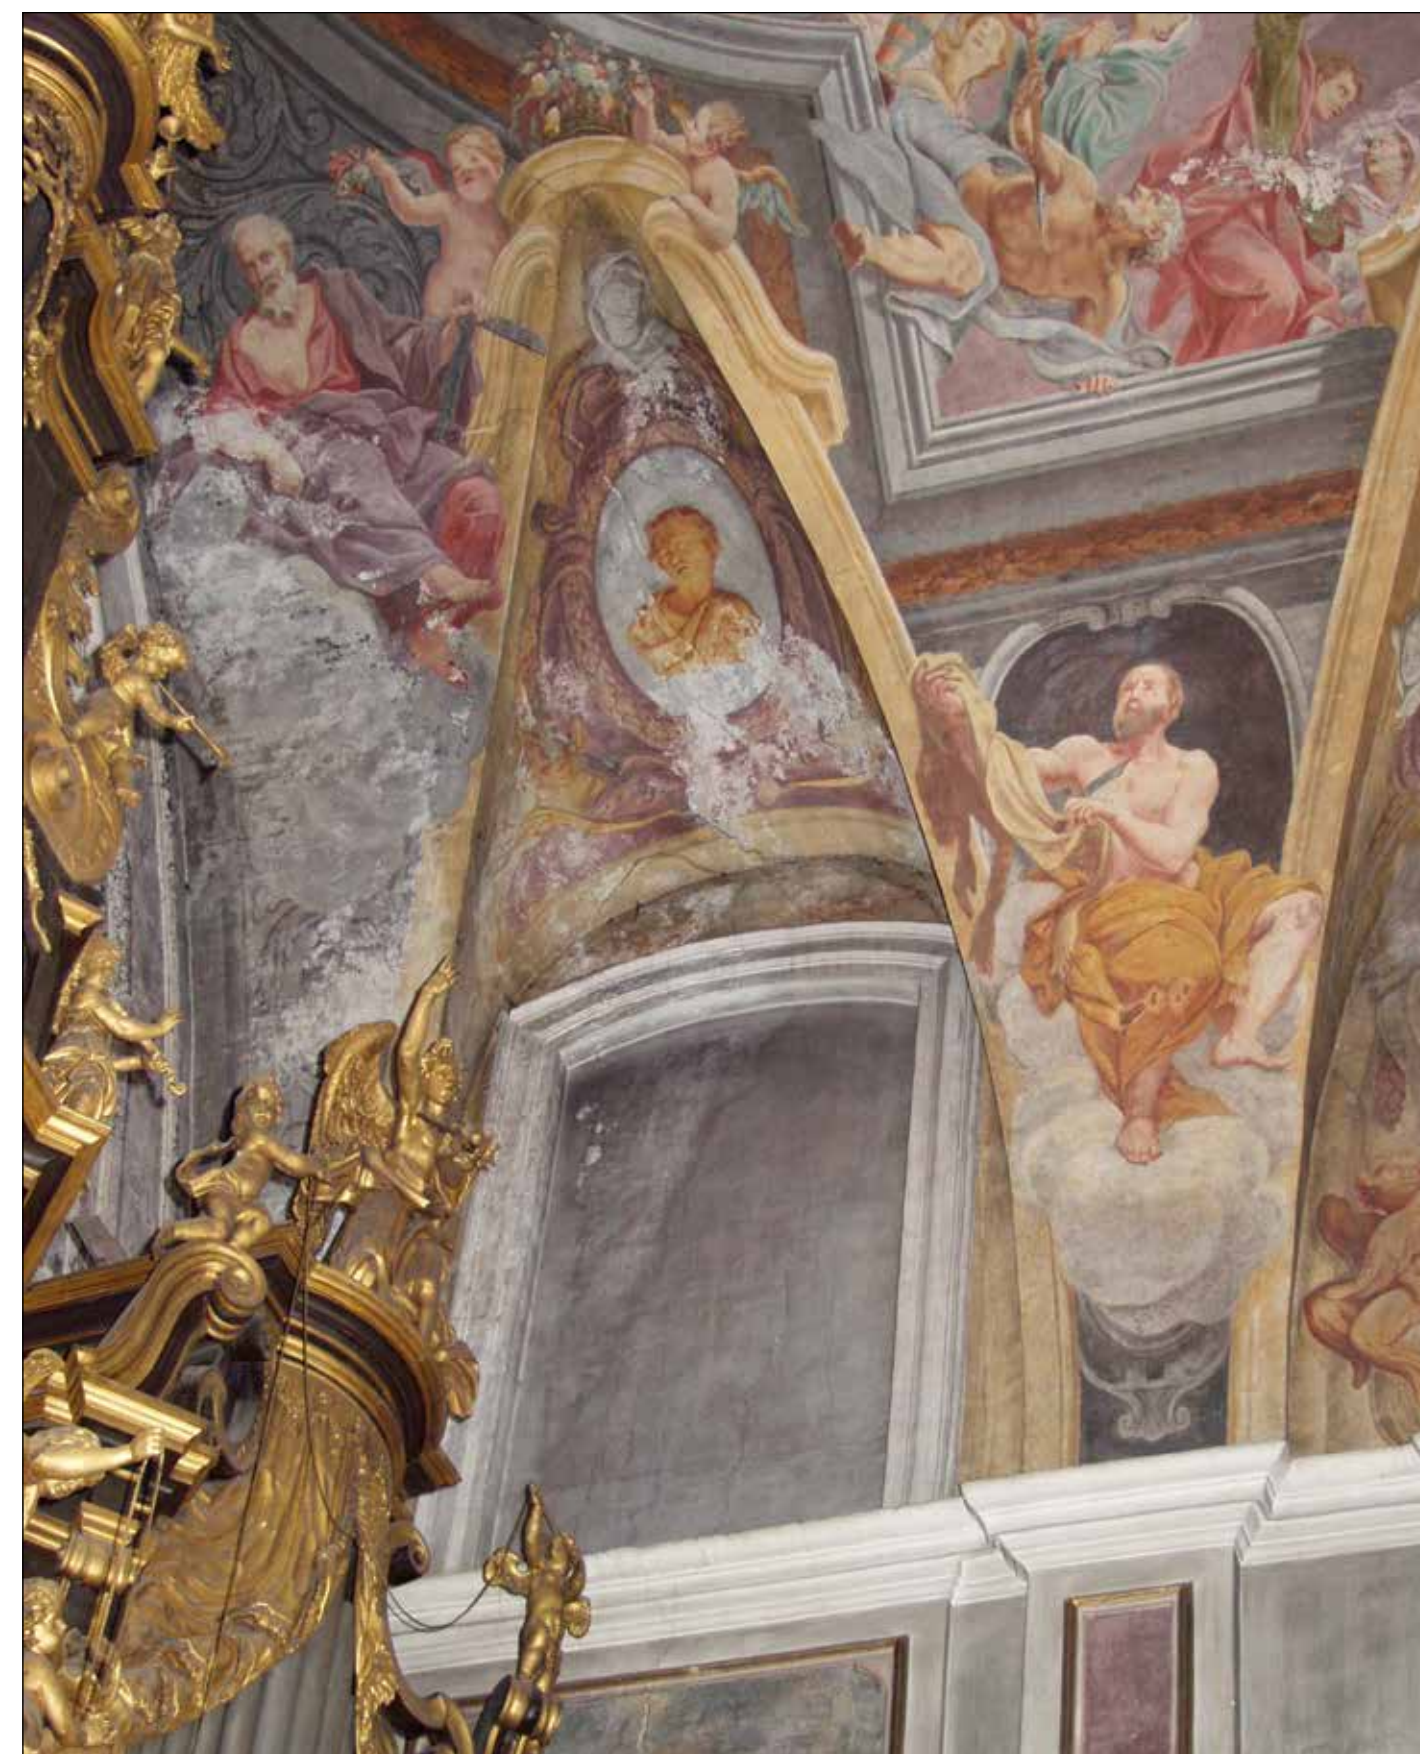
Figure 92: North-western corner – results of leakage.

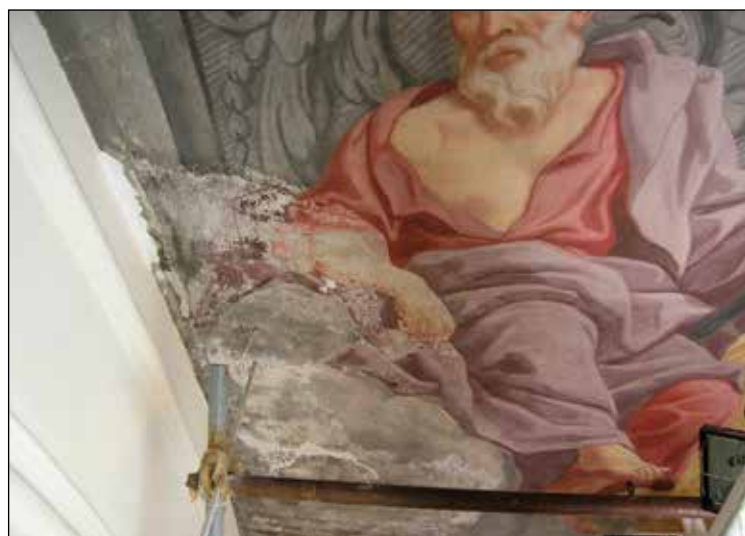
Figure 94: Junction of the northern and western wall – results of leakage.

When the earthquake struck, the walls swayed at different frequencies because of the raised height of both bell towers, which caused numerous heavy cracks on the western side.

The occasional unsuitable proofing between the bell tower and roofing can be a source of problems in numerous churches, particularly in storms and melting of snow in the winter. The water which thus enters through the roofing slowly leaks through all the layers in the vault, bringing substances into the construction and plasterwork that with time appear on the surfaces of the wall and ceiling paintings.

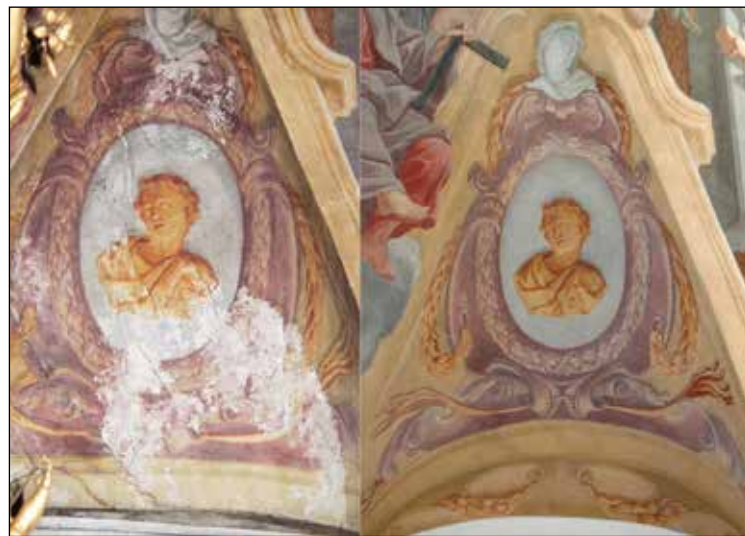
The damage that had occurred due to various degrees of expansion and stress on the materials, most probably also because of big and small earthquakes, was visible in the form of wide cracks from which plaster, black sooty impurities, pieces of brickwork and small stones fell down (figure 89). Such disintegration of the built surfaces is visible at all junctions between the northern and southern wall of the nave with the initial arch of the lunettes (figures 90, 91), which acts as proof that all walls were first constructed to their complete height, then workers embarked on the production of the roofing with roof cover, and then safely began construction work on the main vault and lunettes. The majority of most extensive and, in terms of complexity, worst damaged areas can be located in the region of the junction between the western and northern wall (figure 92). Obviously the worst damage to the walling and roofing occurred here already at the time of the famous earthquake in 1895, or just after, which was indicated by the numerous heavy cracks across the entire western wall (figure 93), as well as traces of leakage at the bottom part of the vault near the bell tower (figure 94). Heavy scaling and flaking of the colour layer as well as the deeper plaster layers (figure 95, left) was

Figure 95: Junction of the northern and western wall – before renovations and after.

the result of more recent leakage at the junction between the bell tower and the roofing. Despite heavy damage, we were successful at restoring the region (figure 95, right). In the top region of the junction between the western wall and the nave vault we documented the area where the original plasterwork had been replaced by new plaster, which was coarser in structure and not well-matched in terms of colour. This was also the only area across the entire surface of the painted vault from which a part of the mural together with the plasterwork fell off during the earthquake (cf. figures 56, 57). Some damage was certain to have occurred in 1988 during masonry work on the reconstruction of the tympanum,²² when the walls were injected and water run down the already damaged paintings. In figure 96 the junction between the north and west wall in the attic can be noticed, with visible newer reconstructions and improvised support of worn out beams. In the thermographic record (figure 97), a red line is visible in the lunette which denotes the crack that seemed minimal at first glance. When the crack was expanded, quite a lot of fine material dropped down from the abutment above the vault. The piece of plaster that we removed during this was black from soot and other impurities on the inside, which proves that the crack had been open for a longer period of time. The plaster between the bricks in this region was so weakened that individual bricks had no intermediary bond, so to say (figure 89). The crack continued across the field above the window, reaching into the depth of the northern wall (figure 92).

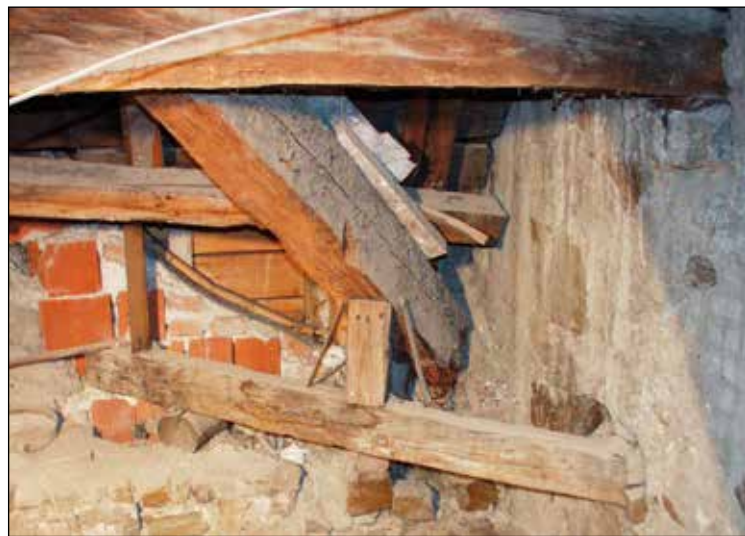
Figure 96: Junction of the northern and western wall in the attic.
