THE RESTORATION OF QUAGLIO'S WALL PAINTINGS
IN LJUBLJANA CATHEDRAL

The Restoration of Quaglio's Wall Paintings in Ljubljana Cathedral

A conservation-restoration project involving the wall paintings created by Giulio Quaglio (1668–1751)

on the nave vault and the western wall of the Cathedral of St Nicholas in Ljubljana, IPCHS Restoration Centre (2002–2006)

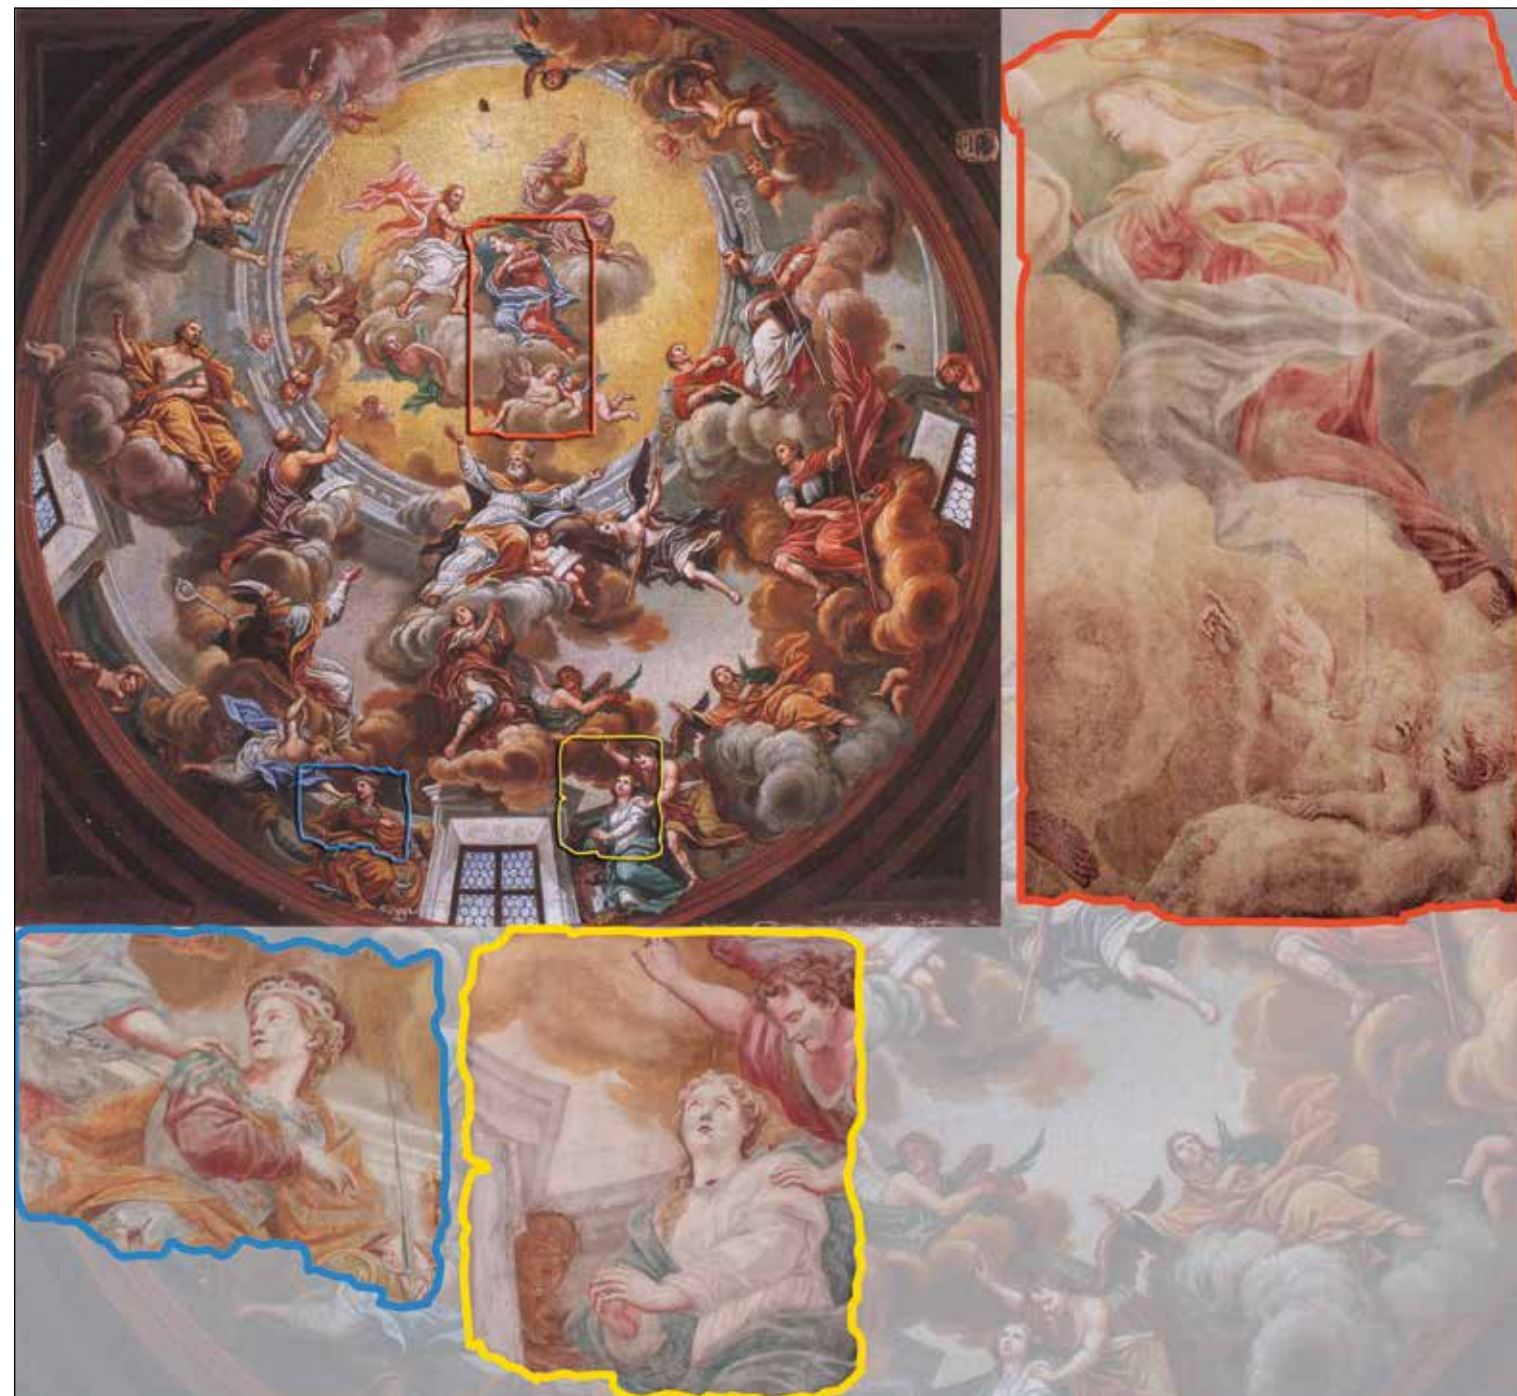
Figure 98

Giulio Quaglio painted the interior of the illusionistic dome in September 1703, from which only three fragments remain. Their positions are shown in the oil painting by Matevž Langus, who documented Quaglio's work and preserved some precious information on the composition of the time (figure 98). The wooden plastered construction of the illusionistic dome was in 1841 removed and replaced by a real, built dome. The preserved fragments show a darkened pigmentation in the regions of the nose, cheeks and lips. This occurrence was even more intense on some of the faces of the figures on the ceiling of the nave depicted during 1705 and 1706 (figures 99–102). After completing the modelling of the faces with oxide red, which appears fairly sedate, Quaglio applied bright red highlights in a cinnabar (vermillion) based colour which, however, blackened with time.²³ The bright red pigment was also used in depicting the flower wreaths (figures 103 and 104), which were inpainted in a tempera technique using an organic binder. The colour layer here lifts from the ground; a similar occurrence can be noted in the case of the green-coloured leaves (figure 105). In figure 106 we partially removed the top, darkened layer and discovered particles of an intense red pigment

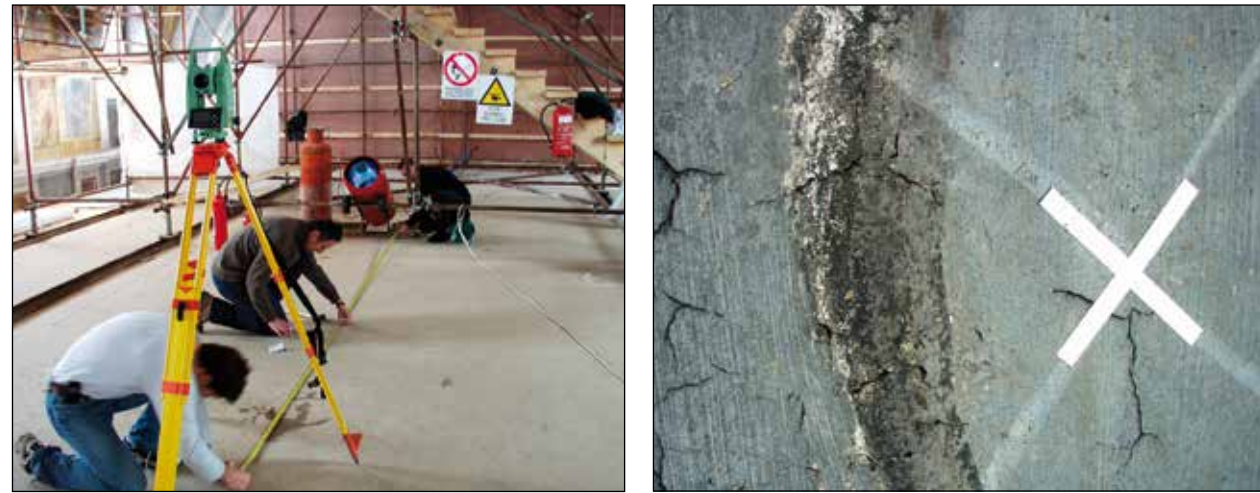
Figures 108, 109: With paper crosses marked points measured by laser – transferring the grid of quadrants with 100 cm sides onto the vault.

Figure 108 shows the drafting of points at a distance of 100 cm from one another along the middle longitudinal line at the beginning of making the system of grid points. These central points were then projected onto the vault at 90° angles and marked with small crosses (figure 109). From these central crosses positioned at their highest points, 100 cm lengths were measured out at a 90° angle directed onto the central line. All measured out points were then marked by small paper crosses. Figure 110 also shows the measured out distances (7 m) from the middle of the platform. When photographing from the same point, only turning the camera at a right angle on its axis towards the quadrants of the vault, the distortions in the photographs produced were minimal. In order to gain a good shot of events on the platform, sometimes quite a lot of climbing ability was required (figure 112). All observations and findings were documented on the working platform as work went along (figure 113).

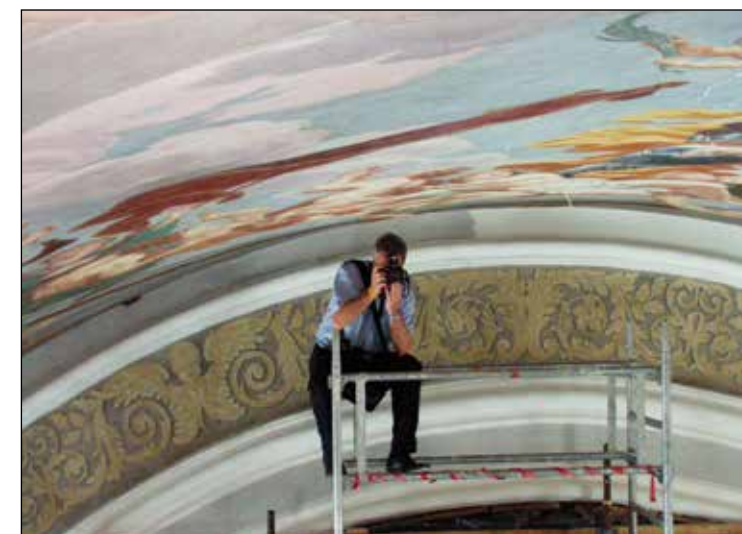
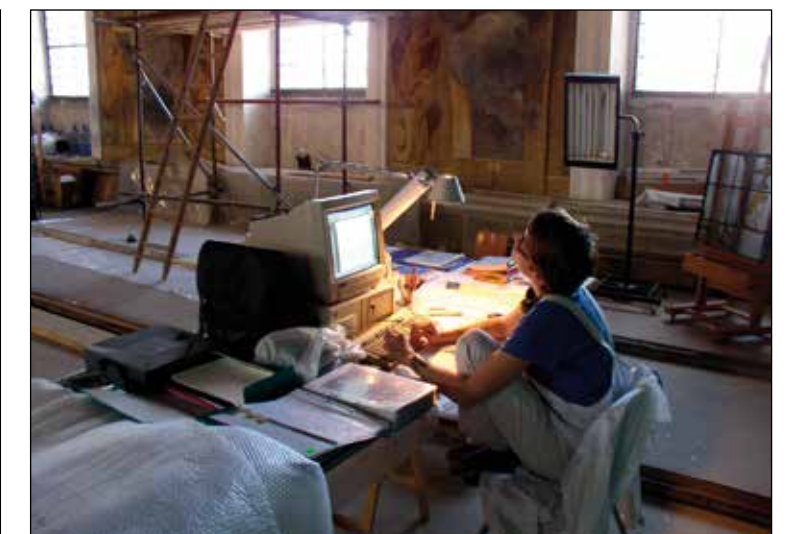
Figures 112, 113: Photographic and written documenting of the mural paintings condition.

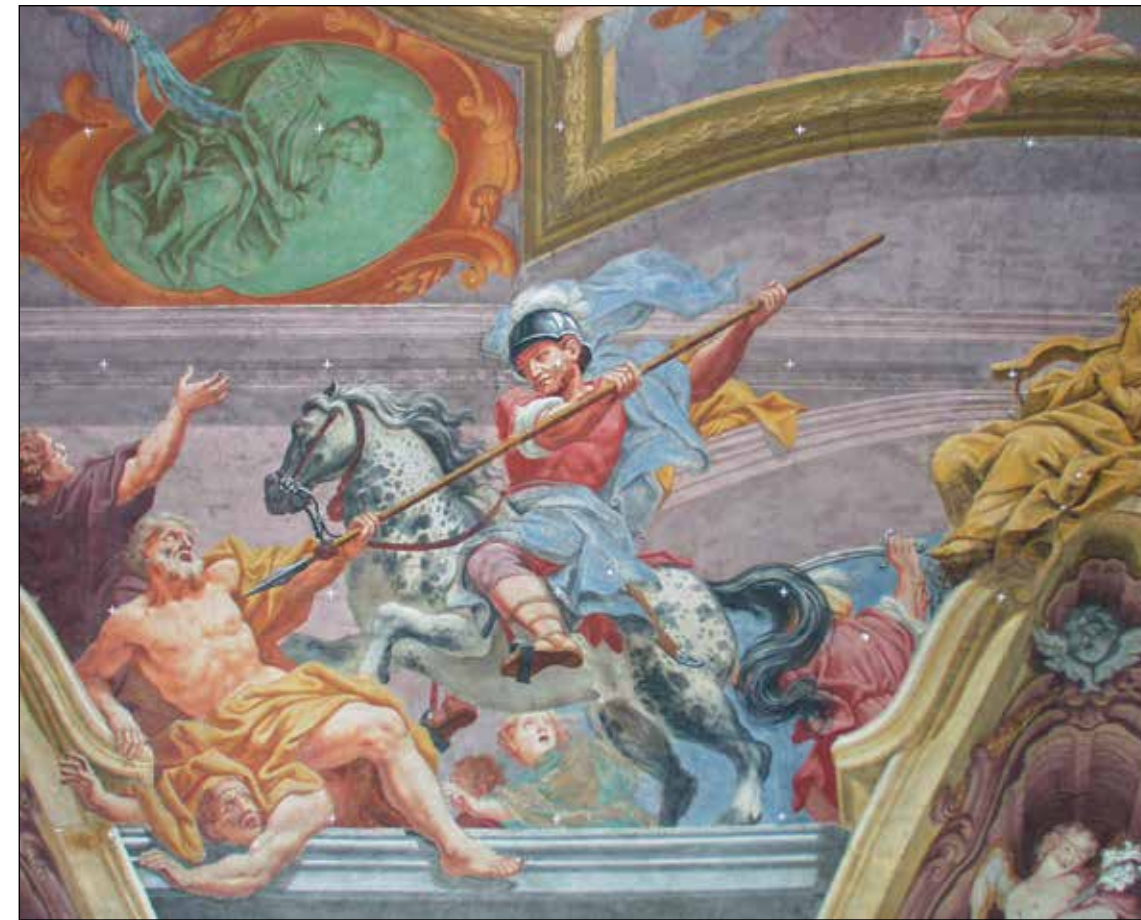
Figure 115: Condition before treatment, image of the vault painting with stuck on cross markings.

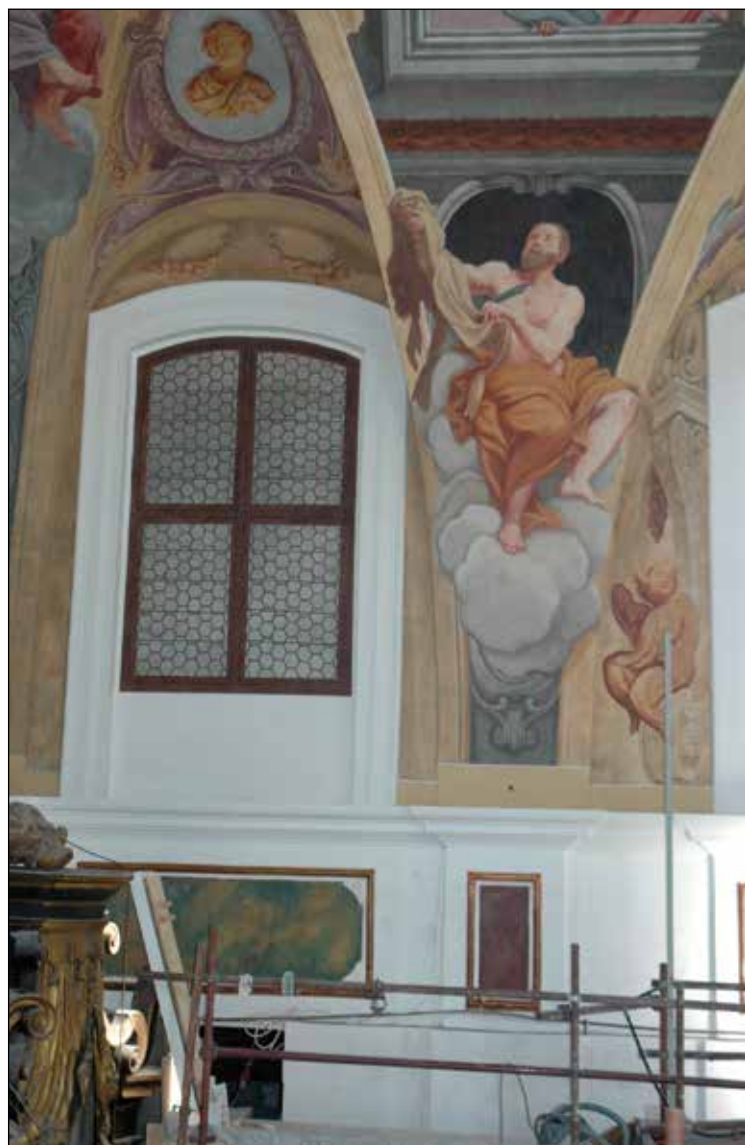
Figure 122: Reconstructed wall painting of the blind window.

Besides the newly discovered mural on the triumphal arch wall, also the wall paintings on the two otherwise walled-in windows in the western part of the nave, to the left and right above the altar, are considered to be discoveries of restoration work belonging to this period. During removal of more recent, darkened whitewashes around the window openings (figure 119), the original painting was discovered under the whitewashes of the two mentioned windows (figure 121). Figure 122 shows the reconstructed mural on the blind window. By probing underneath all original windows, the original height of the windows was also discovered, which ties in with the lower edge of the newly found mural (figures 119, 122). Since the roof above the tribunes on the outside was raised during a certain period, the windows, or window openings, had to follow likewise. The beautifully adorned stained-glass windows (figure 120) were changed with new ones during treatment at that time, since the old frames had become rusty and many glass parts were cracked or broken. Because of the missing glass parts, a draught was coming in through the openings causing air to circulate in the church and hence increasing the raising and settling of dust on the painted and non-painted surfaces. Besides that, the openings provided big and small animals with free access to the interior of the church. Precise measurements were taken from the oldest preserved window above the northern sacristy of the church and new windows were produced accordingly. Additional flat glass panes were installed on the outside to provide improved warmth insulation and mechanical protection.

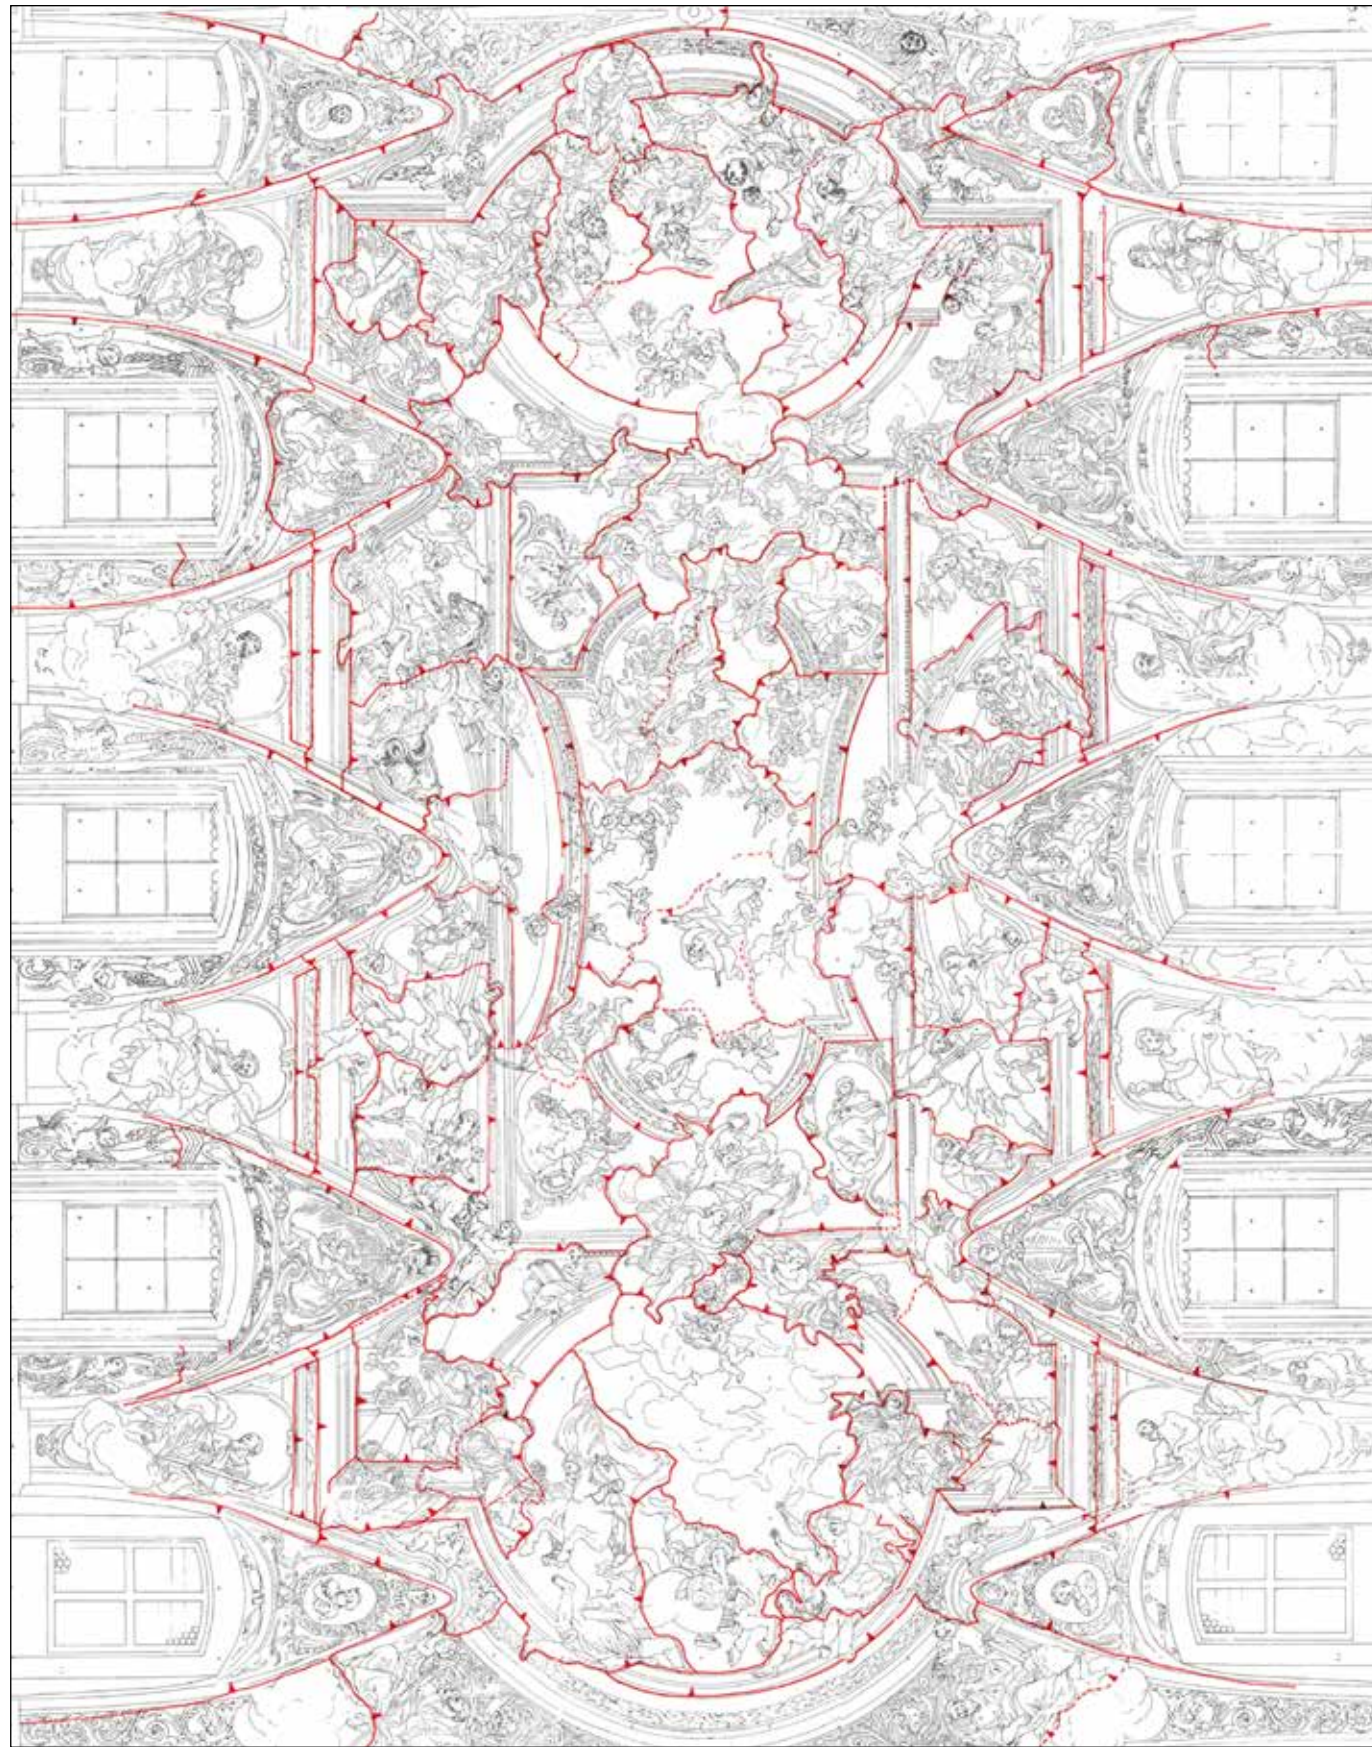
Figure 123: Marked giornate found on the vault.

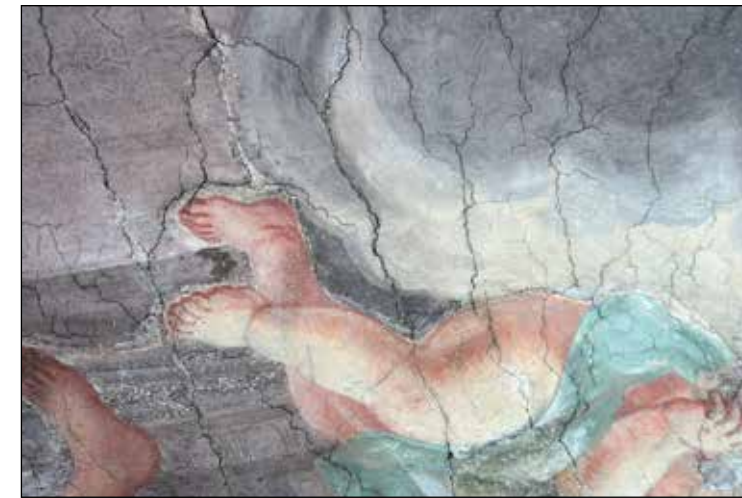
Damage relating to the giornate can most often be seen in the form of the darker overpaints or inpaints, or lighter edges (figure 124) on or at the edges of the giornate. These, obviously later added layers (darkened areas) occurred with previous restoration treatment in places where attempts had been made to sort out the surfaces by using retouching and reconstruction, from which the colour layer had flaked off, or where the edge of the previous (older) giornata was damaged by the gliding or smoothing of the new plaster against the old one. The thin, smoothed layer of the newly applied plaster dried at a quicker rate on the edges and did not sufficiently carbonise in these areas thus becoming dusty. Besides this, the imprecisely applied areas could not be removed completely despite immediate washing since it is commonly known that whitish traces always remain after such removal. Usually these unsuitable transitions were corrected by the artist himself, although always using the tempera technique, since he knew that the calcium carbonate crust had already formed, therefore painting onto a partially already carbonised ground with just pigments and water would cause patchy, unevenly painted surfaces because of the different absorbency of the ground. Precisely this drying of the plaster at different rates on the junctions of the giornate as well as the corrections were causing the colour layer to flake and dust off due to the poorly adhering, uncarbonised colour layer, while this damage was becoming increasingly noticeable with the centuries. Since the binders used for retouching these areas during previous restoration treatments were substances (casein, animal adhesive, even oil) that darken in the air and in contact with a wet lime ground, with time the retouched areas became more and more visible and disturbing to the eye. At the beginning, looking from afar, these overpaints seemed like Quaglio’s purposefully emphasised strokes, however, upon more exact examination this was proven otherwise.

Figure 124: The light edges of the giornate and the darkened retouch between the feet.

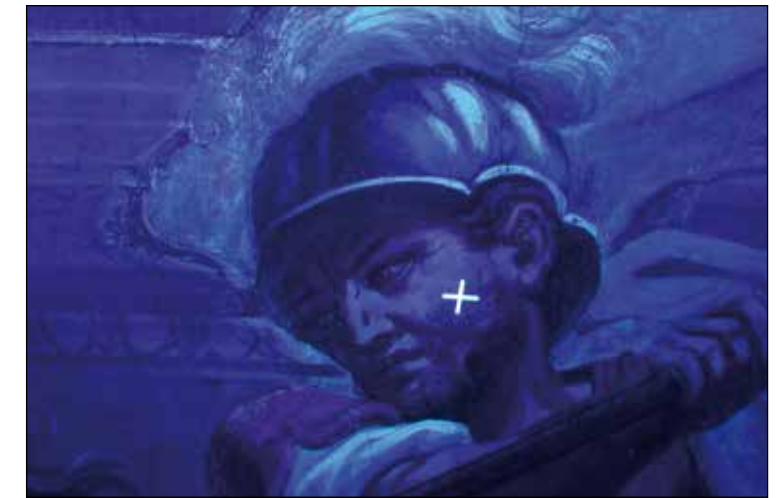
Figure 125: UV-image before treatment – visible corrections in the region of the giornate.

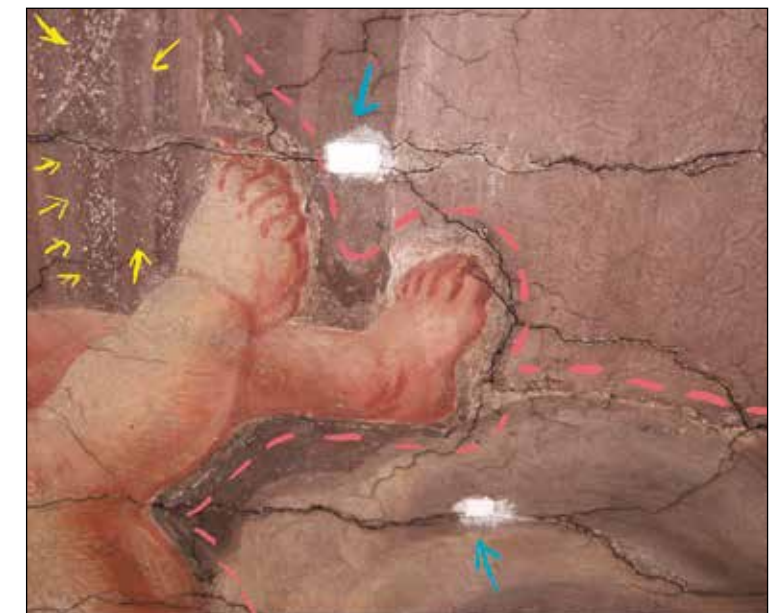
Besides the progression of the giornate (red) and darker overpaints, figure 127 also shows the slight flaking of the colour layer (yellow). A portrayal of a simple movement of the cracks: the crack is bridged over by plaster, since the tiniest movement causes visible cracks on the plaster layer (blue arrow).

Figure 127: The bridging of gaps with plaster – a simple method for observing the activity of cracks which, however, is merely informative – if the plaster splits in the direction of the crack then we know that the movement arose, but we do not know when it took place or whether the crack is still active.

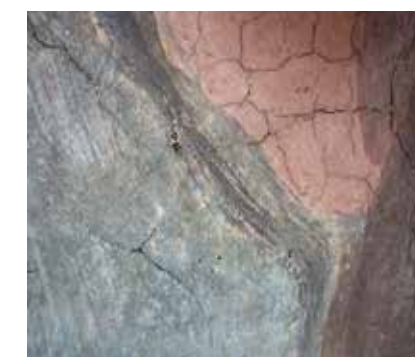
Figure 128: A darkened retouch on the junction of two giornate.

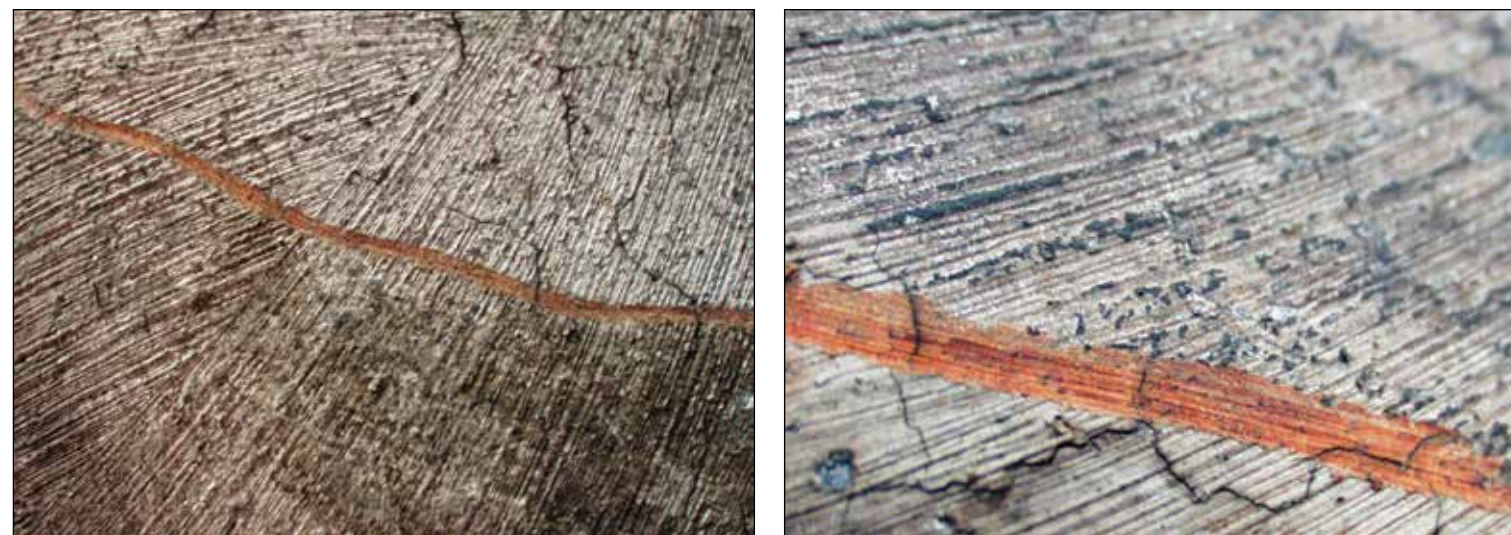
Figures 130, 131: When observing with the naked eye the preparatory drawing functions as a graphite drawing that has left a red trace, whereas the enlargement, particularly in figure 132, establishes that those are in fact brush strokes.

Figure 130 and its enlargement (figure 131) are particularly significant for understanding the technique used in painting the vault. The images clearly show the relief traces done with a wide brush applied with thick lime whitewash. The trace on the left side of figure 130 comes from the first coating, followed by the top coating, with the third diagonally covering both. Each new brush stroke completely redirects the old grooves of lime towards its own direction, which proves that these whitewashes were applied to the plaster simultaneously, so to say. The still wet covering traces of the wide brush are horizontally interrupted by the red coloured undulating stroke of a thinner brush – proof that can mean two things.

1. That Quaglio (or more probably his assistant Carloni or someone else), soon after the masonry master had applied a thin layer of intonaco in the designated scope (but then again not too quickly since the wet whitewash would soften the intonaco causing it to spread out), coated this area with a thick lime whitewash as soon as possible and immediately began to draft a red preparatory drawing with a fine brush (figures 131, 133), naturally keeping to the already prepared model. Within the boundaries of this preparatory drawing, Quaglio then painted the surfaces with thicker lime tones, on his own or with his assistants, continuing with darker tones in a more watery technique. If the intonaco and the whitewashes did not dry out too quickly (summer months), he was able to paint the larger surfaces at a faster rate, whereas the moist layer of intonaco together with the lime whitewash and pigments was also able to carbonise quite well. Unfortunately no traces of sinopia (or preparatory drawings we could also say) were found across the entire surface of the vault mural; that is drawings on the brown coat (arriccio) layers, which usually denoted the rough division of the composition as a whole into pre-planned giornate. Perhaps the charcoal mark similar to a cross (figure 134), which was discovered on the damage in location H19 with the removal of damaged plaster up to the brick support – can be taken as proof that charcoal was used for drawing in the initial composition of the mural. Using charcoal to draw on plaster is often mentioned in literature.³¹ On the surfaces, onto which it can be vouched with certainty that the drawings of the cartoons were transferred, no traces of the cartoons having been fixed with nails or similar material were found. Individual finds of holes (figure 135) are not sufficient evidence on the use

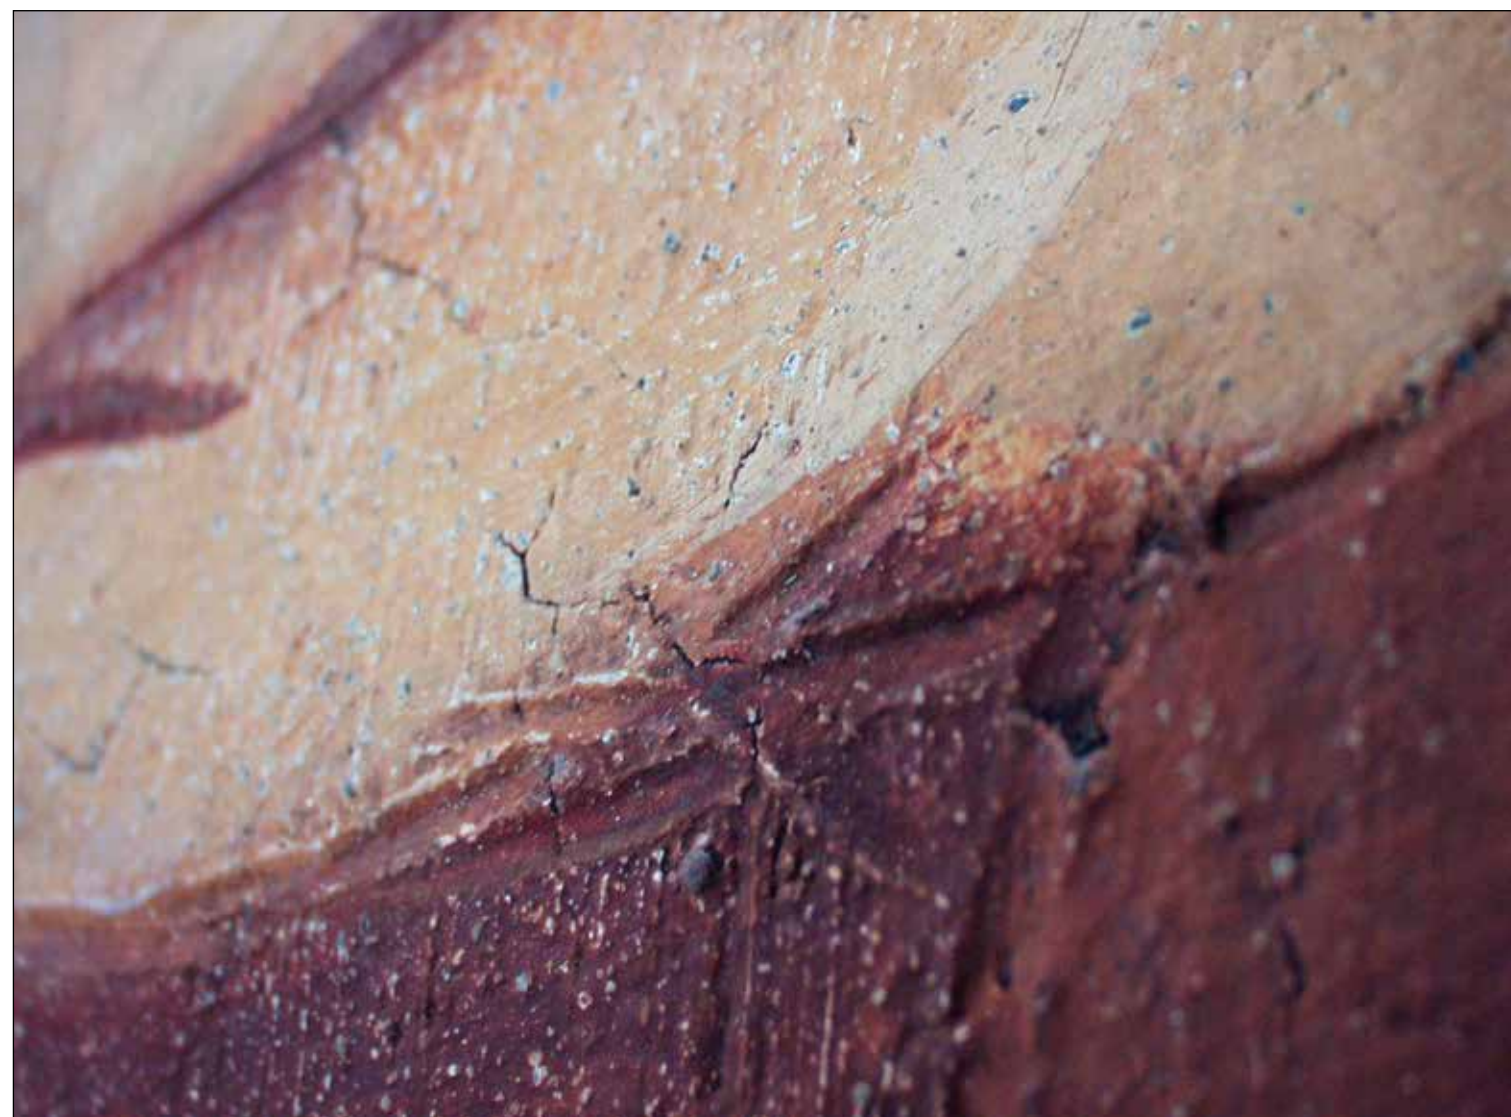
Figure 132: Incisions and imprints.

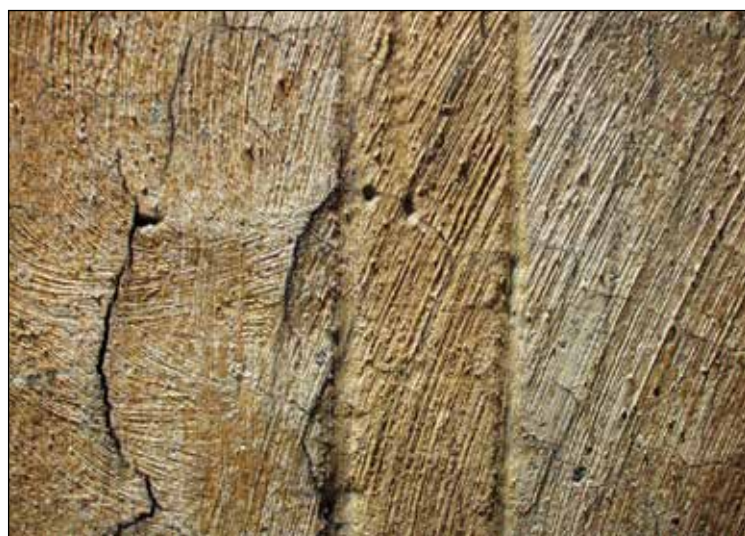
Figure 135

of nails for temporary attachment of a cartoon in transferring the drawing onto plaster, since numerous nails were removed from the vault before superficial cleaning of the vault, which had more recently served for fixing various ropes and wires when decorating the interior. The two vertical lines in figure 135 are not grooves impressed through a cartoon in the process of drawing, but traces of the brush with the red preparatory drawing in a thick lime whitewash, later painted over by a layer of ochre. Since the ornamental lime coating was not applied to a fresh layer underneath it did not adhere properly to the ground and began to flake off due to its fragility.

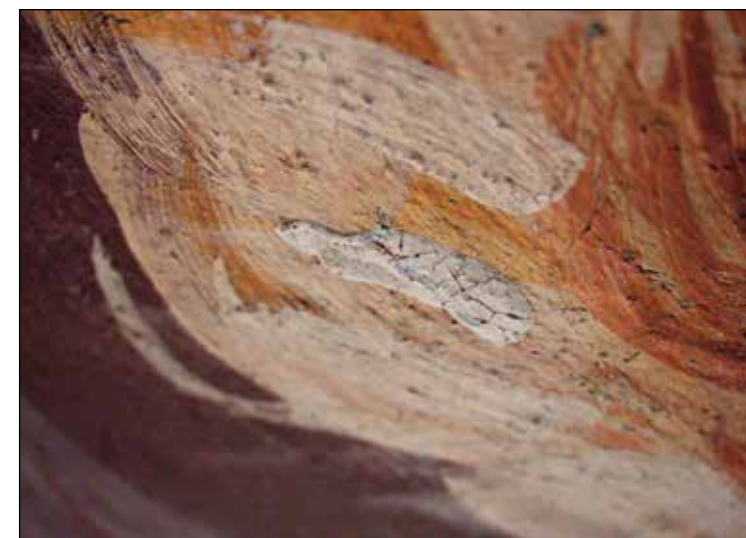
Figure 137: Highlights applied with original lime whitewash.

In some places the relief of the application of whitewash is more noticeable, in some places less. In the intensely modelled and thickly applied layers, traces of the whitewash underneath cannot be discerned. The highlights applied in a very thick, pasty whitewash are frequently cracked due to the thickness of application and quick drying (figure 137).

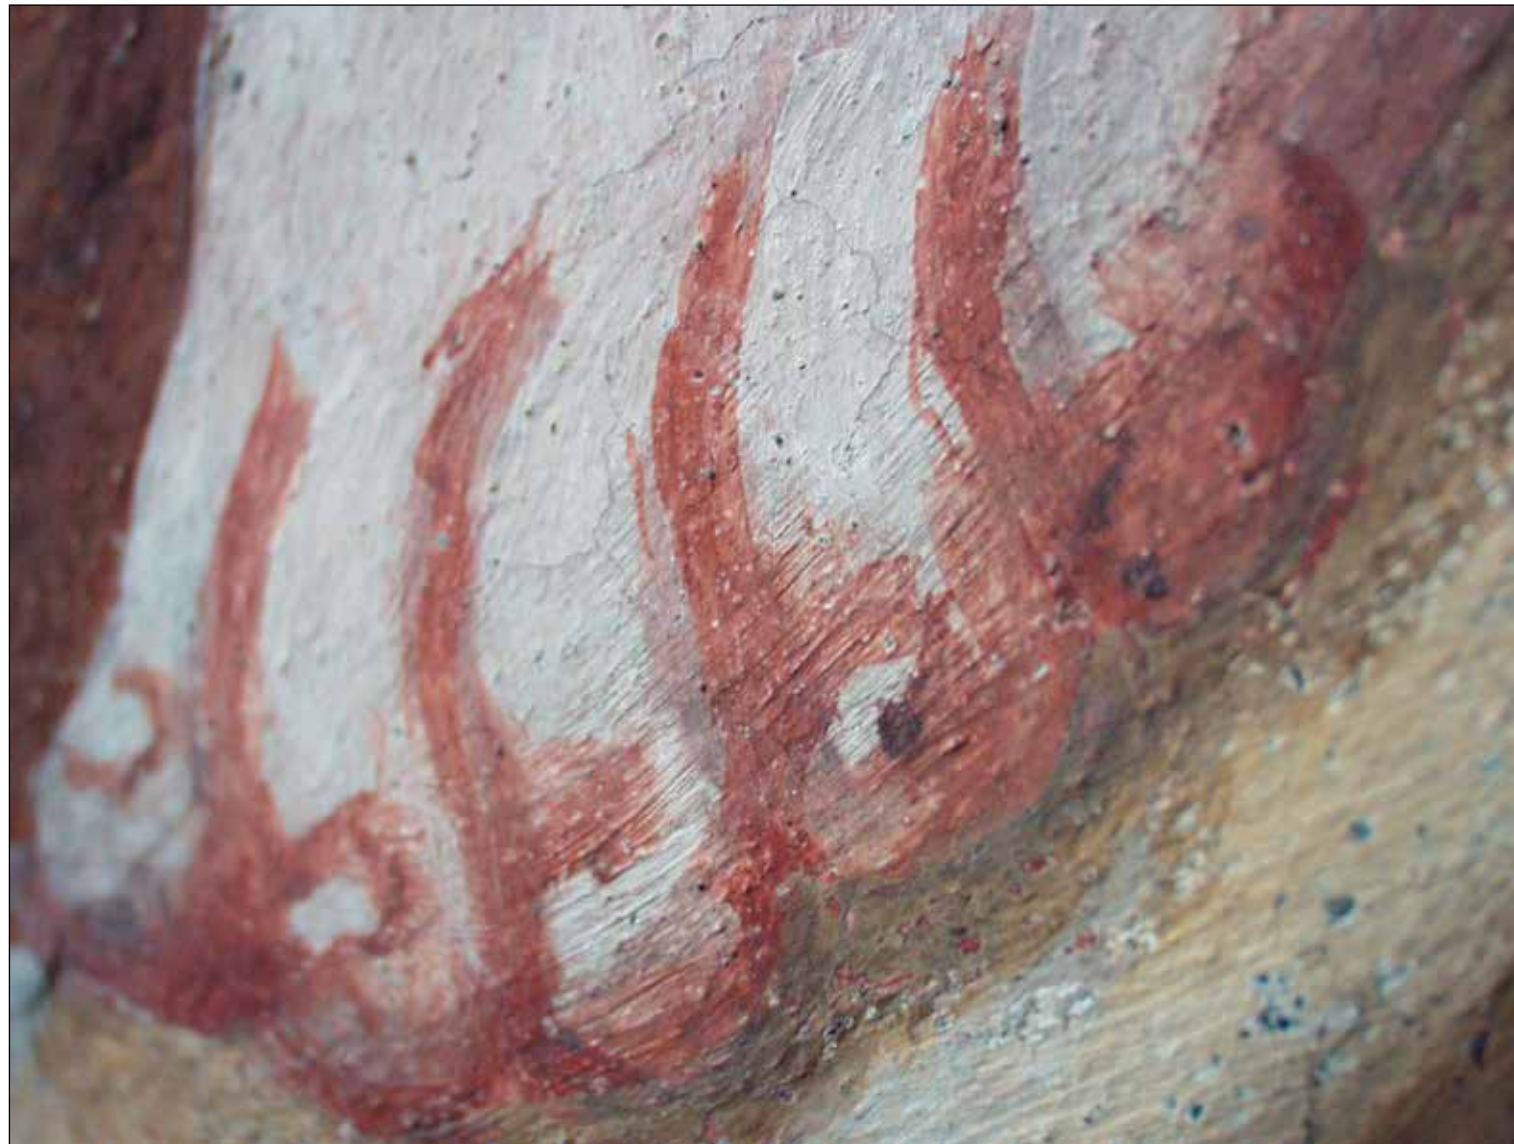
Figure 138

An example of painting onto wet intonaco with a coating of thick whitewash can be seen in figure 138. The top layer is not flaking or peeling off because of the quality of the binding of the lime through all the layers. The painter caught just the right moment when the whitewash had hardened enough in order to be able to paint in an almost watercolour manner – had he begun too early, the tops of the grooves of the lime whitewash underneath would have smudged and the reddish brushstrokes would not have been as sharp and intense, but rather dull and dirty since they would have mixed in with the whitewash, which was too wet. The fingers have been painted onto fresh plaster or whitewash in a watercolour manner with a red pigment. Even the individual strands of the brush can be noted; under the red there is a light purple sketch of the position of the fingers, which also functions as a shadow. The later added offside shadow was no longer added in a watercolour manner, but in an impasto using a thicker ochre coloured whitewash. Because of the weaker binding with the ground, the flaking of particles of this layer is more visible here.

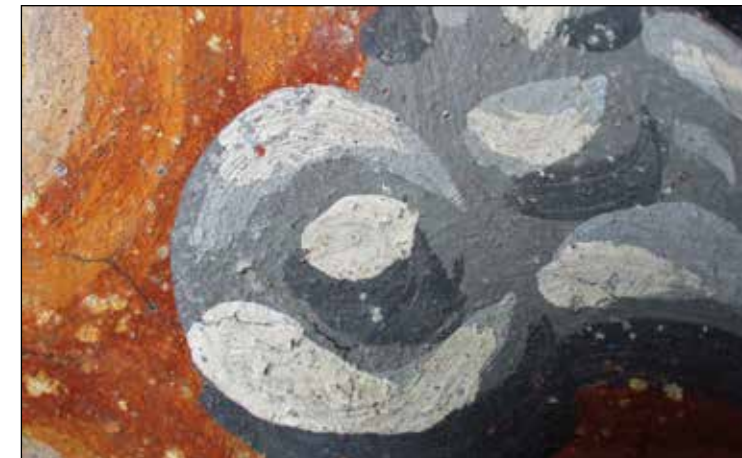
Figure 139: Similarly to figure 137, the lightest areas have been painted with a lime-based white paint (bianco sangiovanni), which used to be prepared by prolonged drying of small loaves of slaked lime in a strong sun. The white powder obtained was used as a white pigment.

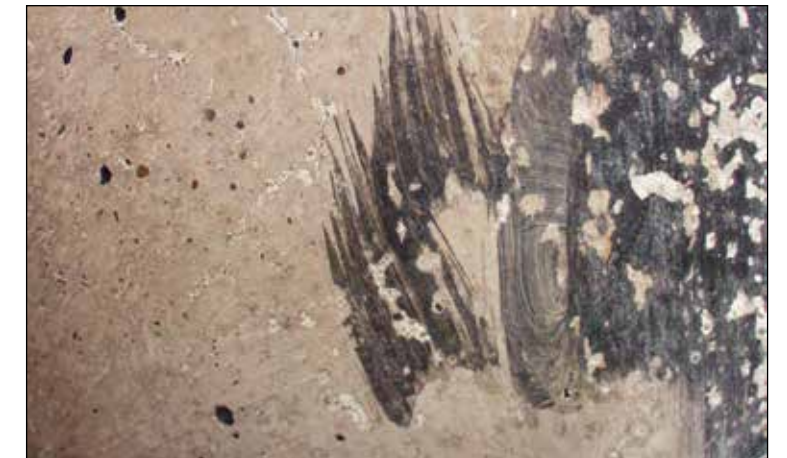
Figure 140: A detail of a patch on the horse in the area of quadrants O16, 17, 18 and N16, 17, 18 represents an example of quick painting with a dark pigment – the impression of Quaglio's brush is clearly visible.

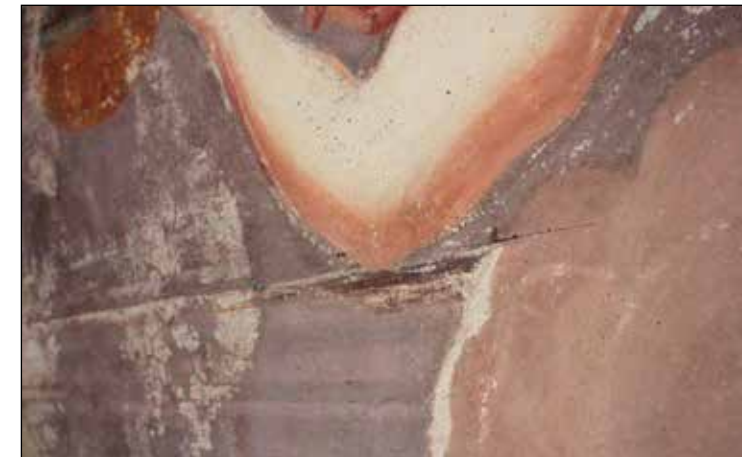
Figure 141: Rare auxiliary lines, cut directly into the fresh plaster, without cartoons, were noticed when mapping out the architecture, which served as orientation points onto which the red preparatory drawing leaned.

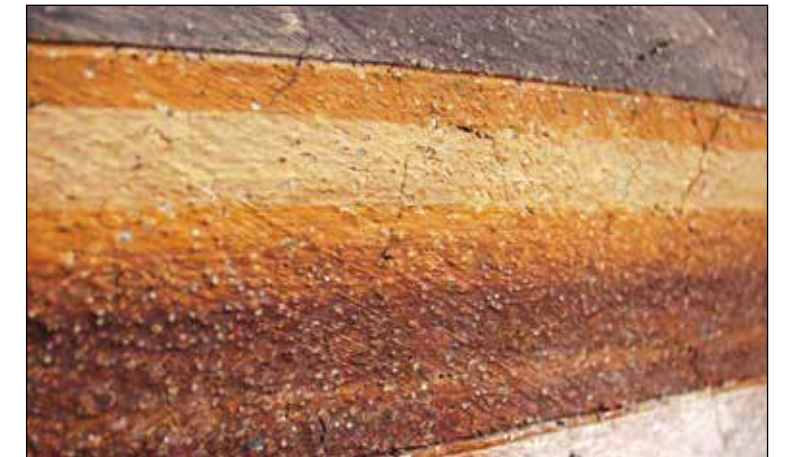
Figure 142: Detail of the horseman's stick, a rare example of an imprinted line into fresh plaster – modelled by dragging a flat brush along a ruler.

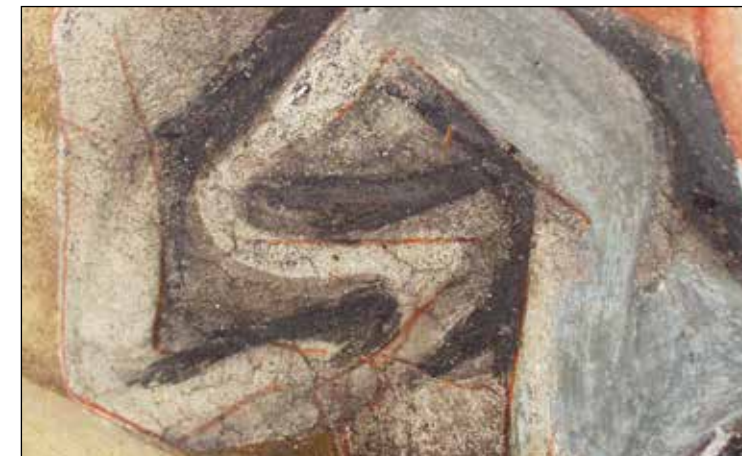
Figure 143: A detail of the drapery from which the process of painting can be seen. The sketchy red preparatory drawing with some short lines indicates the measuring of points, within which directly, without a cartoon, the entire drawing is built up, firstly shaded with glaze, then thickly applied dark areas are added, and finally the thickly applied highlights are put in place. Until now only the lighter layers have been preserved, which contain more lime for binding pigments, and of course the red brush drawing applied directly onto a thick lime whitewash.

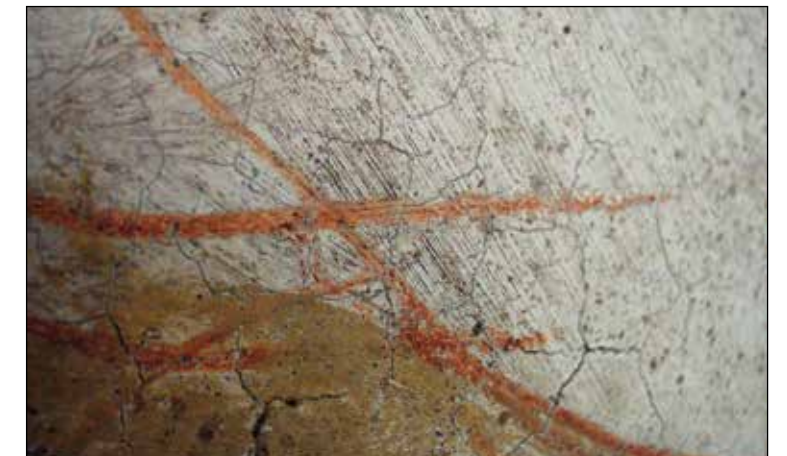
Figure 144: The strokes indicate a search for the correct position by the way that the position of the lines changes, which points to an obvious transfer of a smaller drawing into a larger scale, without the aid of a previously drafted quadrant grid.

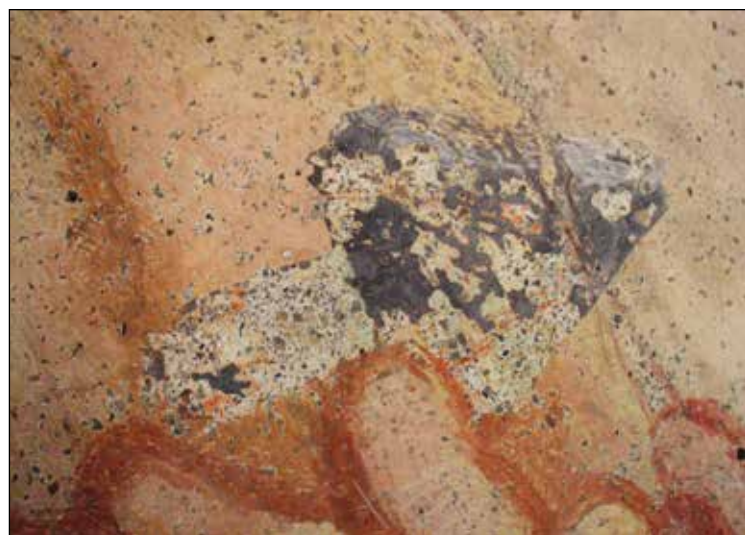
Figure 145: A detail of the painted nail – the contraction of the binder has torn off the layers beneath.

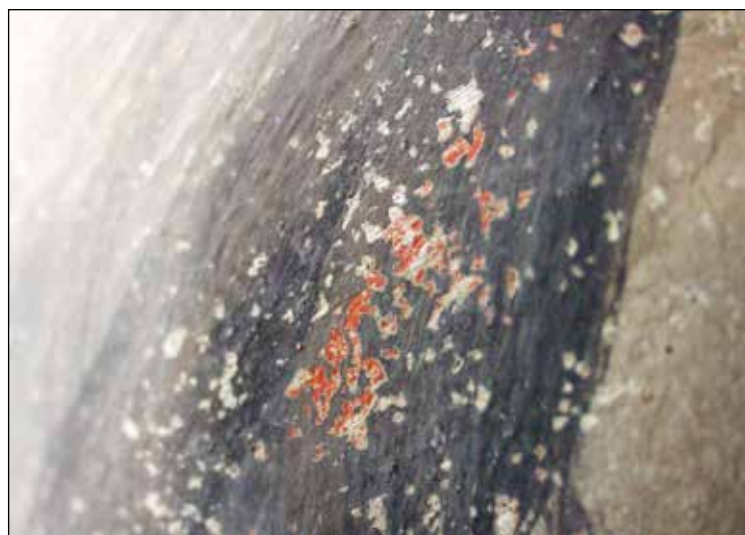
Figure 146: Despite the impasto application of paint, the lifting of the top layer is still visible.

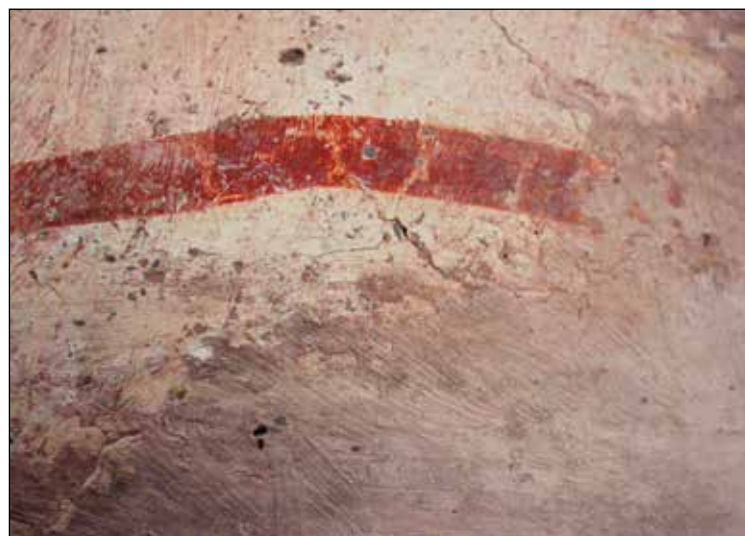
Figure 147: Red line – buon fresco, thick application of paint – fragile lime whitewash.

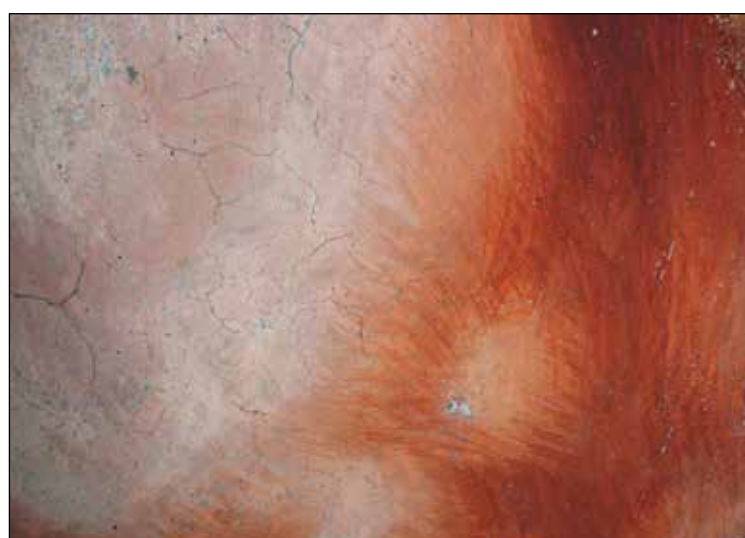
Figure 149: Quaglio's typical and recognisable strokes in shading the incarnate.

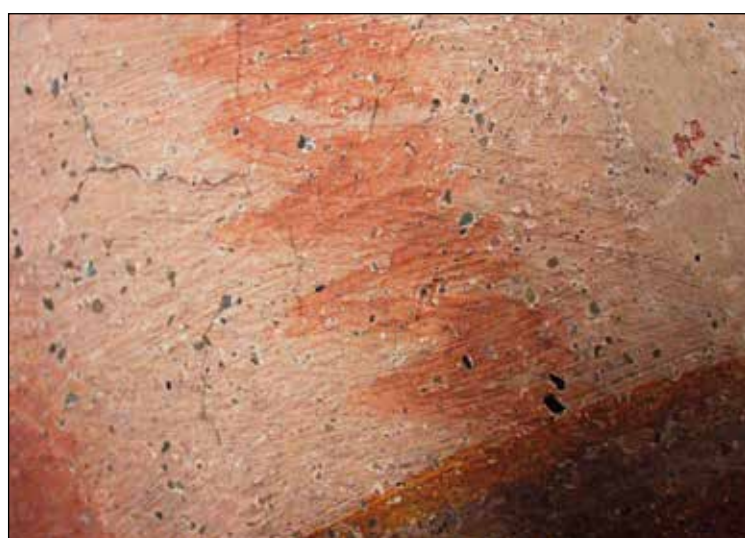
Figure 150: Quaglio's method of heavy shading using zigzag lines.

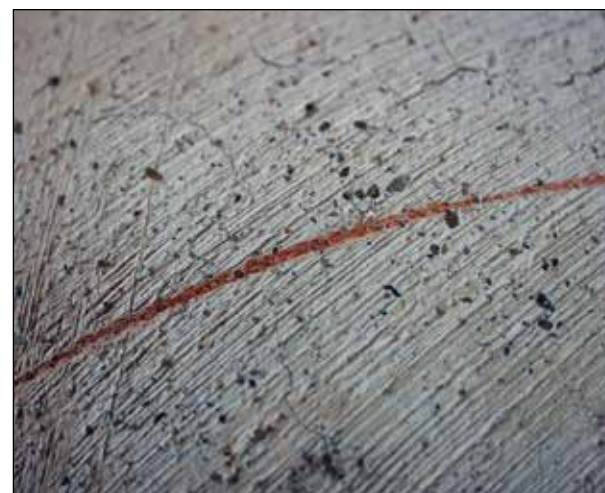
Figure 154: A typical surface with a basic coating of lime whitewash. Already here, on the yet to be painted surface, split off particles of the whitewash can be discerned, particularly visible are the tiny dark stones, probably the constituent part of the whitewash. Although perhaps these poorly adhering particles, which would have otherwise fallen off by their own accord and disturbed the painting process, were intentionally removed from the top layer by brushing (HUDOKLIN 1955, p. 39, fig. 37).
