THE RESTORATION OF QUAGLIO'S WALL PAINTINGS
IN LJUBLJANA CATHEDRAL

The Restoration of Quaglio's Wall Paintings in Ljubljana Cathedral

A conservation-restoration project involving the wall paintings created by Giulio Quaglio (1668–1751)

on the nave vault and the western wall of the Cathedral of St Nicholas in Ljubljana, IPCHS Restoration Centre (2002–2006)

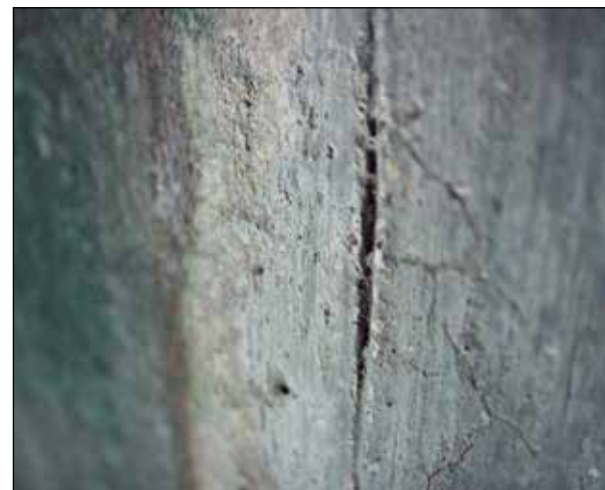
Figure 155: This is not a trace of a drawing impressed through the cartoon, but an incision into fresh plaster.

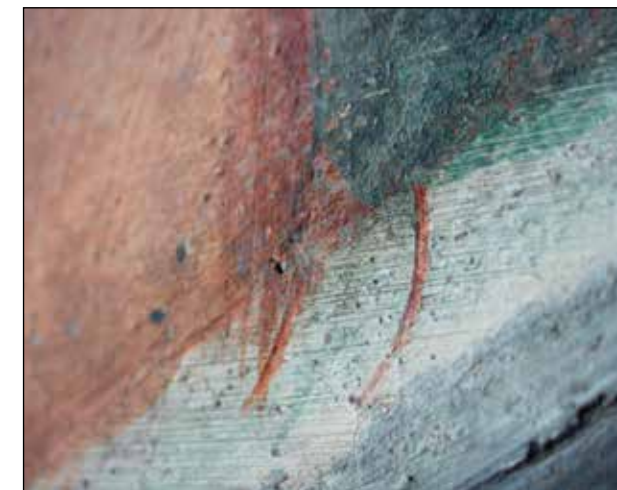
Figure 156: The red brushstrokes have cut deeply into the thick white-wash in places. The grooves half-covered by later whitewashes could mislead us to the incorrect assessment that these are traces of the drawing impressed through the cartoon.

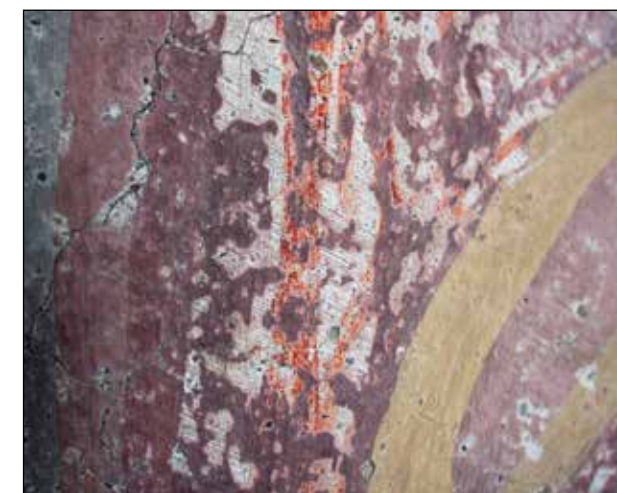
Figure 158: The layers of whitewash, applied to the already dry intonaco and basic whitewash, did not adhere to the ground as well due to the carbonised surface. Their adherence was assured only by a thin, weak layer of calcium carbonate, which took place within individual whitewash layers, therefore resulting in the flaking and peeling of the weakly adhered top layers of whitewash.

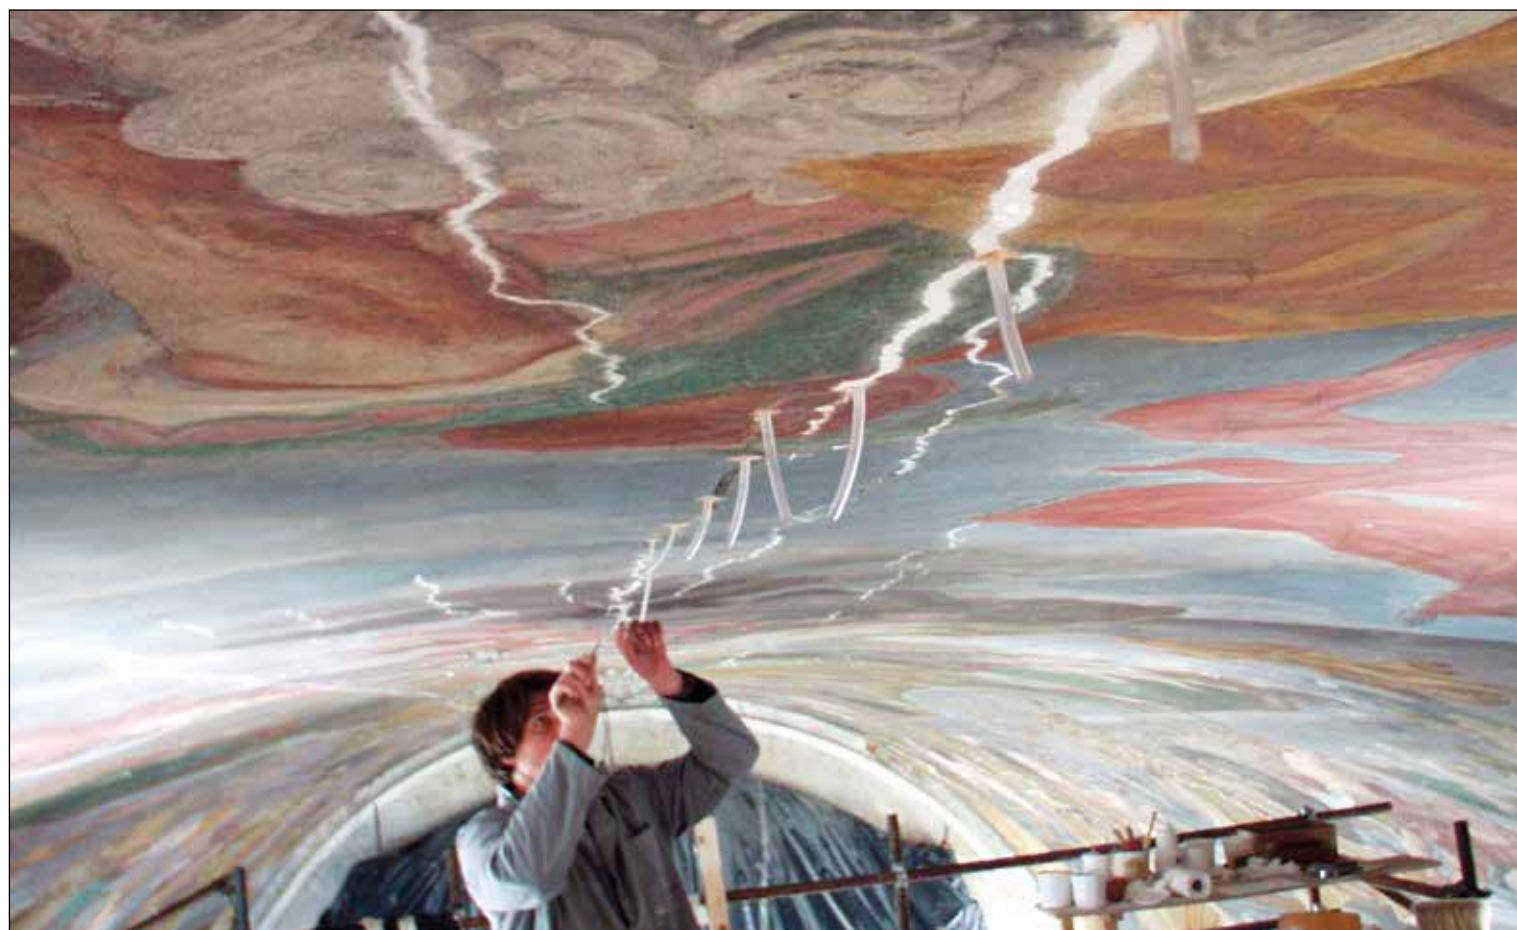
Figure 159

Numerous longitudinal cracks, which ran in parallel along the whole length of the nave, were appropriately prepared and filled with lime mortar. After inserting tubes from the underside (figure 159) and the top side (figure 160a) a suitable material was micro-injected. The sketch (figure 160b) shows the injecting material being poured from above through a drilled crack. Tubes were inserted into the drilled holes from the underside so a watch could be kept as to whether the cracks were totally filled. Before filling the cracks, the entire vault in the attic was thoroughly cleaned. With the years, several tons of material had accumulated in the attic. Filling channels had to be drilled through the cracks from the top side to the underside, and this could be done only in places where no danger of vibrations causing additional damage to the paintings was

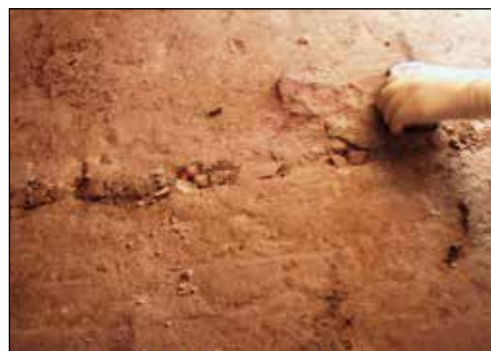
Figures 160a, 160b: Injecting of cracks from the top (attic) side of the vault.

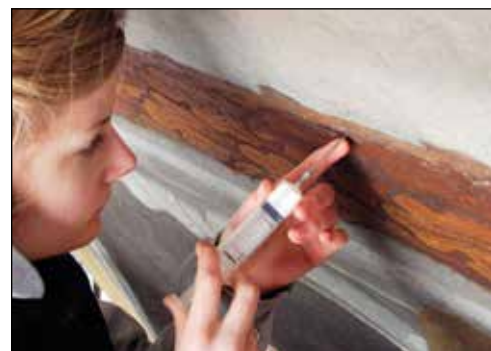
Slika 161

present. Tiny areas of damage were micro-injected (figure 161), whereas larger areas were filled in layers with mortar of a suitable structure (figure 162). Filling in cracks and adapting the structure of the newly formed surfaces to the neighbouring, original surfaces requires special expertise, which can sometimes be compared to the demanding nature of retouching (figure 163). New ground should not be too smooth nor too coarse, since in both cases this becomes visible and disturbing to the eye despite a well executed retouch. There were quite a few surfaces on the vault mural, which had cracked similarly to varnish and the colour layer on a canvas support (figure 164). In these regions the plaster was either applied too thickly or was too wet (possibly the sun shone through the window warming it up locally), or had dried more quickly due to various other

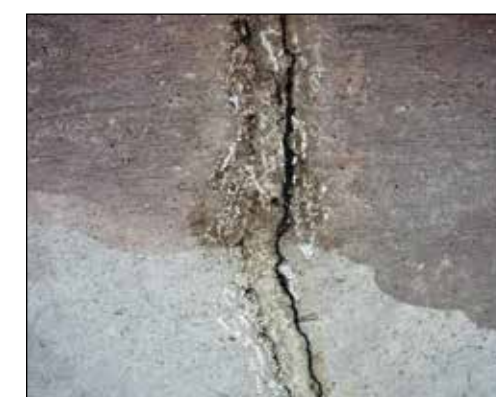
Figure 166

reasons. Quaglio painted that part expertly, before moving away about a meter with his brush. When he noticed the cracking of the plaster in a few hours, it was already too late; any kind of smoothing or levelling of the cracks would have caused irreparable damage, since this would cause damage to the delicate calcium carbonate crust, which had during that time already bound the colour particles. Quaglio was well aware of this therefore he kept these cracks since they did not lessen the grasp of the plaster onto the ground. A second type of crack occurred, however, as a result of movements of various structures within the building, in this case the brick vault (figure 165). The once already filled cracks (repairs after the earthquake in 1895) cracked again on both sides due to these movements, even though microscopically small (figure 166).

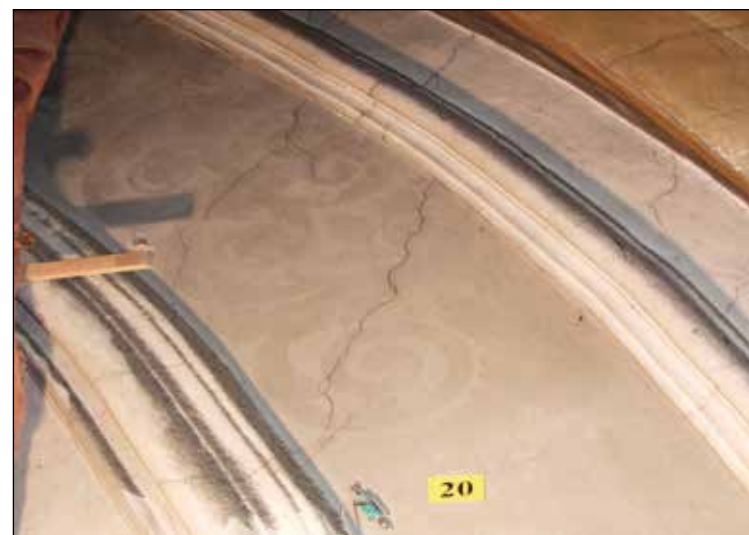
Figure 167: Visible traces of arch painting before probing.

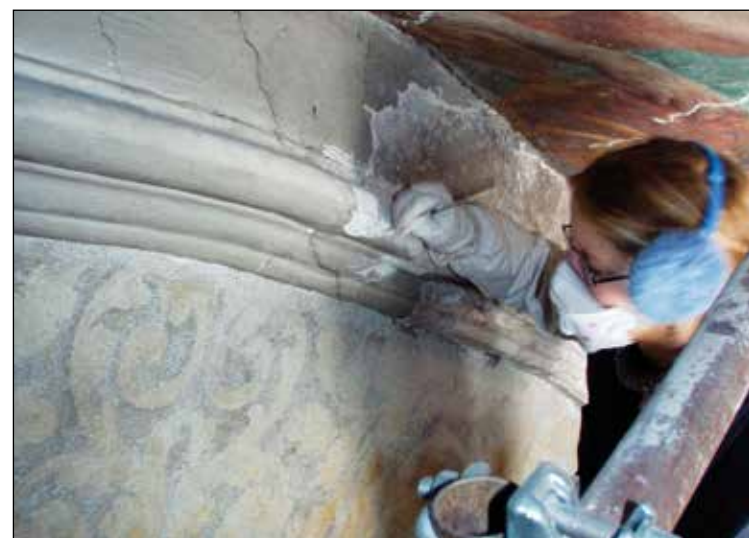
Figure 168: The removal of whitewashes – a part of Quaglio's mural crosses over onto the triumphal arch wall. In relation to the mural's crossing over the edges of the actual architecture attention must be drawn here to the three-dimensional additions that were found in certain regions, usually on the edges of the lunettes (clouds, the end of the side of Andrew's cross ...).

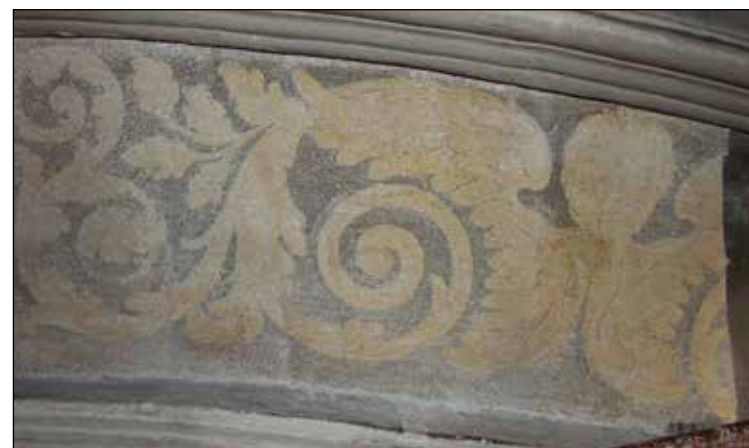
Figure 169: Condition after the removal of whitewashes.

Already at the onset of work on the triumphal arch, it was noticed that a hardly visible decorative mural shone through the top layer of whitewash. After the removal of these layers it was found that this was a tonal stencil painting, which had been originally depicted more sculpturally with the wish to create a three-dimensional effect of gilded stucco ornamentation. Given the fact that, after the removal of the top layers of whitewash, not enough data was available for a complete reconstruction of the original pattern, a decision was passed together with the art historical profession³⁴ to preserve the mural in the range as had been found, that is without intense shadows or highlights, only matching all parts of the pattern – which is the reason why the newly discovered painting has not been preserved to the same extent along the whole of its length. An investigative study³⁵ was produced on the set of problems relating to the renovations of this decorative mural on the triumphal arch.

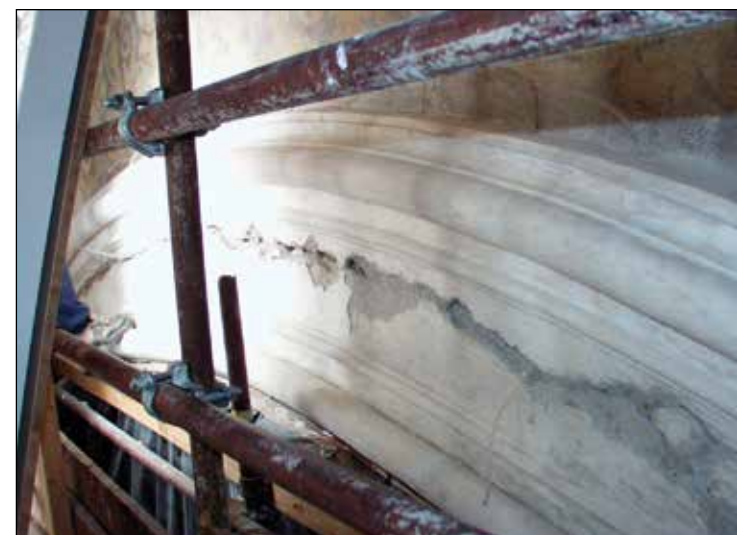
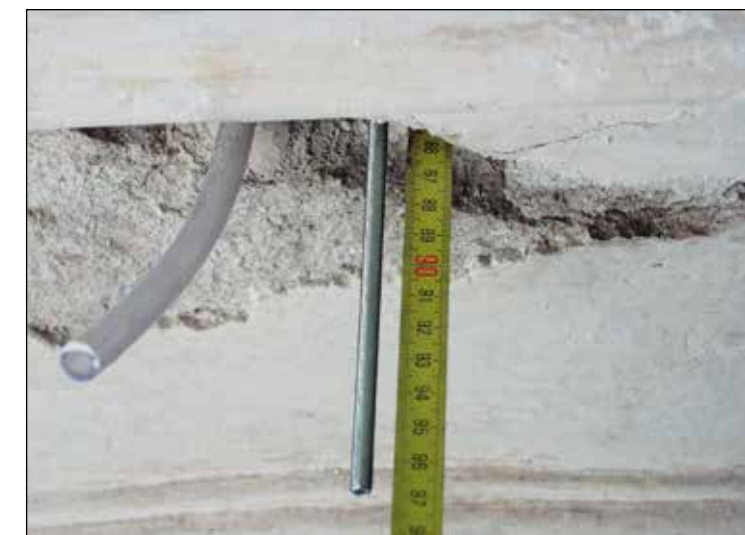
It must be stressed that when the whitewashes on the triumphal arch wall were removed, numerous large and small cracks were discovered that had already been walled in. The density of these cracks was greatest on the apex of the triumphal arch. The cracks filled with mortar were visible only on the top and bottom profiles; there were none in the middle painted region, which means that a decision had been taken during previous repair work on the triumphal arch to apply a layer of new plaster due to the great number of cracks. A similar decision was accepted by the restorers of those times also on the western wall, only that here also the mural was whitewashed, which indicates that renovation work was undertaken straight after the earthquake, or more probably at the beginning of the 20th century (Anton Jebačič). Attention must be drawn to a large and deep crack discovered during our conservation-restoration treatment. It can be seen (figures 170, 171) from footage that its depth measures around 80 cm and more. Obviously it is a kind of decomposition of the layers of construction of the triumphal arch. This crack, and all larger areas of damage, were hand-injected with mortar based on hydraulic lime. Attention must also be drawn to two almost symmetric more prominent cracks in the northern and southern part of the triumphal arch wall, which proceeded downwards somehow towards the springing of the arch. Both were monitored as part of the measurements of the crack expansions during the time of the project. Only the frontal surfaces were treated on the triumphal arch wall, despite visible damage disturbing to the eye that had occurred due to leakage, since the inside of the arch was not accessible from the existing scaffold.

Figures 170, 171: A more than 80 cm deep crack.

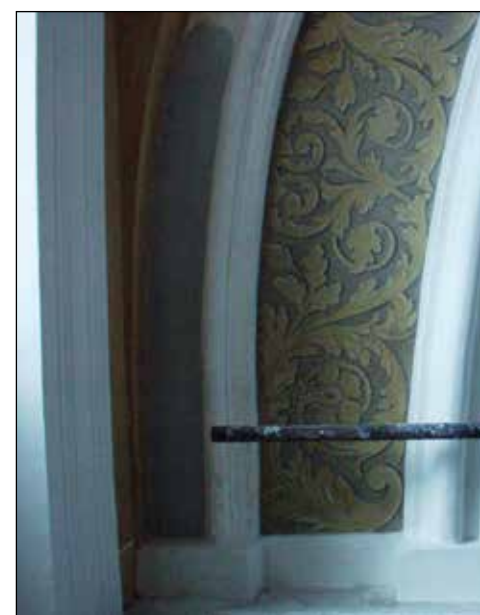
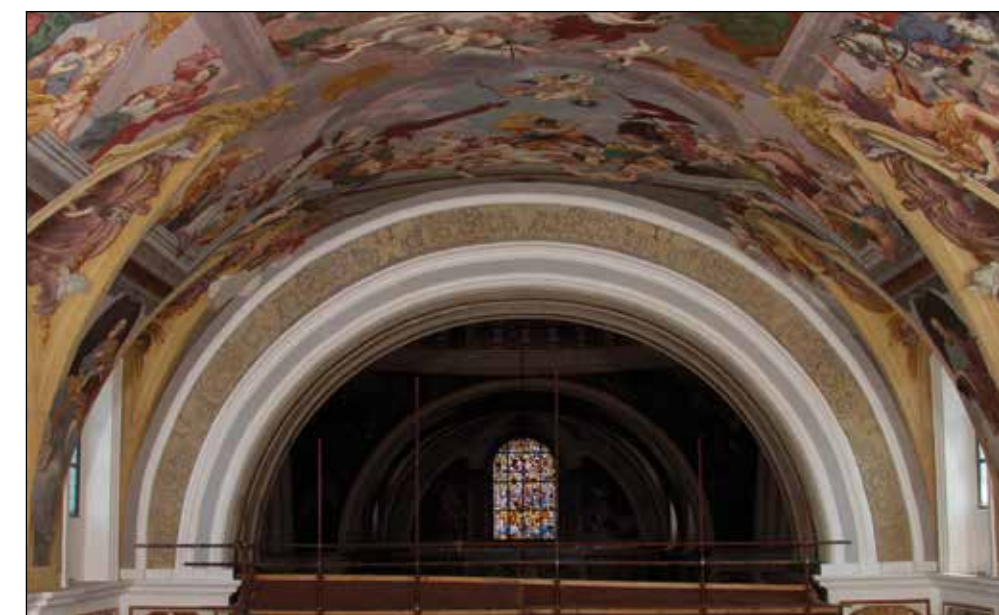
Figures 173, 174: After completed treatment on the triumphal arch wall.

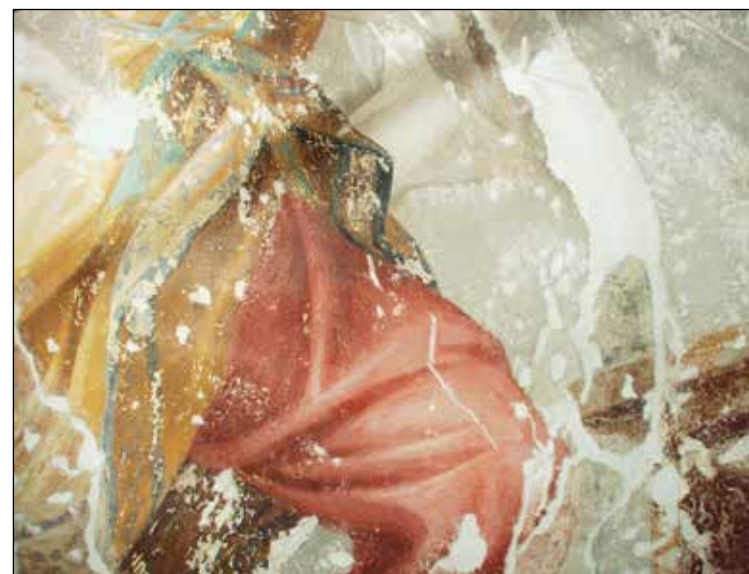
Figure 175, 176: Filling of numerous cracks.

The filling of these numerous tiny areas of damage, together with the repair of the larger and very deep cracks (figure 175 and 176), was demanding and time-consuming.³⁸

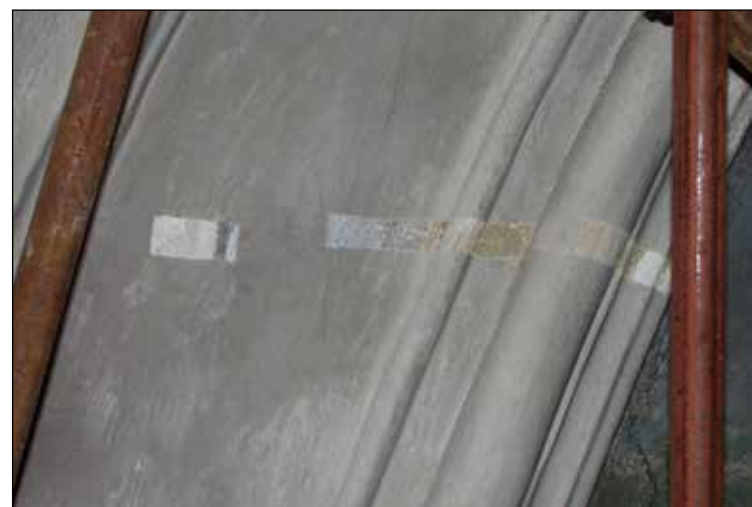
Figure 179: By probing it was discovered that the profiling on the larger arch, the profiling along the windows, the capitals, and the marbled surfaces on the pilasters had been an ochre colour.

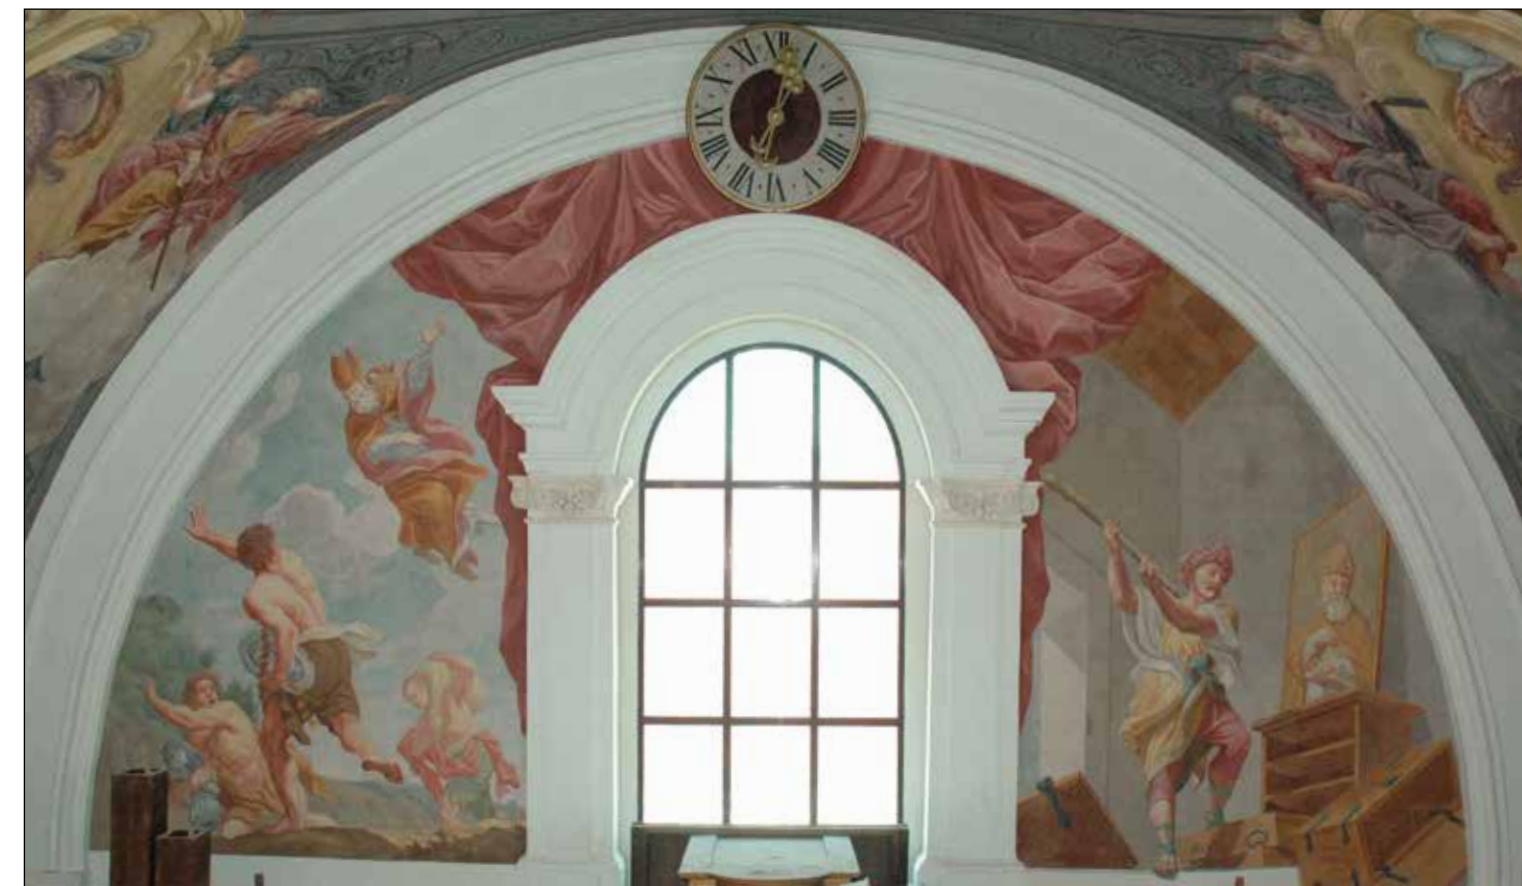
Figure 180: The western wall after the renovations of the wall paintings and architectural parts.

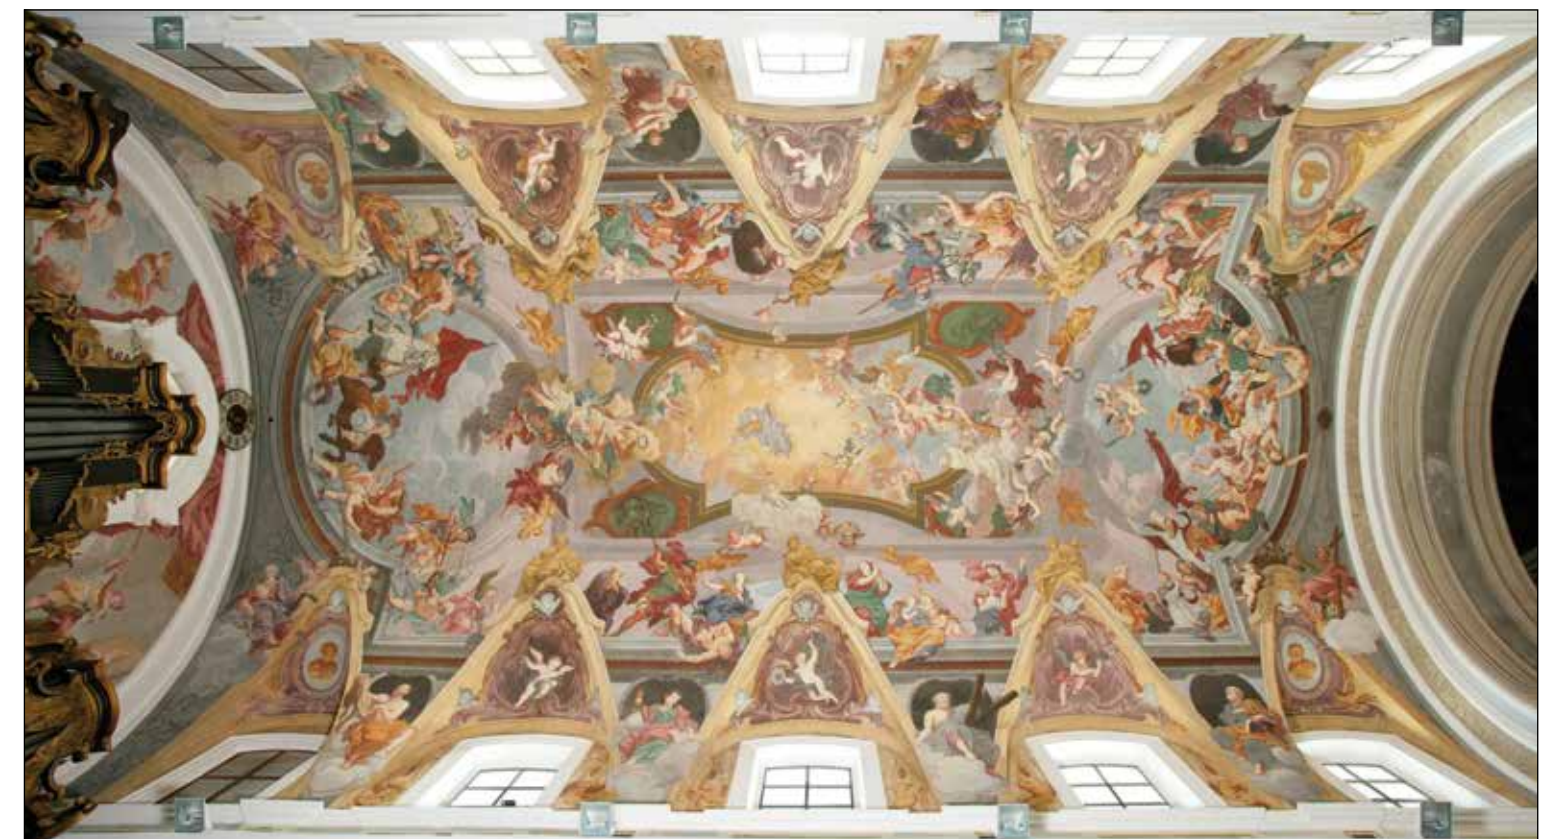
Figure 182: The vault painting after completed conservation-restoration treatment in 2006.

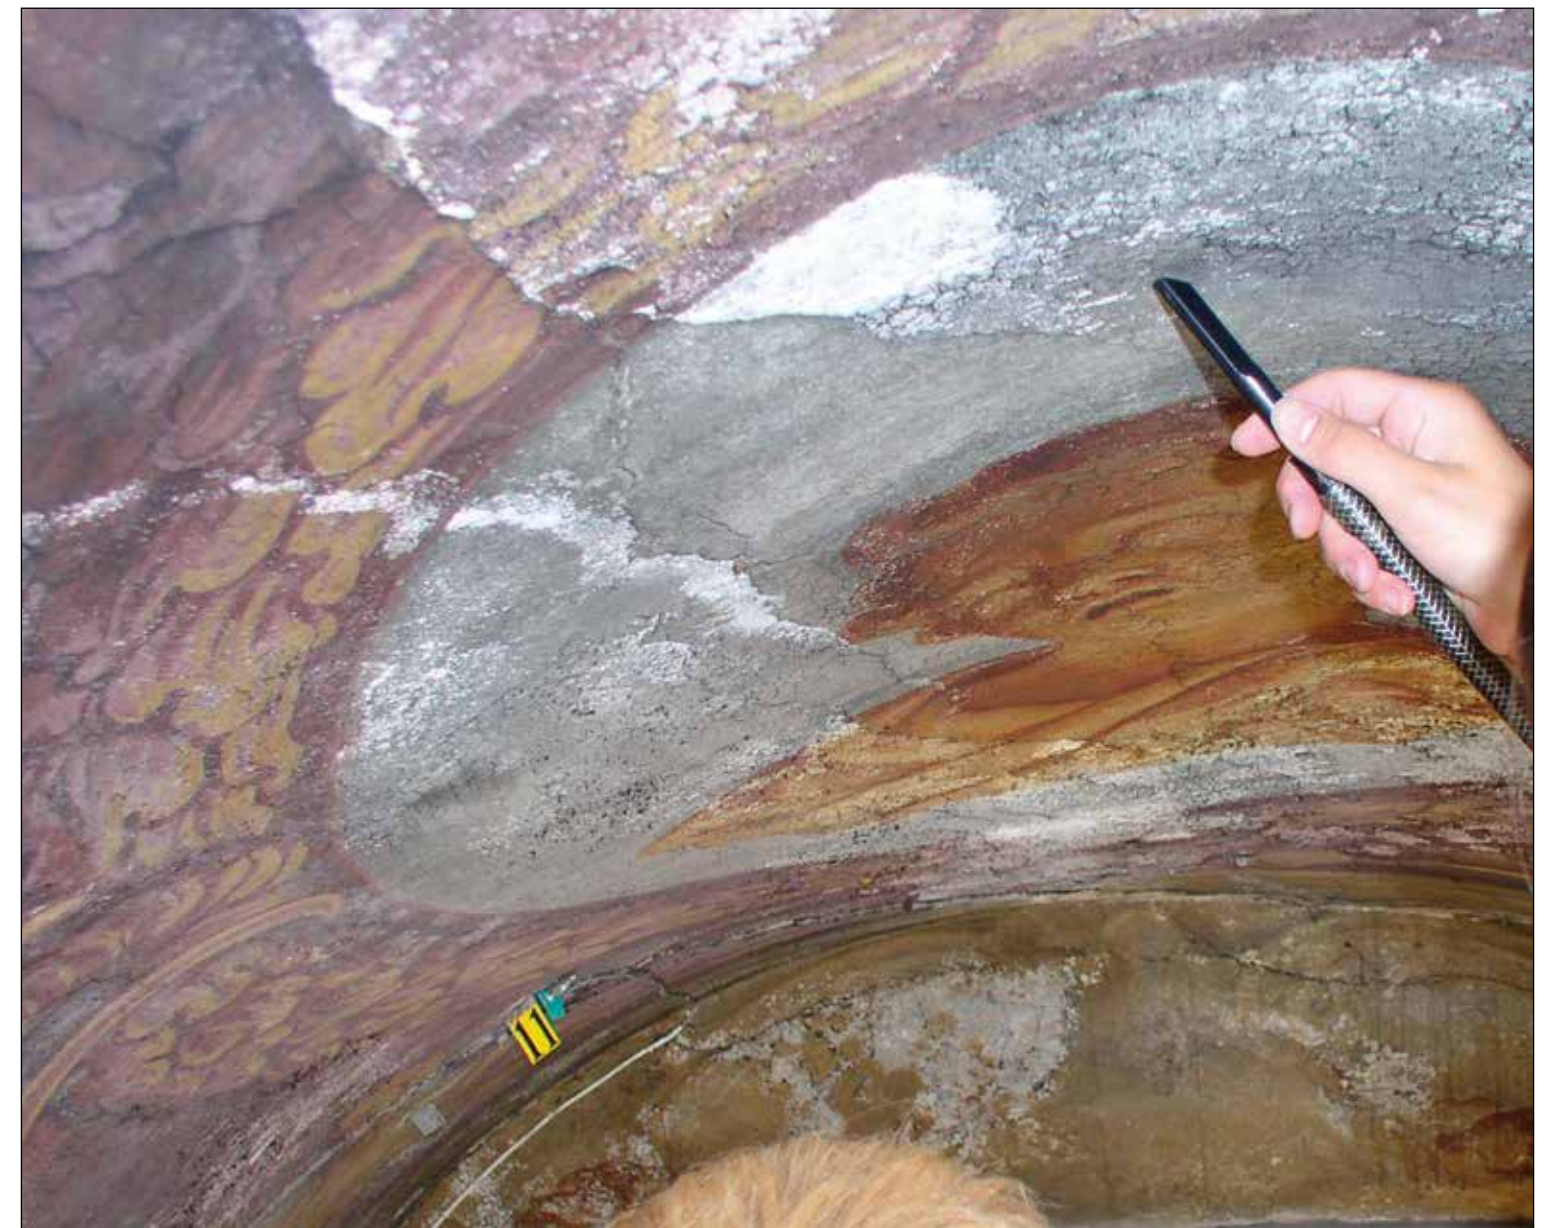
Figure 185: Careful removal of dust and other impurities above the northern walled-in window.

The first attempts of mechanical cleaning were carried out in easily reachable areas and relatively firmly painted surfaces by means of probing (figures 186, 188) using Wishab sponges of various hardness and Wishab powder (figure 189). Prior to that, coarse dust, soot, cobwebs and other dirt was removed by using soft brushes without touching the surface. In the removal of these impurities, micro vacuum cleaners were also used (figure 185). The initial results were quite forthcoming (figures 186, 187), even though such a mechanical method can only be used on unproblematic surfaces. The problematic areas of the wall and ceiling paintings (scaling and lifting, heavy dust and flaking of the colour

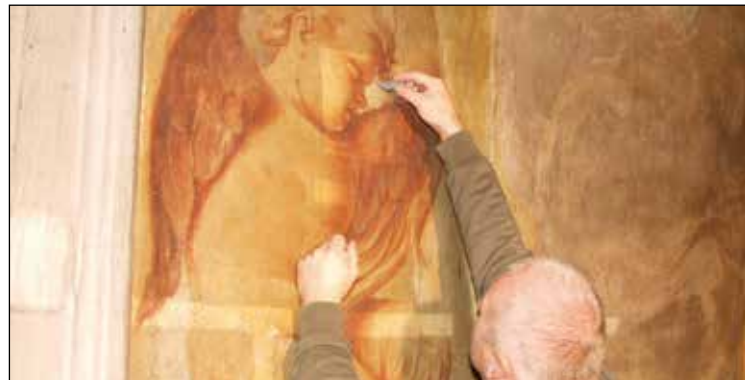
Figure 186: First cleaning probing.

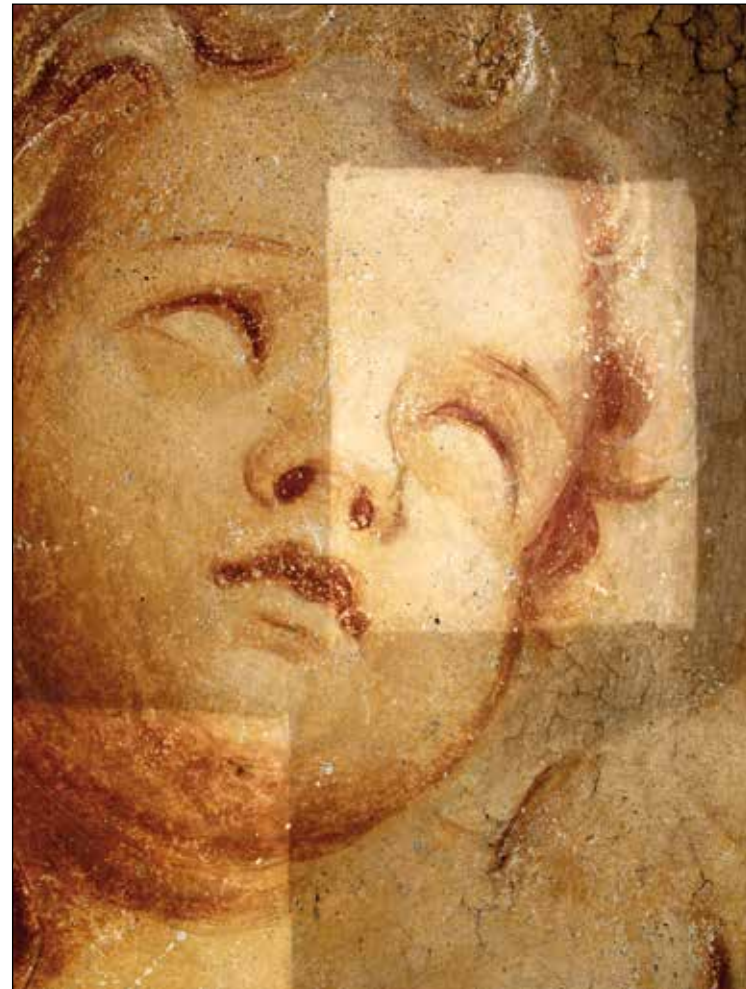
Figure 187: Visible flaking of particles of the colour layer before cleaning.

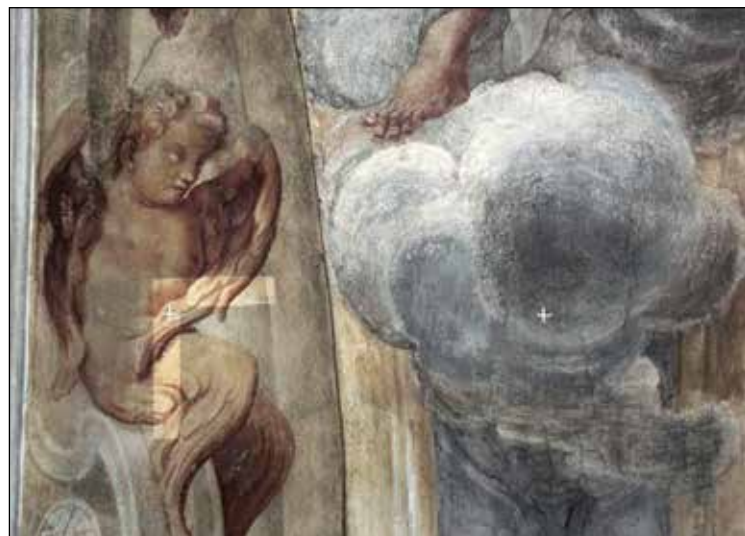
Figure 188: Comparison of cleaned and uncleaned surfaces.

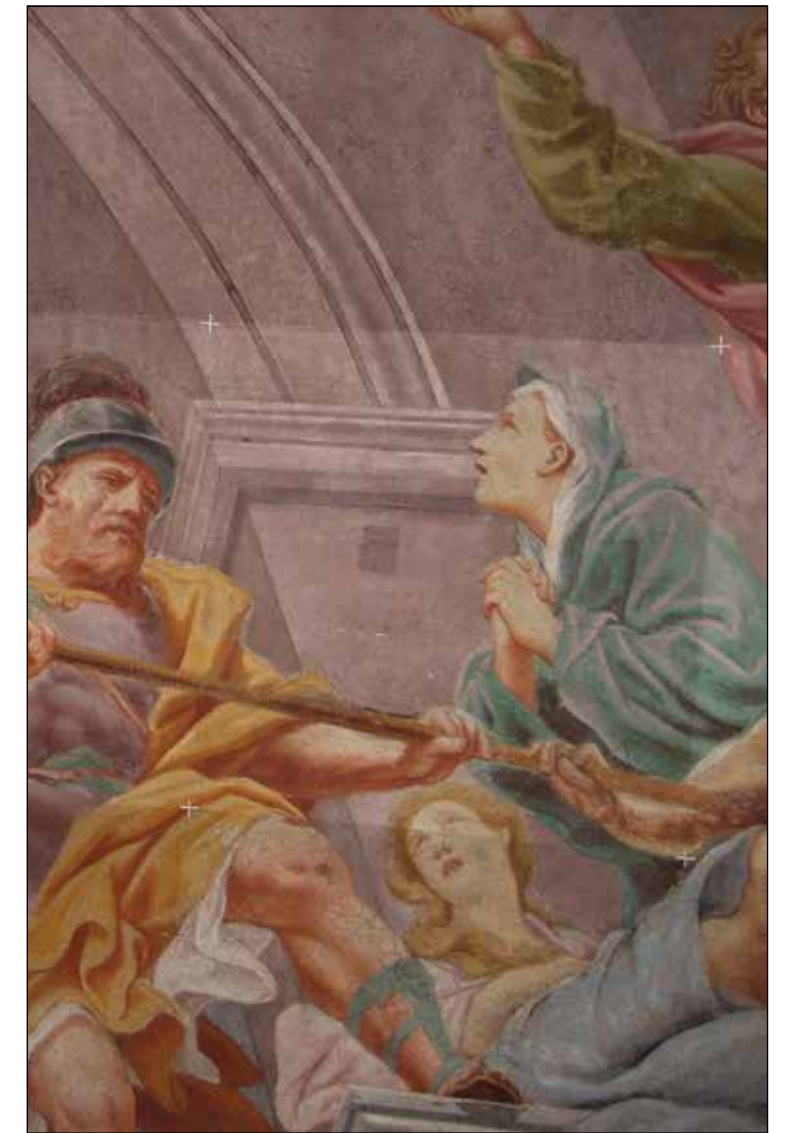
Figure 190b

layer) were not addressed in the initial stage, since the use of mechanical methods would have caused irreversible damage. Figure 190 clearly shows the difference between the cleaned and uncleaned surfaces. Here the soot-filled cracks stand out; it is very likely that air currents found their way through them, absorbing tiny particles of dust and soot on the way. This assumption is also supported by findings of soot and dust ingrained deeply within larger cracks after removal of old worn out fill material. This proves that cracks were present, at least in the central part of the vault, already before the earthquake of 1895. Figures 191 and 192 document the mechanical removal of impurities by quadrants.

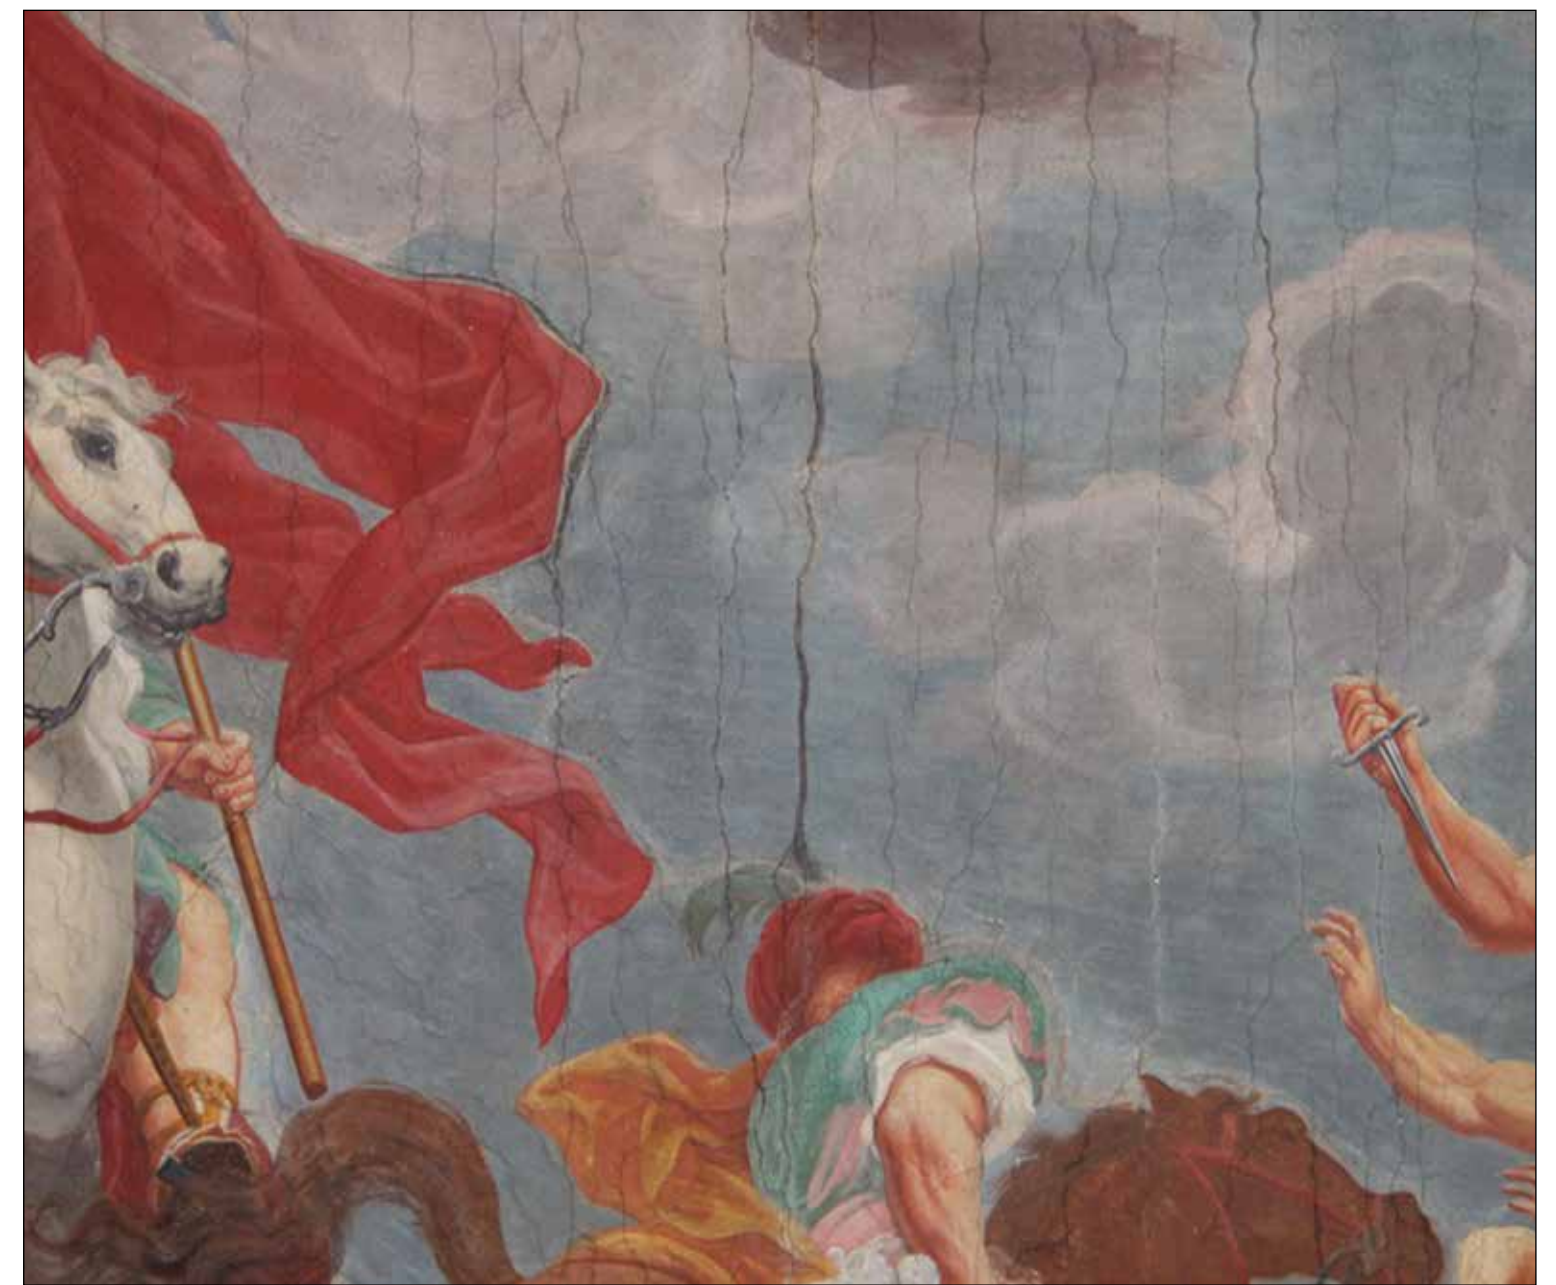
Figure 203: The region above the organ with the thickest network of cracks; in the middle and to the left along the red drapery, darkened retouches from a previous restoration treatment.

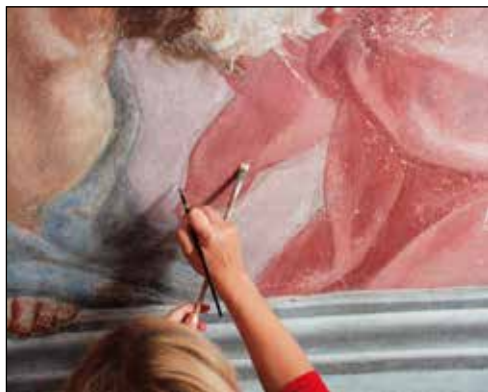
Figure 204: Filling of numerous tiny areas of damage.

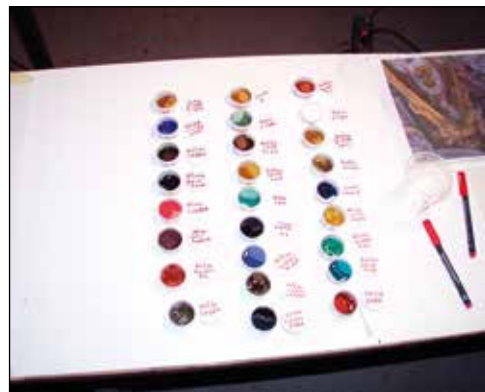
Figure 205: The production of watercolours on the platform.

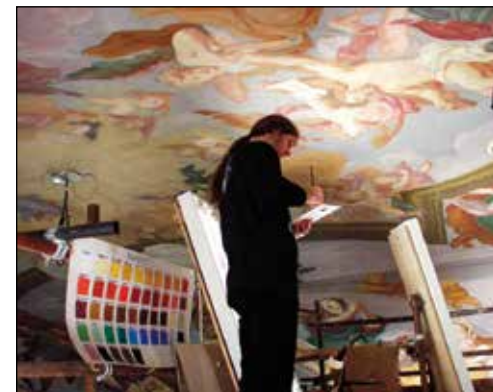
Figure 206: Testing of the binder on the lime support.

The choice of binder was accepted on the basis of research on the effects of condensed cycles of temperature fluctuations and relative humidity on potential binders. Tylose MH 300 was the binder that, in comparison with other binders, preserved the typical colouration of pigments as well as a relatively good grasp onto its ground during the extreme conditions of artificial ageing. The choice of binder for such an important, but also extensive, wall painting is neither easy nor simple. After examination of all painted surfaces and the finding that thousands of tiny particles that had flaked off the mural would have to be replaced, we searched for a pigment binder that would not alter after drying (would neither lighten nor darken), so that restorers would not be required to return to the same spots with their brushes in the attempt to mix the correct shade over and over again. The preparation and application of the binder should be simple and pleasant to work with. The artificial ageing procedure was entrusted to an institution with appropriate equipment and necessary references. It would have been ideal of course had there been an opportunity to test out the binders on site by using real ageing and compare the state of the binder and pigments in ten years' time and only then begin work on the wall and ceiling paintings. This option of comparison and monitoring of changes on this binder will be usefully exploited by restorer colleagues during the next restoration procedure on the vault. In the choice of binder it was necessary, besides the results of artificial ageing, to also check the suitability of application onto the actual material, and not just the clean surface provided in the laboratory. The process of selection was carried out clearly and with the overview of both expert committees that monitored our work. In the choice of binder, which would prove technically unproblematic and most compatible with the original, most experts would decide on lime, that is aged slaked lime. However, lime is more appropriate for filling in greater damage, like cracks and larger pieces of fallen off plasterwork, where it adapts well to its surrounding area

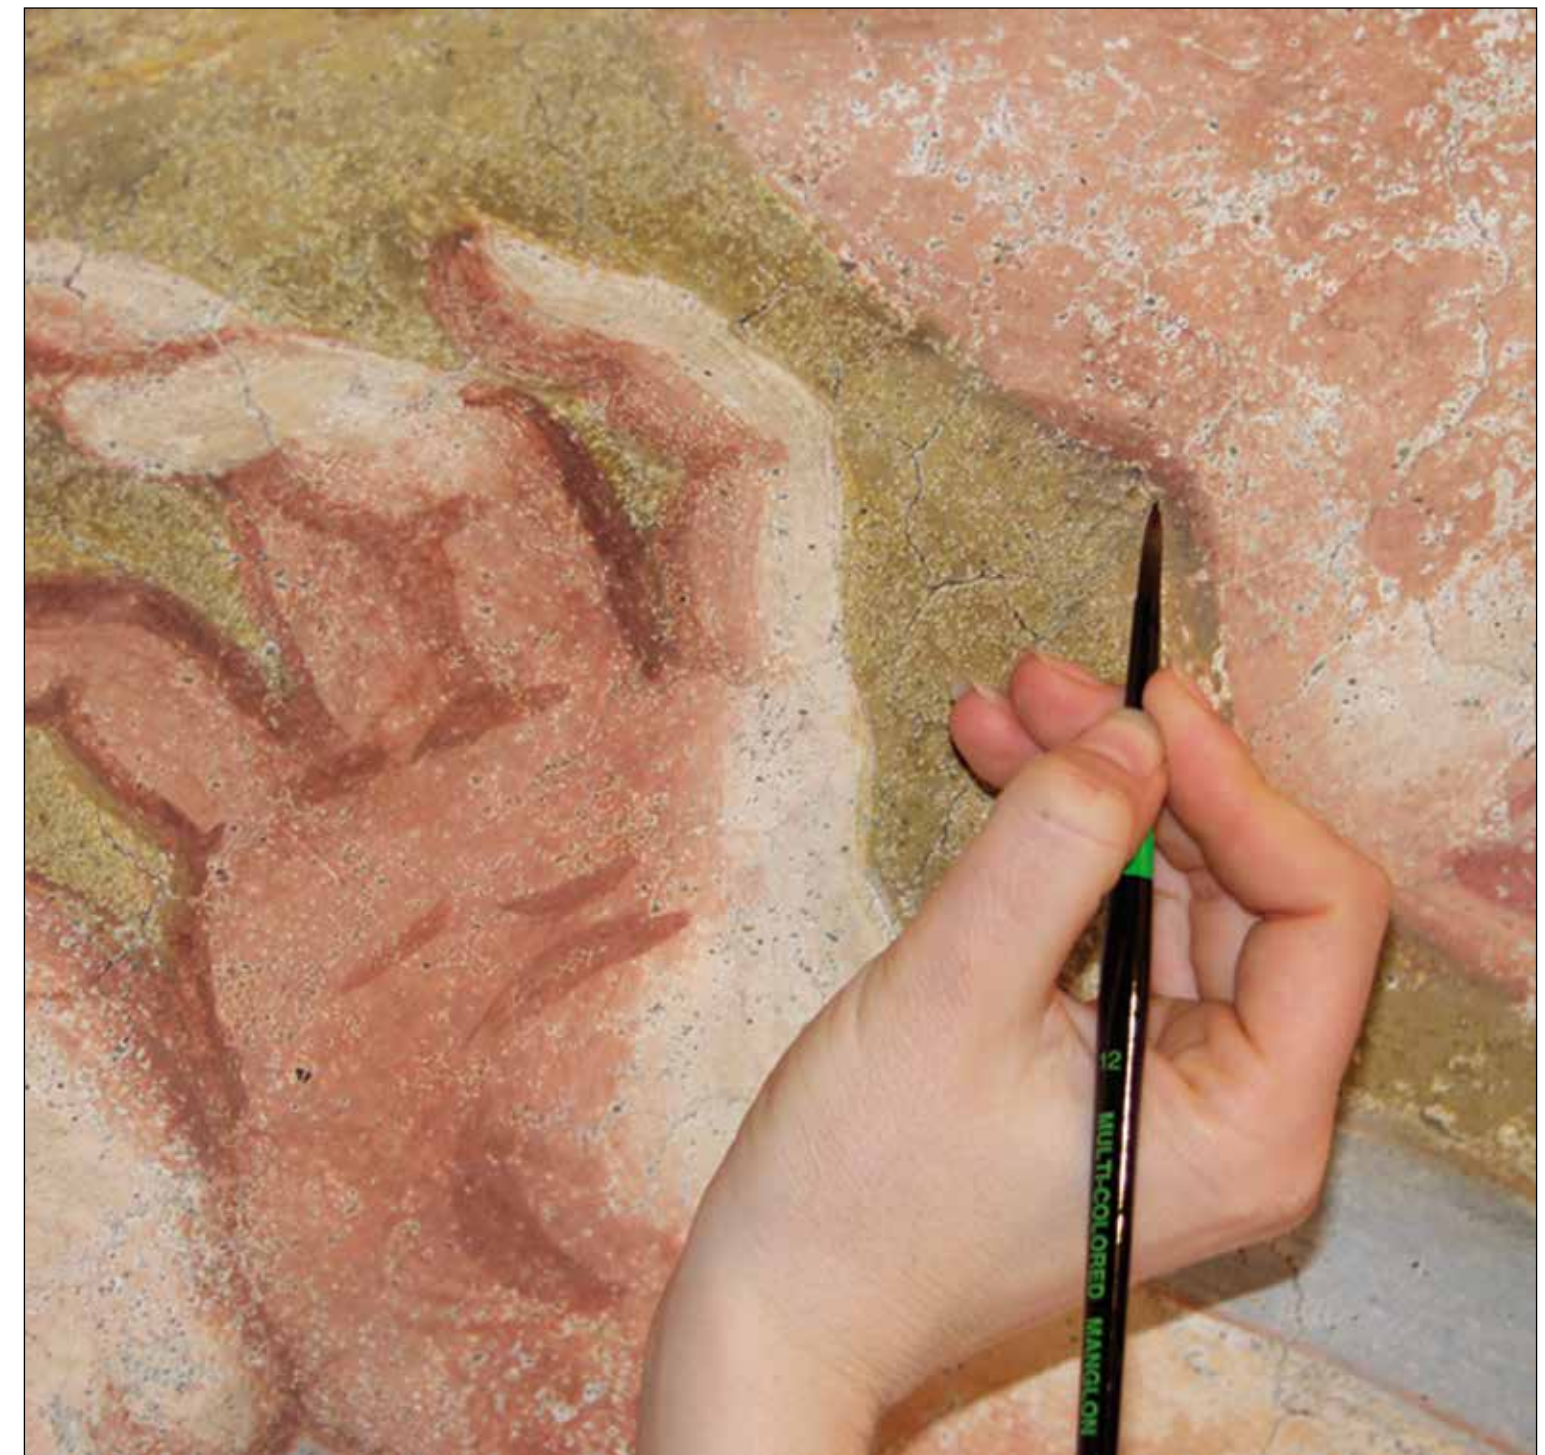
Figure 207: The first retouching attempts were made with ammonium caseinate.

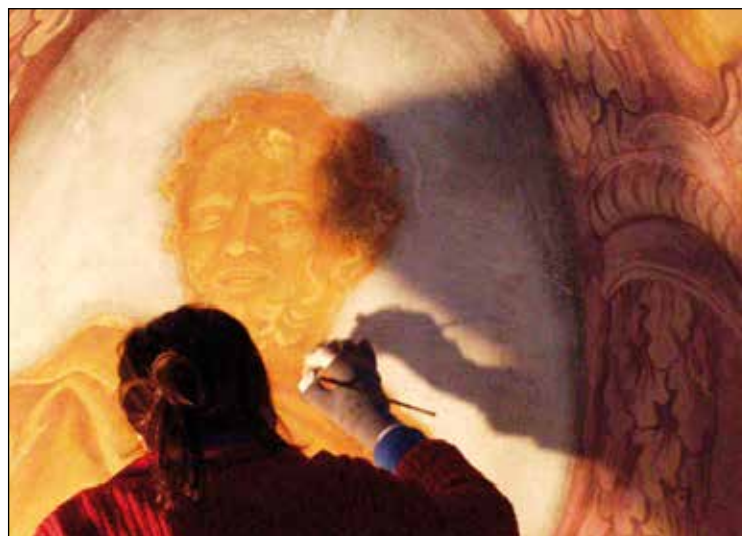
Figure 209: Retouching of the antique bust in quadrant P25.

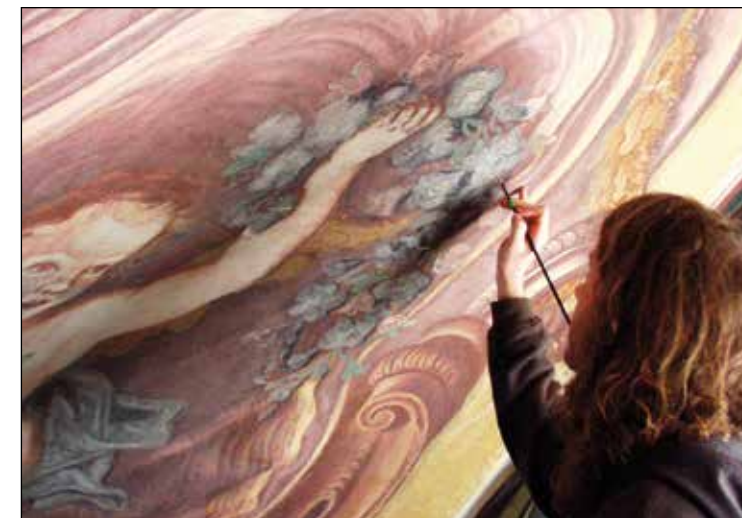
Figure 210: A retouch of the flowers in the location of E14 and F14.

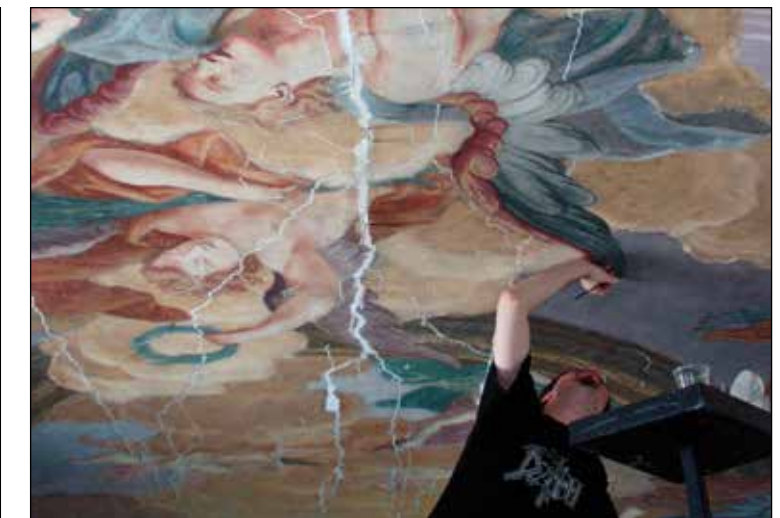
Figure 212: Retouching the angel's wing, K10.
