THE RESTORATION OF QUAGLIO'S WALL PAINTINGS
IN LJUBLJANA CATHEDRAL

The Restoration of Quaglio's Wall Paintings in Ljubljana Cathedral

A conservation-restoration project involving the wall paintings created by Giulio Quaglio (1668–1751)

on the nave vault and the western wall of the Cathedral of St Nicholas in Ljubljana, IPCHS Restoration Centre (2002–2006)

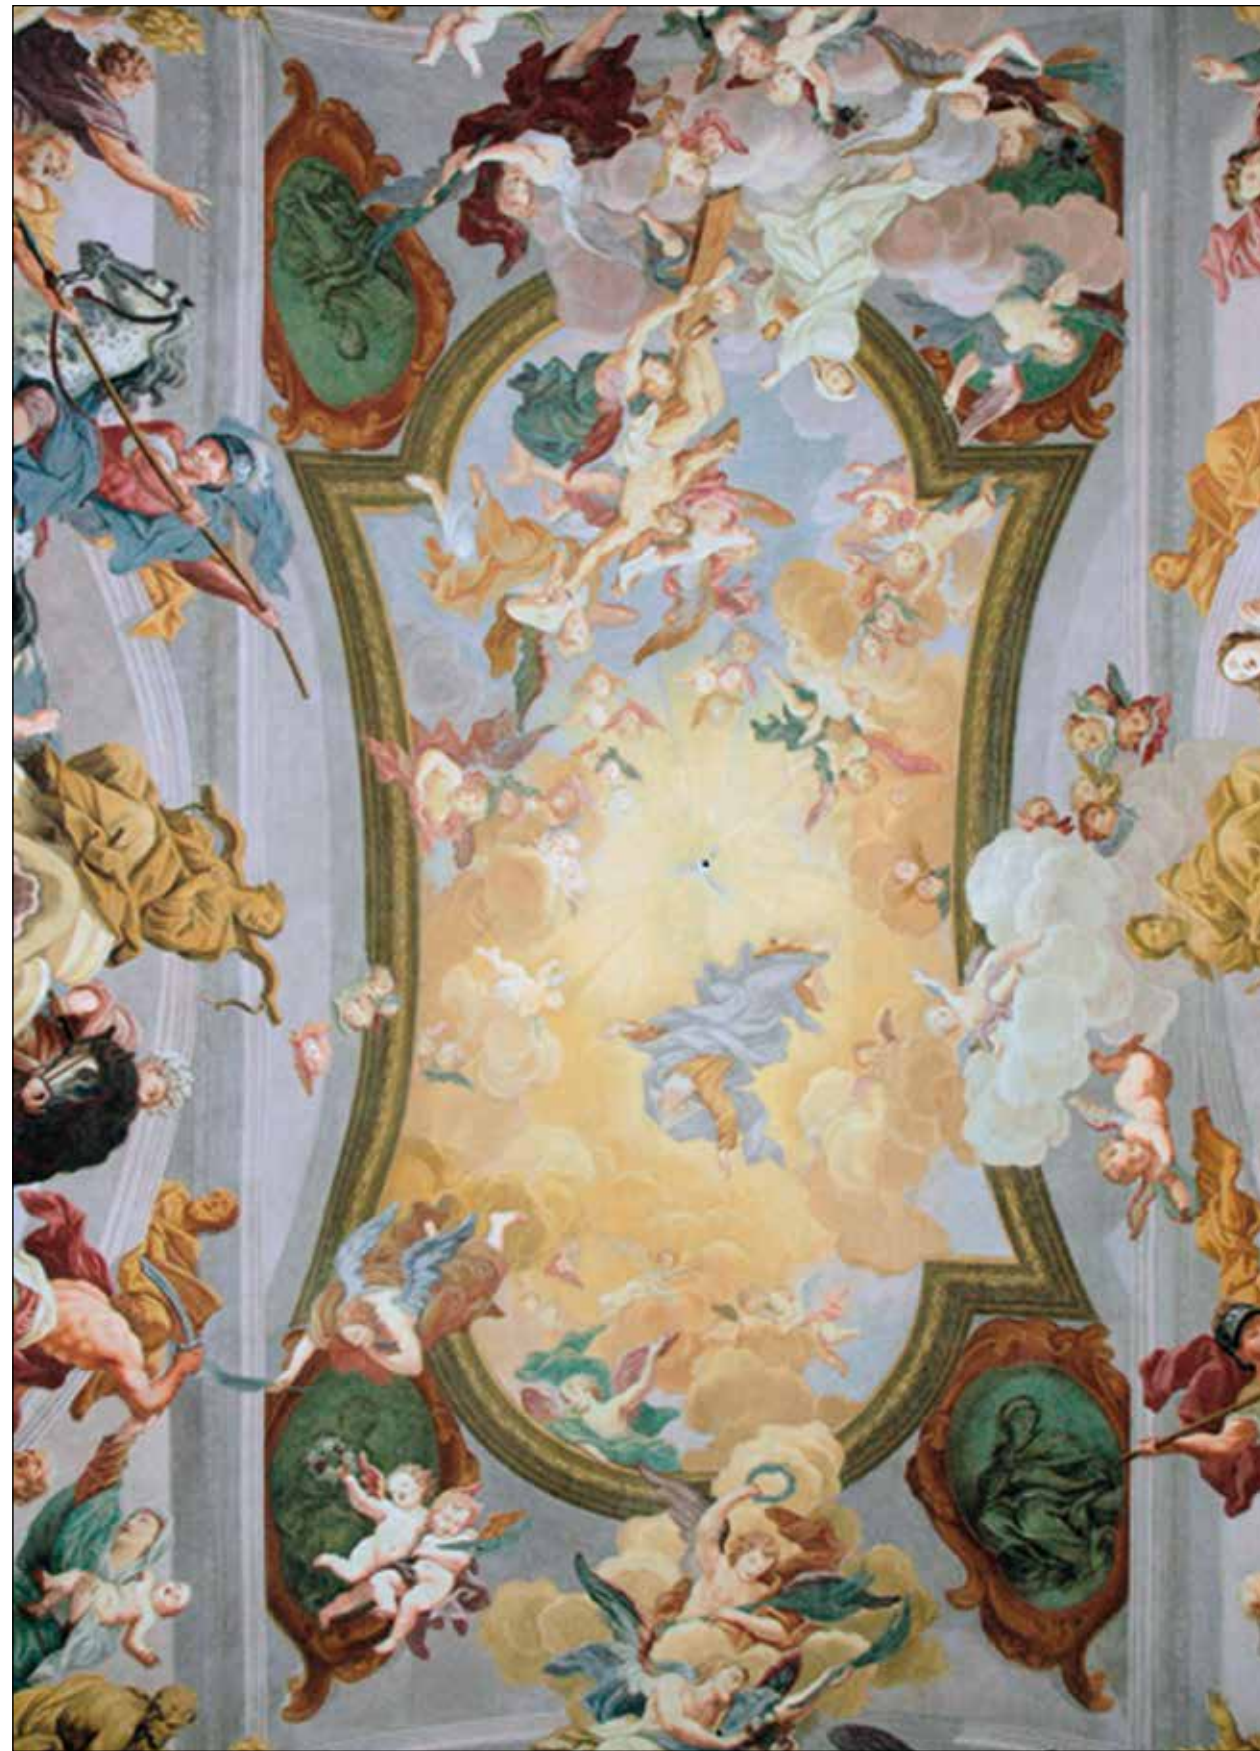
Figure 213: The condition after cleaning, closing of cracks, and the retouching and reconstruction of the mural in the region of the central frame.

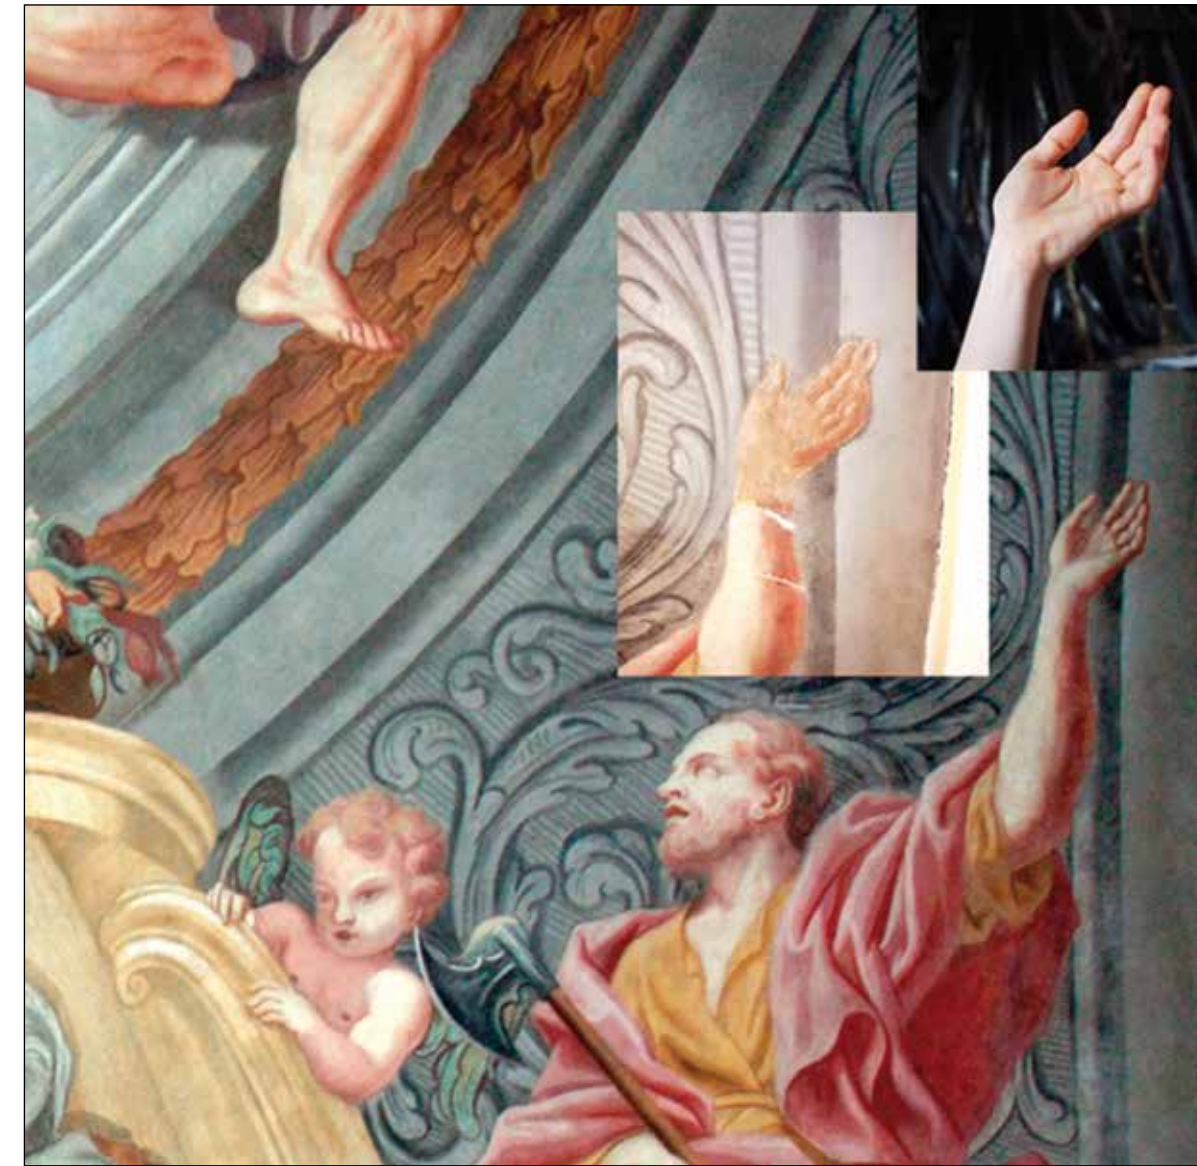
Figure 214: The region of the depicted St Matthew the apostle with a shot of the previous state of the reconstruction of the hand (smaller image above the apostle's head). To the right there is a photograph of the hand which was used by the restorer to produce the reconstruction.

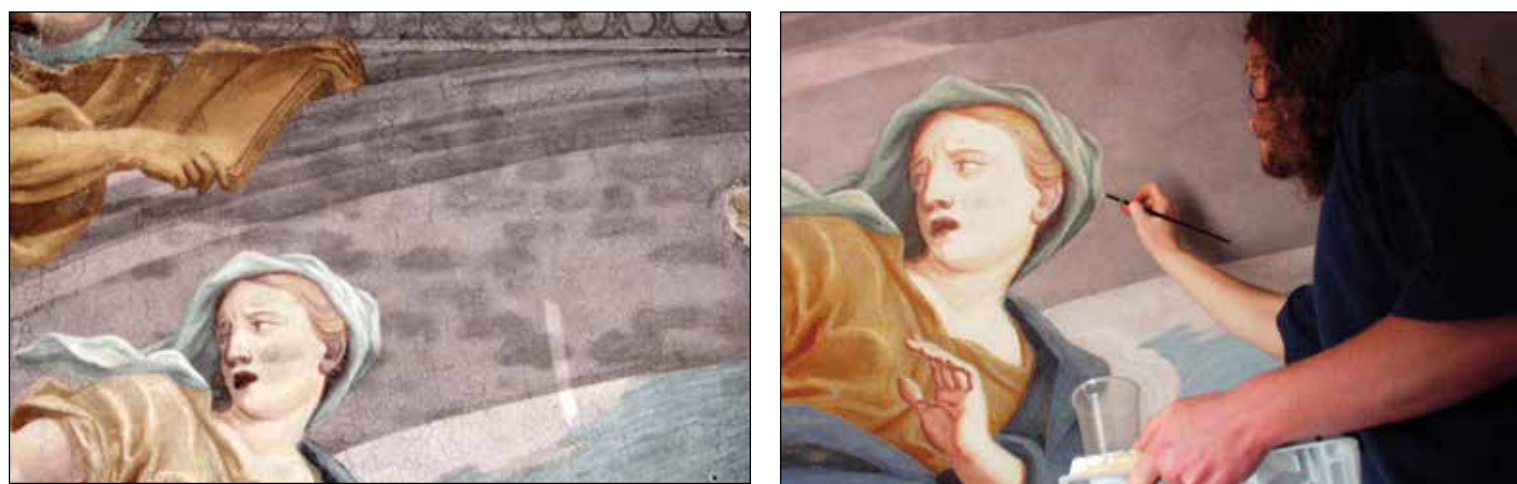
Figure 215, 216: On the northern wall of the vault, more precisely in the region of quadrants G12 and G13, some typical damage occurred due to the infiltration of moisture through variously permeable materials. The state of the mural painting before and after removal of all damage.

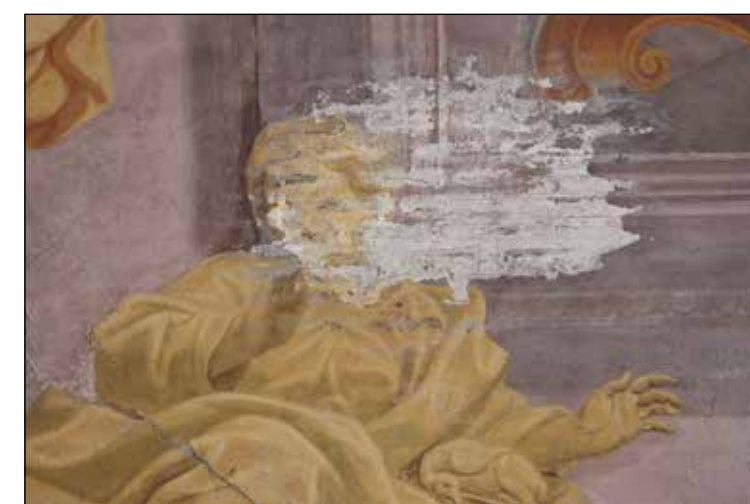
It is interesting to note that the worst affected damage on the colour layer and plaster were to be found in the corners of the depicted rectangle above the lunettes, which indicates a possible leakage of meteoric water onto the roof's wooden construction.

Figure 220: Condition after prolonged leakage through the brick construction with loss of the colour layer in the face and hair area. Damage before treatment.

The repair of damaged areas, where the lime binding had lost its strength due to permanent moisture causing the plaster layers on the surfaces of the vault to flake off, is extremely challenging. Water soluble salts and other dissolved matter that still lingers in the depths of the brick vault can in the presence of sufficient moisture again begin to collect on the surface of the paintings and plasterwork, dislodging plaster particles and colour layers through the formation of crystals.

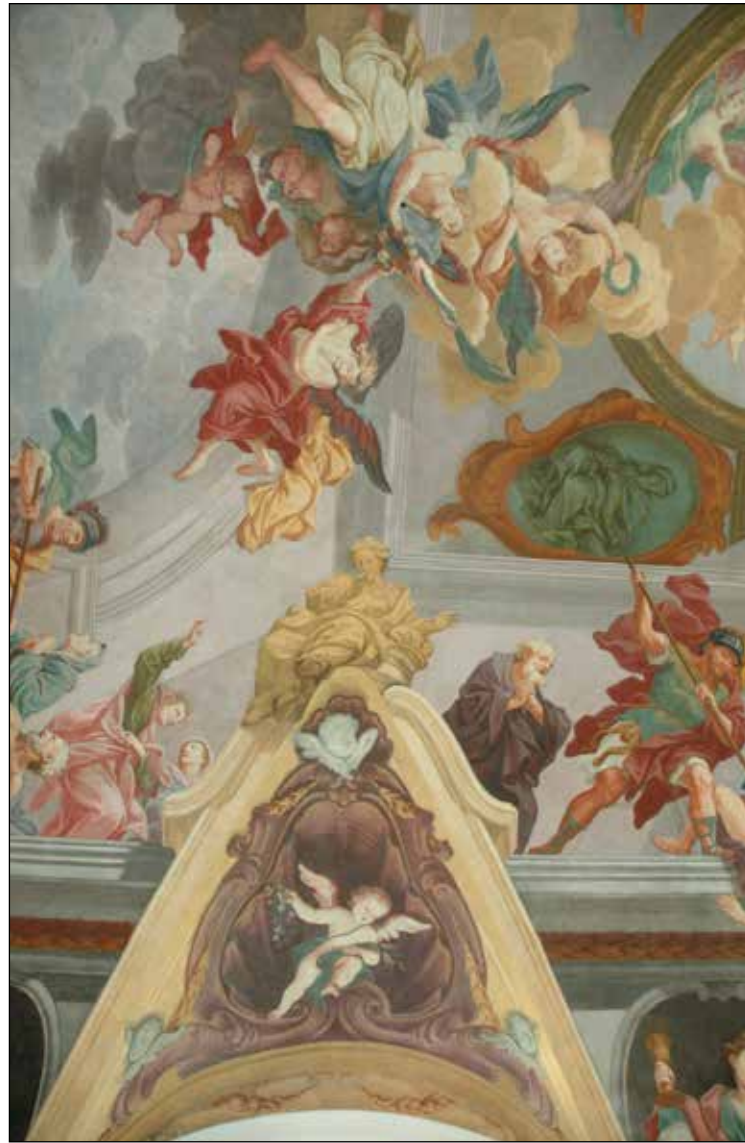
Figure 221: A part of the refurbished vault mural with included reconstruction.

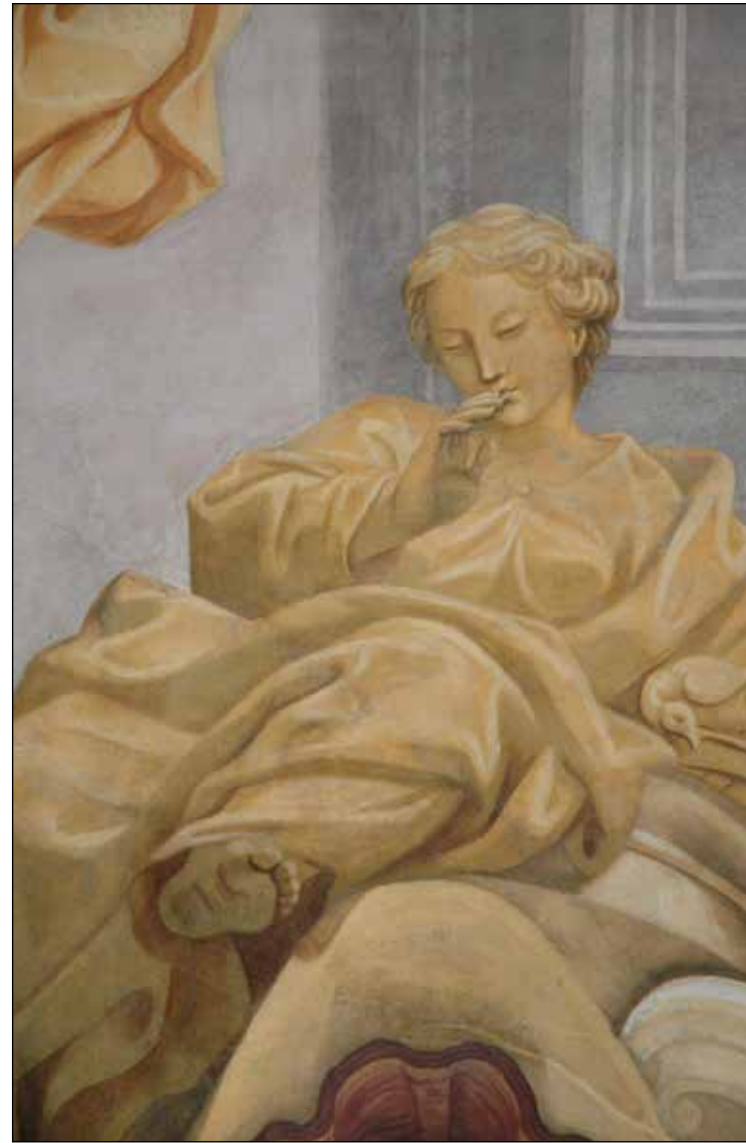
Figure 222: A personified image of a virtue after the finished reconstruction.

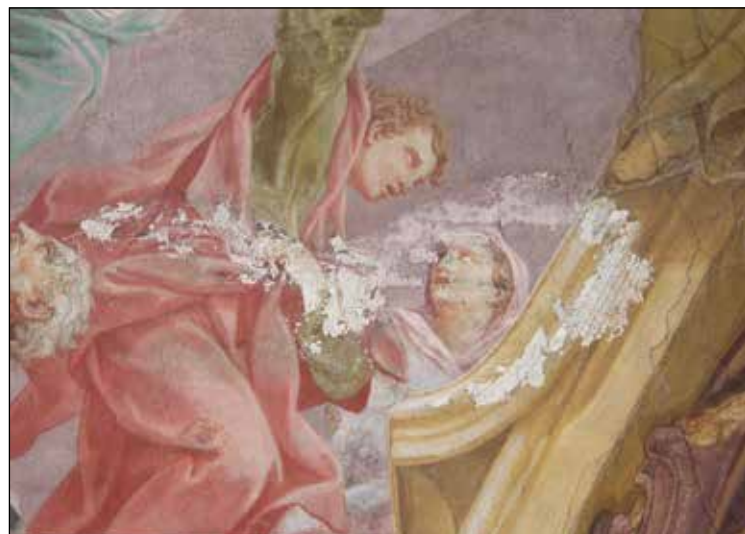
Figure 223: The head of the figure in location F7 with strong signs of efflorescences.

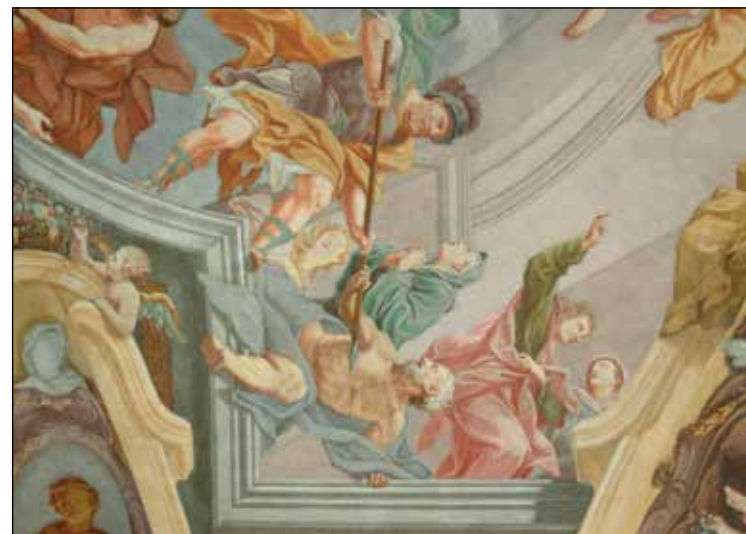
Figure 224: Region F7 after the reconstruction.

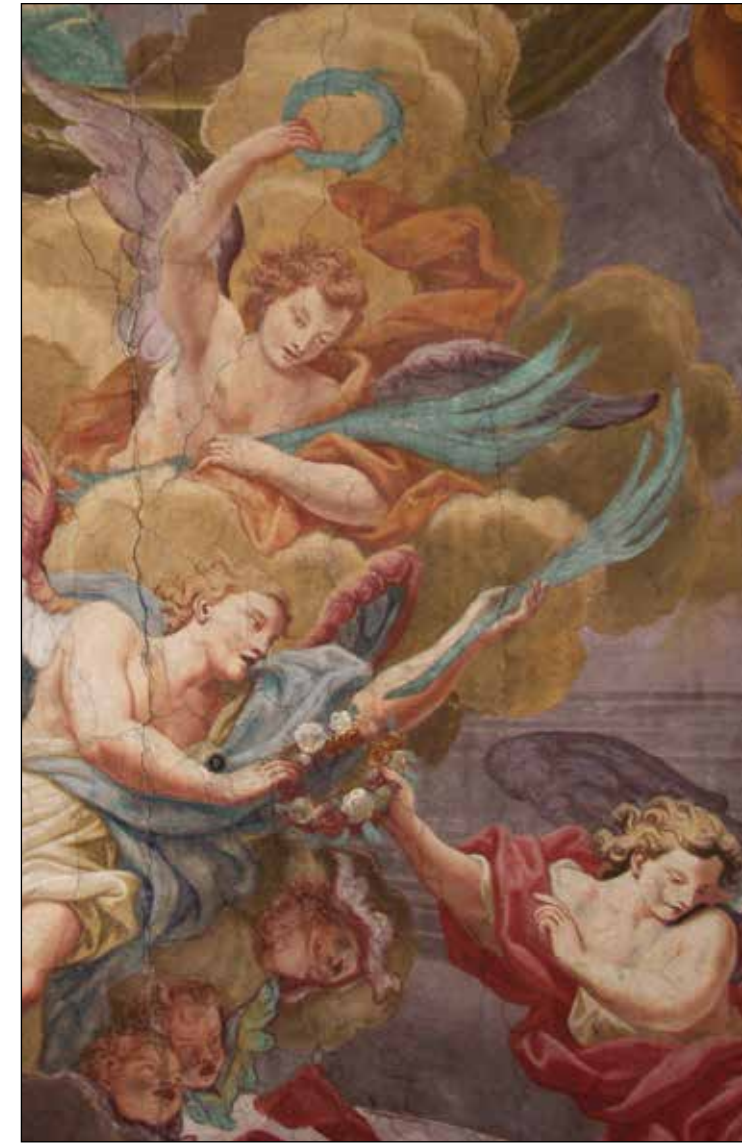
Figure 225: Condition before treatment – numerous overpaints can be seen along the larger crack.

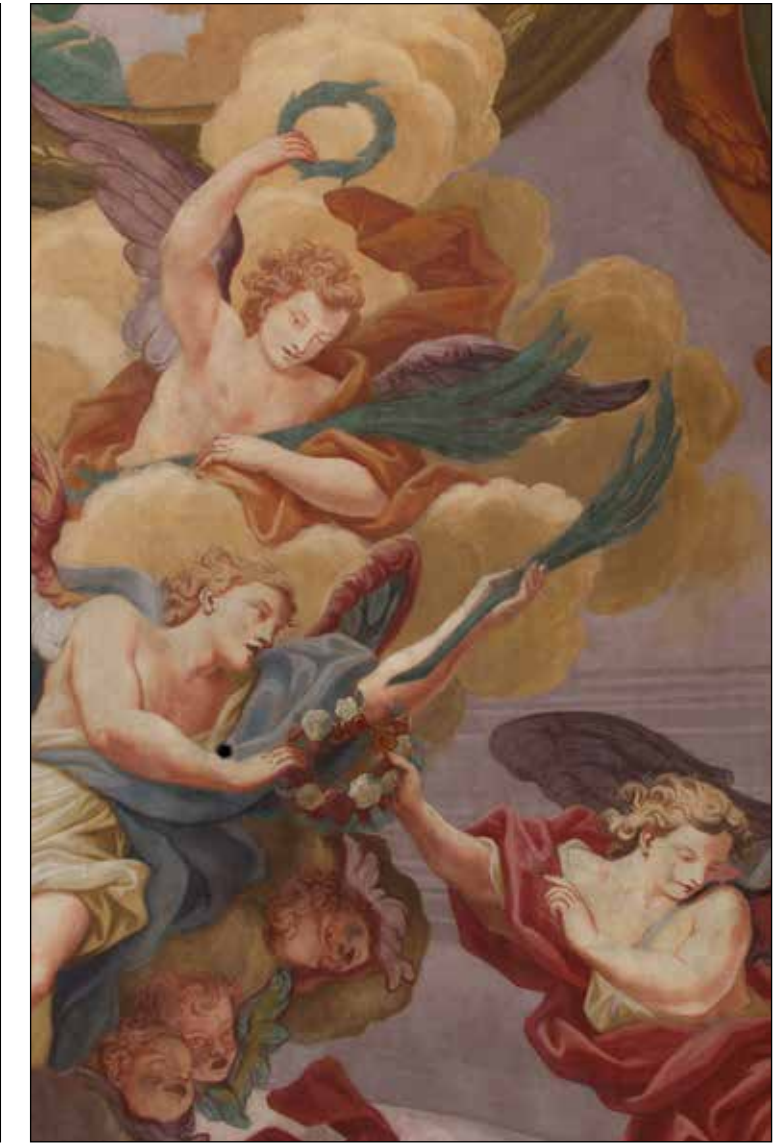
Figure 226: Condition after completed conservation-restoration treatment.

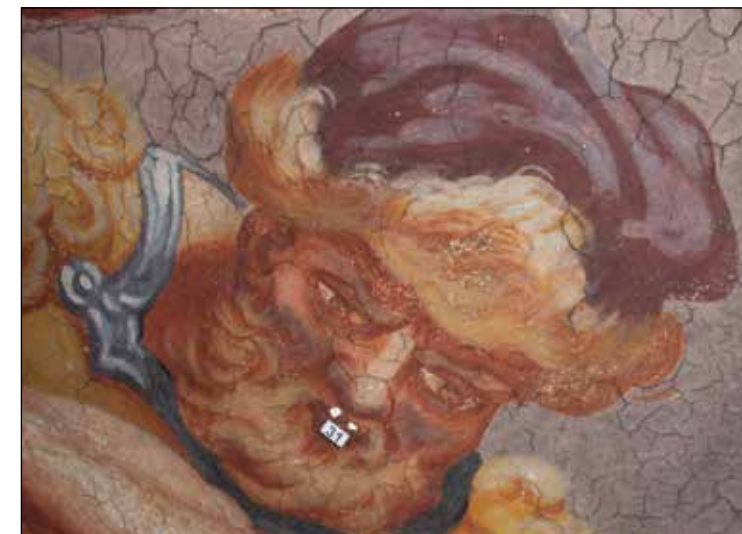
Figure 227: Condition before cleaning and retouching – numerous tiny cracks are visible.

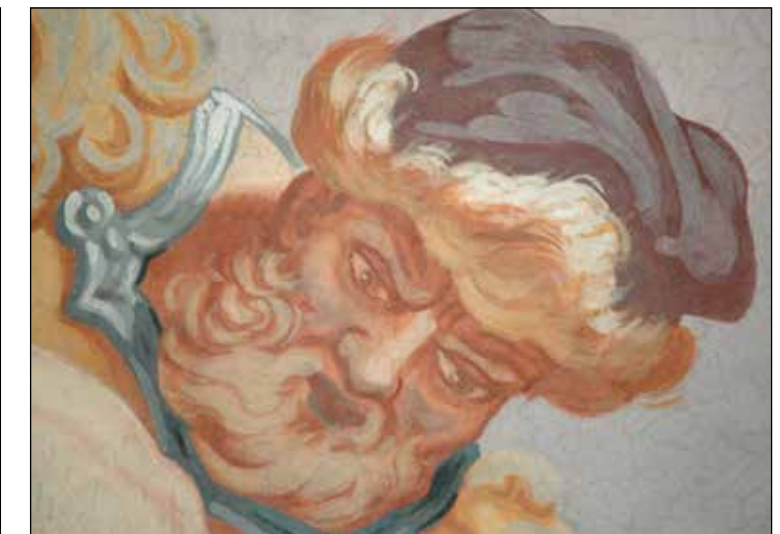
Figure 228: Condition after the renovation – the cracks are less noticeable after cleaning and retouching.

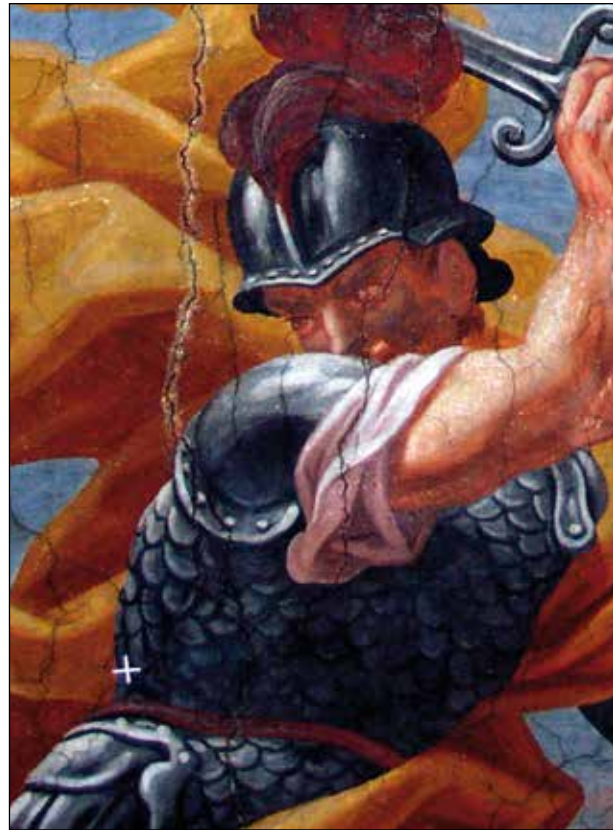
Figure 229: Location K23, before treatment.

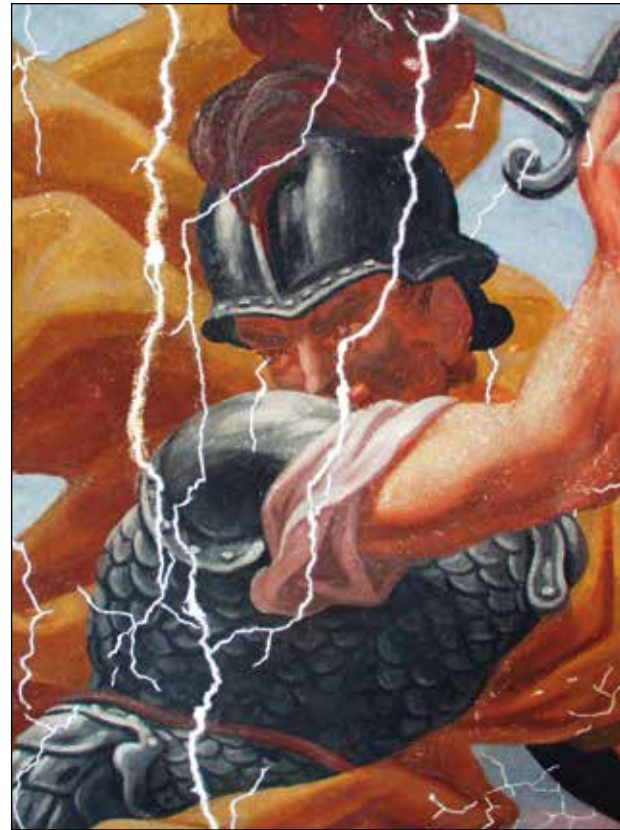
Figure 230: Condition after the preparations and closing of the cracks, and partial cleaning.

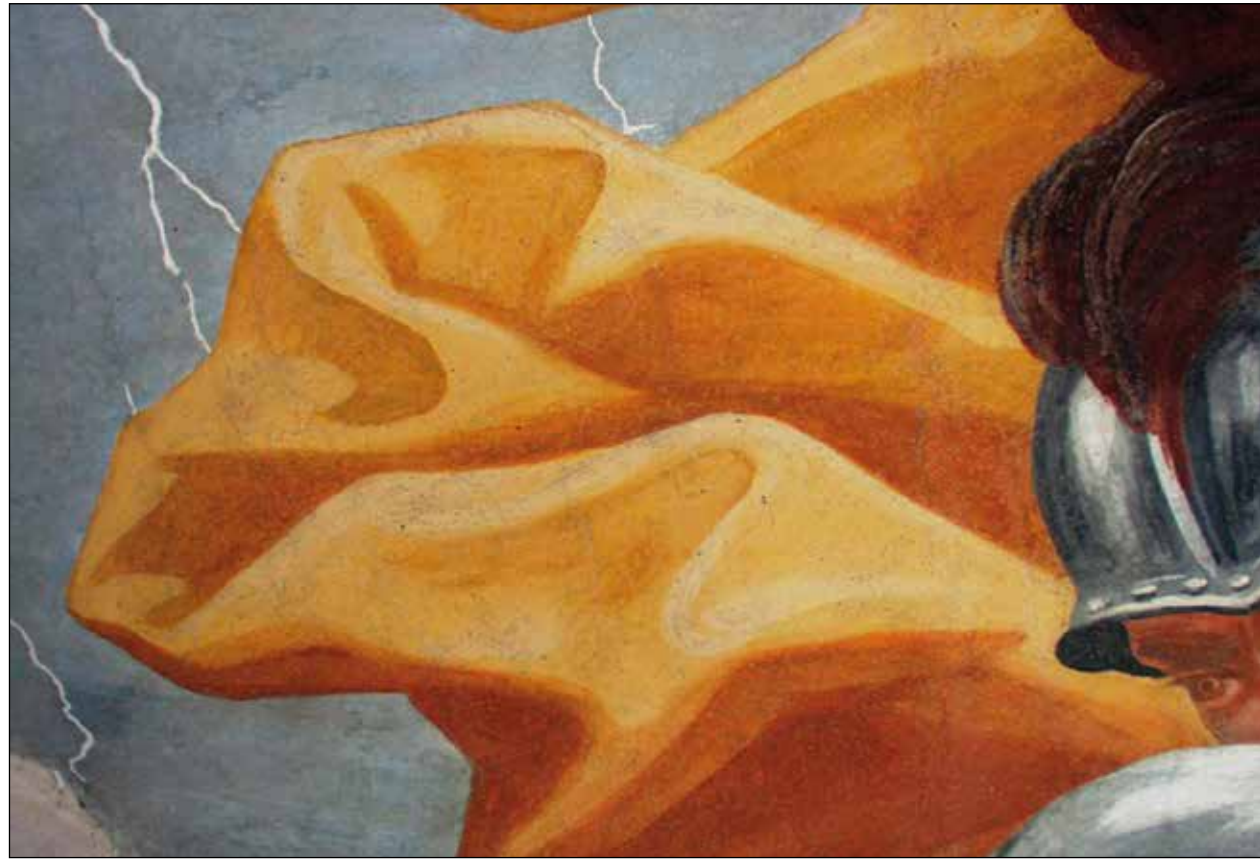
Figure 231: Location J23, condition after cleaning and retouching.

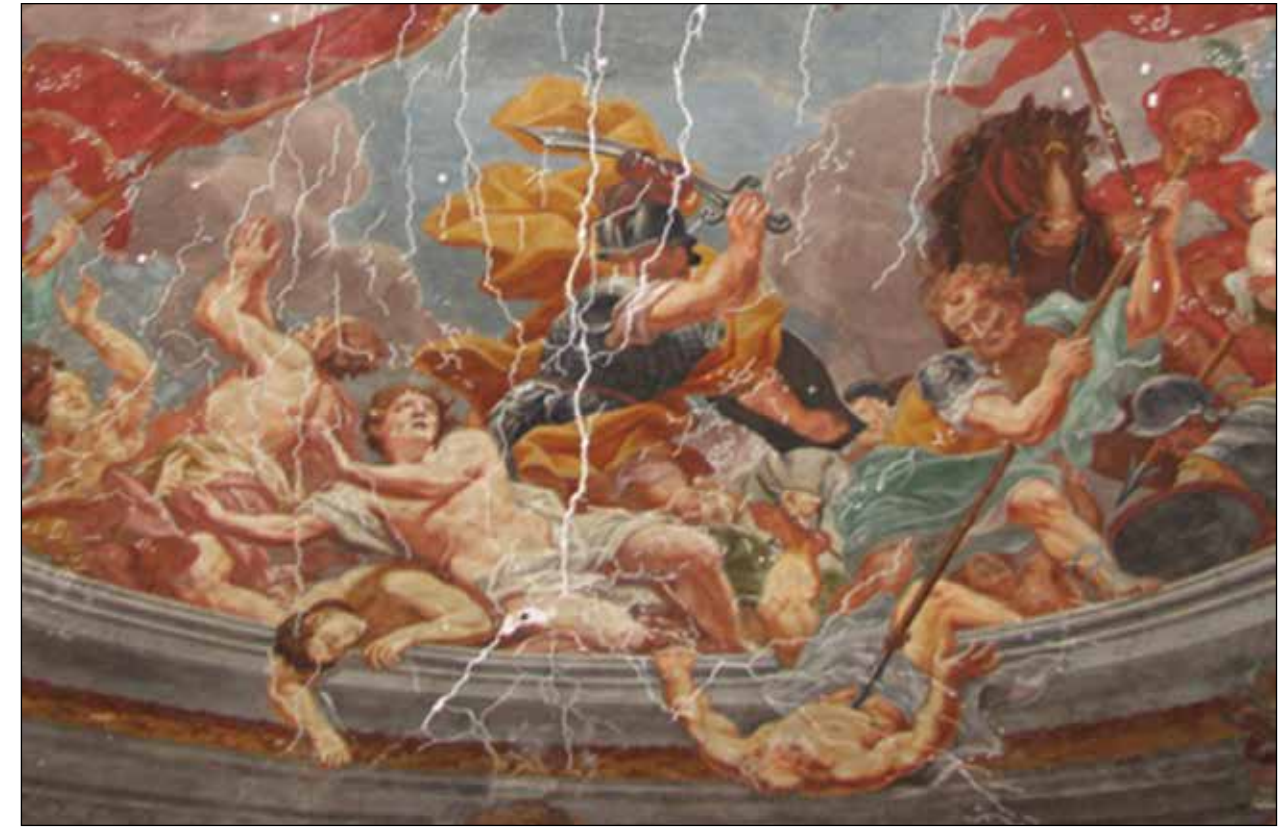
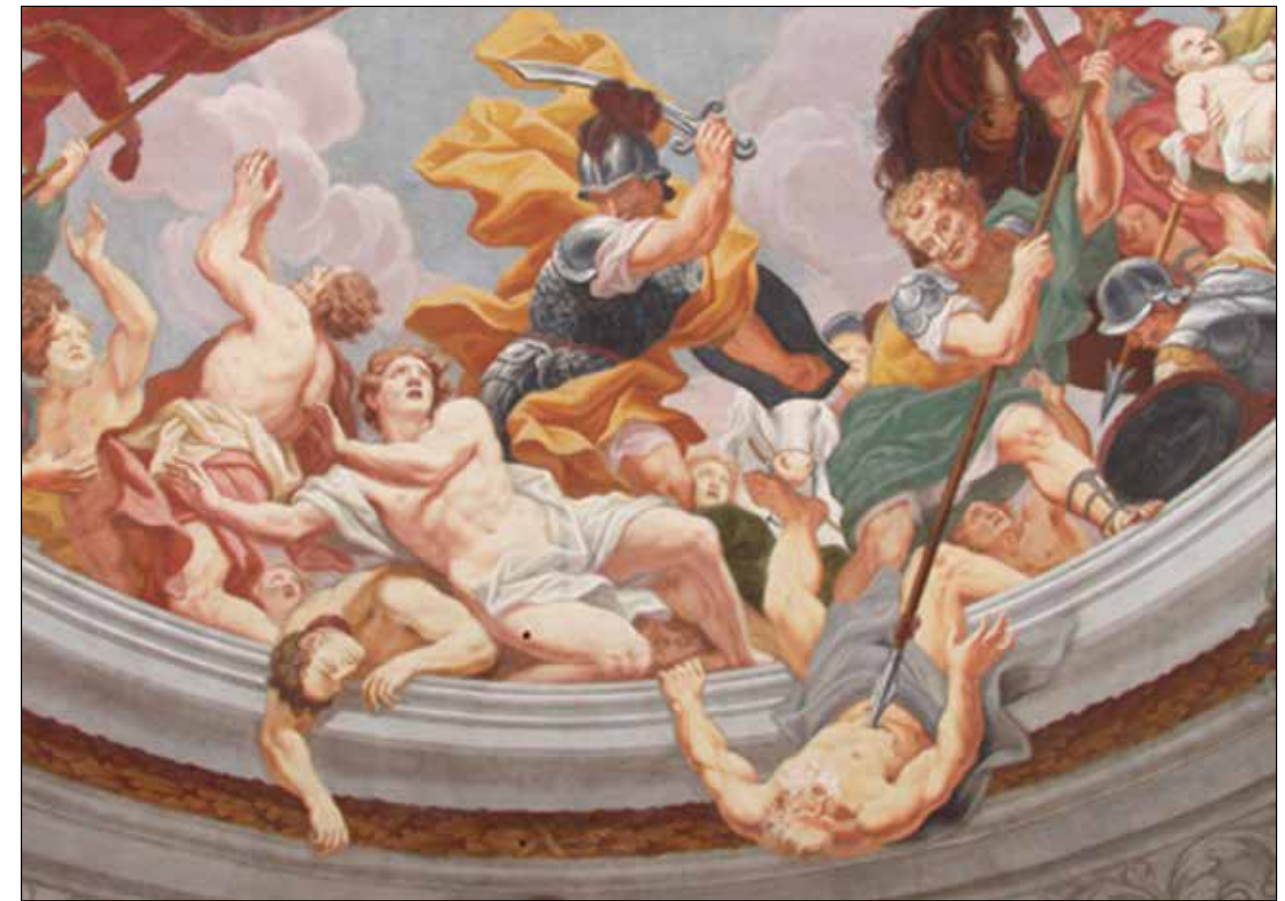
Figure 232a and 232b: The plaster of the central, most active group of figures just above the apex of the triumphal arch was crisscrossed with numerous cracks, almost certainly due to earthquake movements.

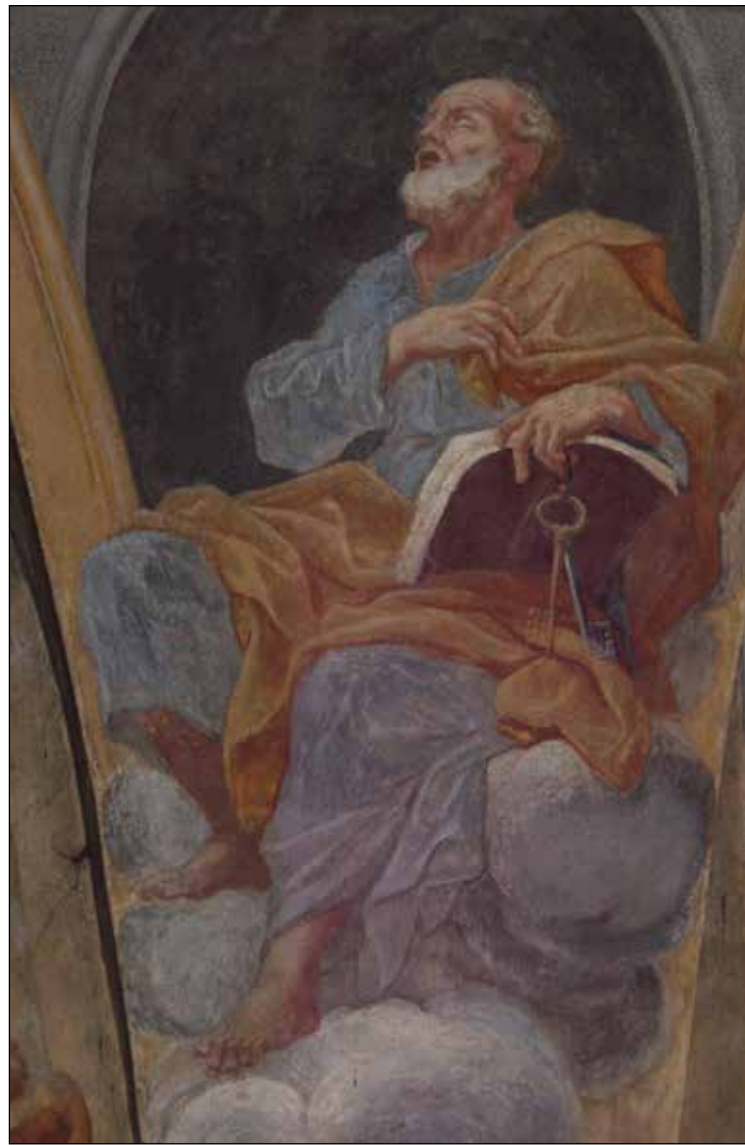
Figure 233: St Peter the apostle before treatment with a visible greyish film of dirt.

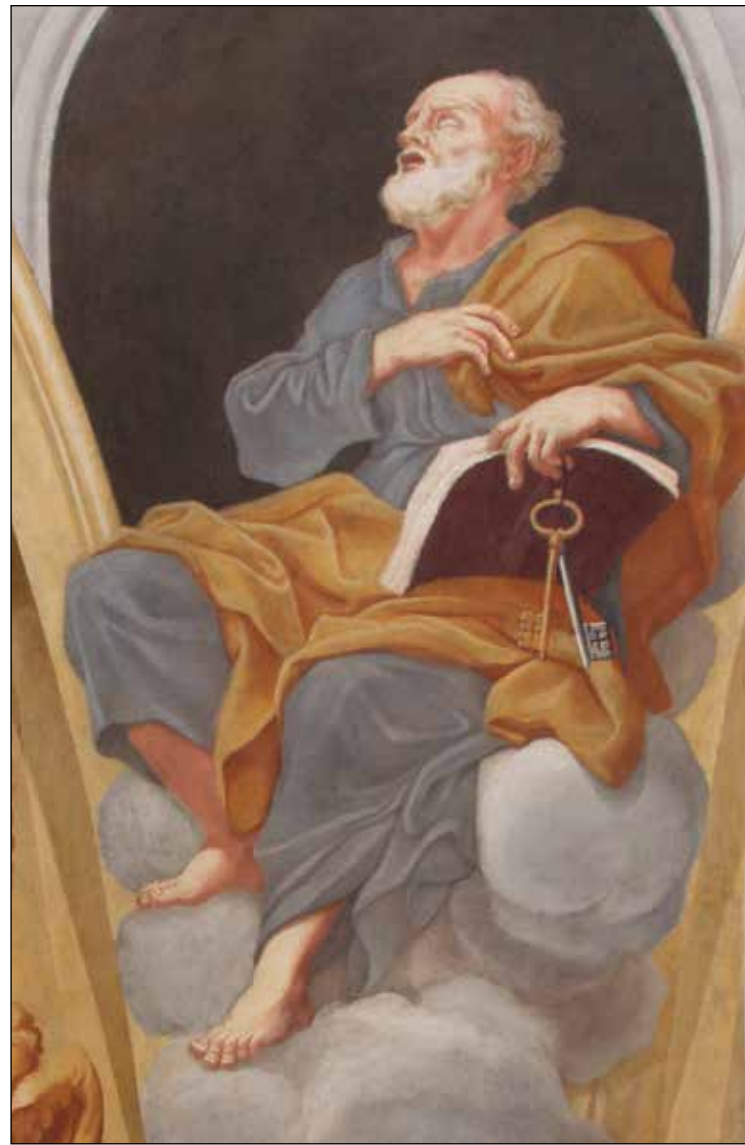
Figure 234: Condition after the renovation – the difference in the intensity of colours is noticeable.

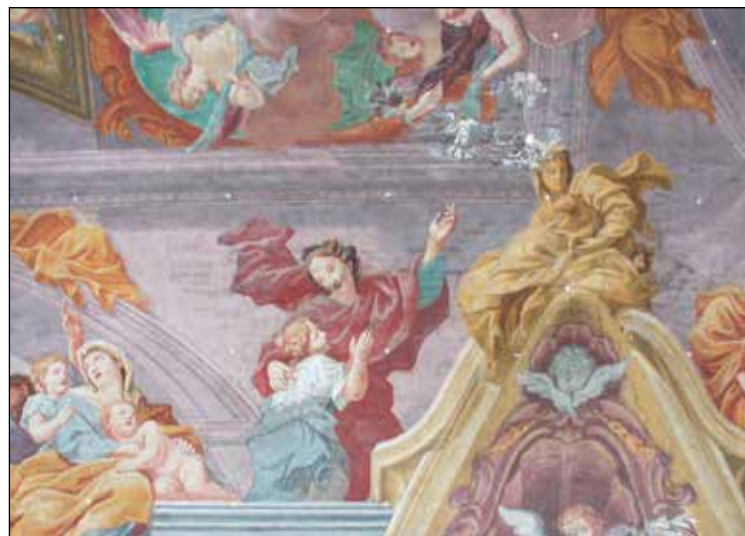
Figure 235: Condition before treatment – a large area with visible signs of leakage.

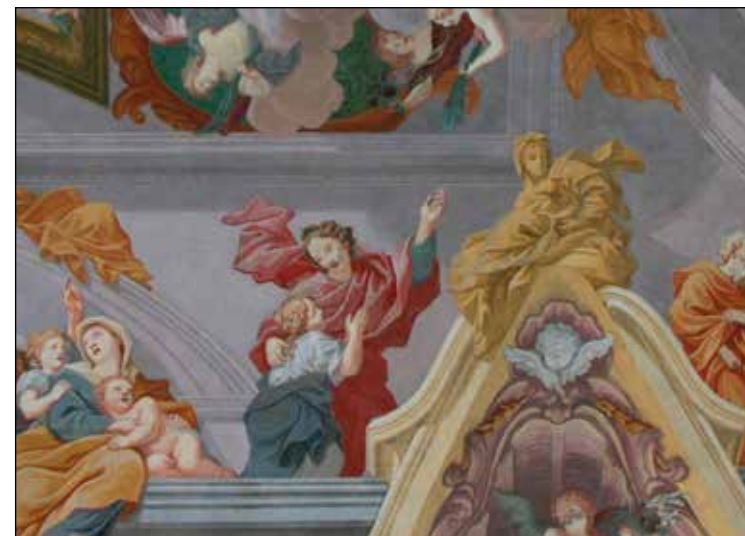
Figure 236: Condition after the renovation with removed signs of efflorescences.

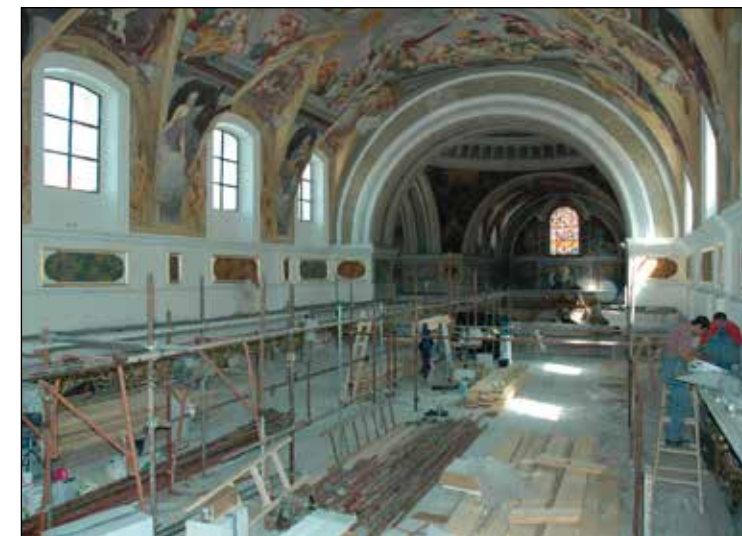
Figure 237: The restoration platform at 13 metres after the removal of the top work surface.

After conservation-restoration work was completed on the wall and ceiling paintings of the vault, triumphal arch and western wall, as well as on all profiles, cornices and areas along the windows, the restoration platform was after four years removed. In order to dismantle it, a temporary scaffold was constructed underneath (figure 237). From this scaffold the RC restoration team first removed all unsuitable whitewashes from the surface, which were not accessible earlier due to the work platform (figure 238). In areas where the platform's construction was anchored into the walls the damaged fields had to be filled and the profiles modelled in, the medallions had to be retouched and reconstructed and the profiles had to be prepared for gilding and then gilded (figure 239).

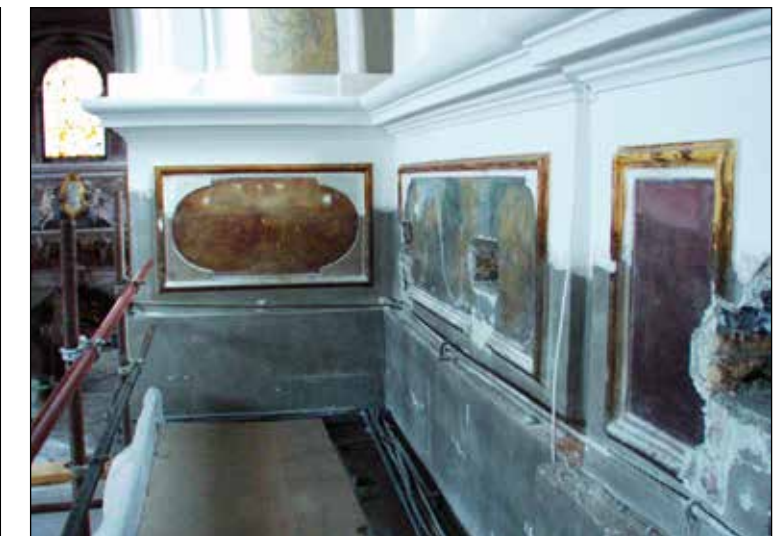
Figure 238: Visible openings into which the anchor ties of the scaffold were inserted and the difference between the cleaned and uncleaned surfaces.

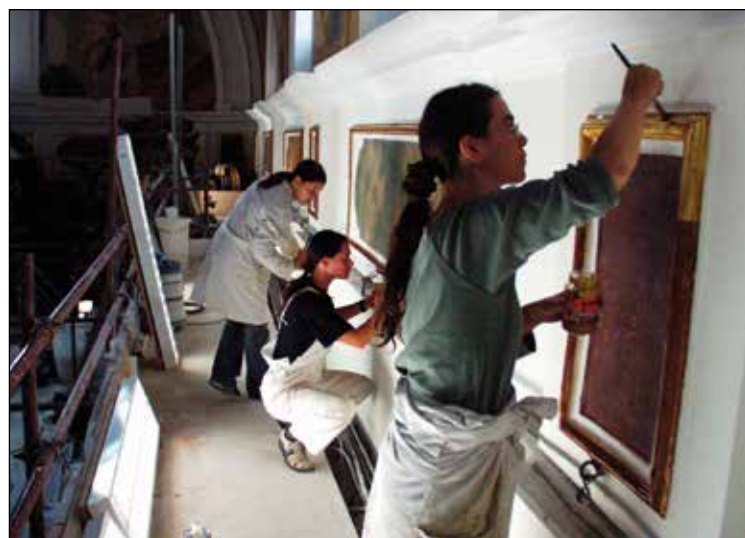
Figure 239: Gilding of the frames on the northern wall of the nave.

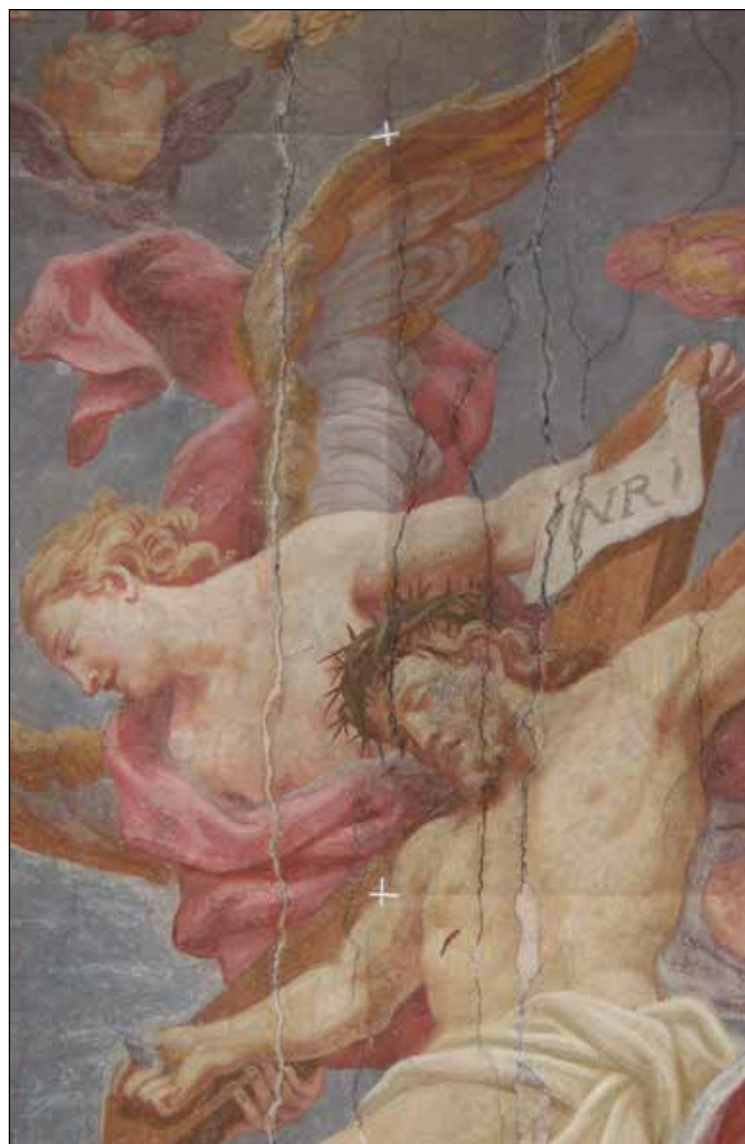
Figure 244 show the condition before and during mechanical cleaning during restoration work on the vault of the cathedral (2002-2006). Such a monotonous, flat and at times unreadable appearance of the wall and ceiling paintings justifiably attracted the attention of the connoisseurs of Quaglio's painting oeuvre. An interesting is overly darkened area of Christ's head, which was, probably due the significance of the figure, overzealously cleaned with moisture so that soot and dust were even more thoroughly washed from this region. It is true to say that the surface was cleaned, however, an extremely fine sooty black pigment was rubbed into the porous top layer of the lime plaster.

Figure 244: Condition before the renovation of the vault painting in Ljubljana Cathedral.

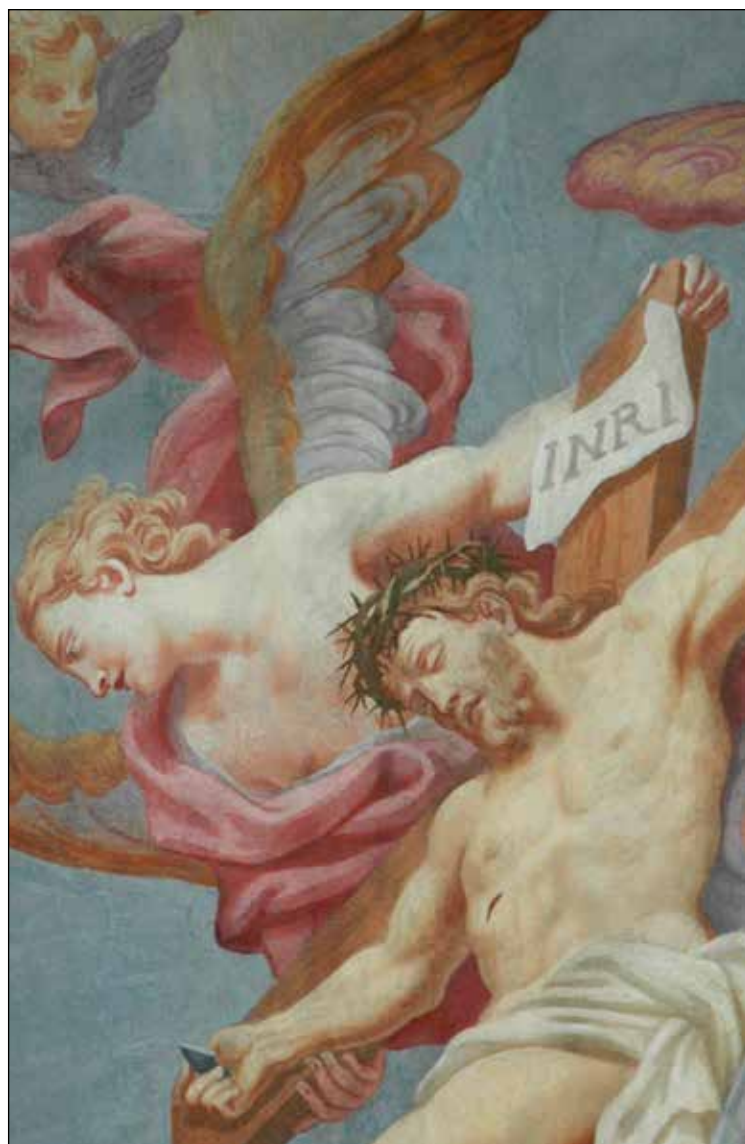
After the removal of all unoriginal layers using mechanical and chemical cleaning, the handling of various and numerous areas of damage to the colour layer and support, and retouching (figure 245) we can talk about the appearance of the vault that once again resembles the original in terms of light and colour values.

Figure 245: Condition after the renovation.

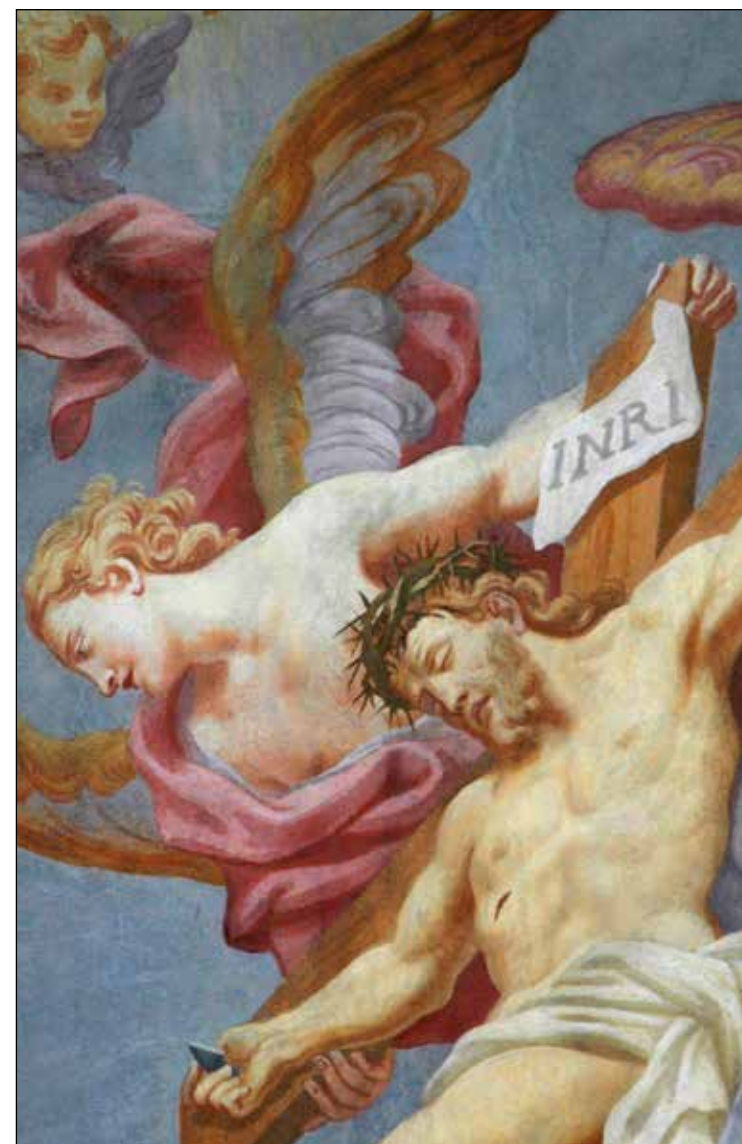
We tried to simulate the appearance of Quaglio's mural in the cathedral in 1706 by using digital technology. We added the light and colour values of figure 247 – which is known to also have been painted in autumn 1706, immediately after the completion of work on the vault – to figure 245 from 2006, which displays the state of the renovated wall and ceiling paintings of the vault of Ljubljana Cathedral. The shots of the Puštal wall and ceiling paintings date from 2005.

Figure 246: A simulation of the appearance of Quaglio's vault painting in 1706.

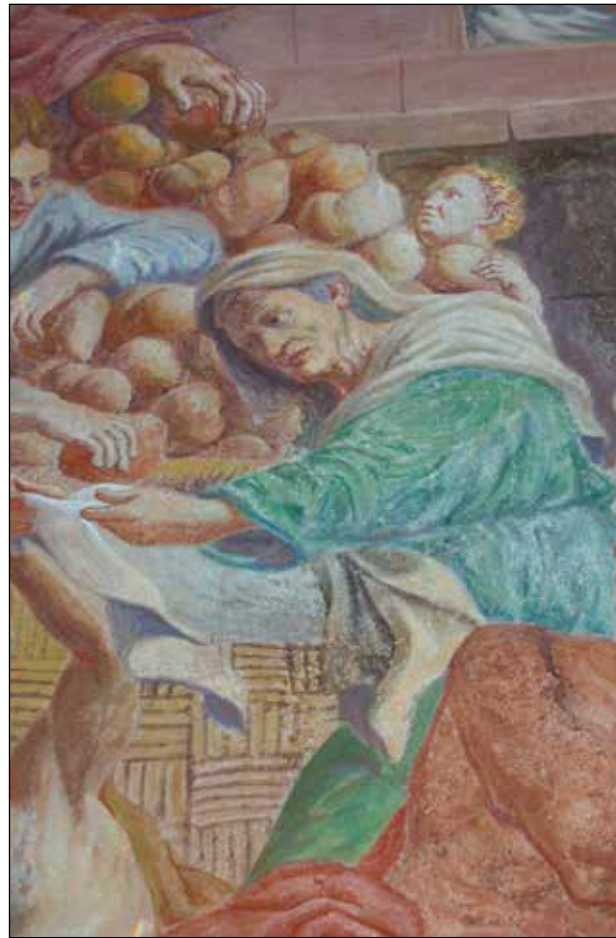
The painted surfaces found in easily reached spaces are usually subject to more frequent cleaning than those which can be accessed only from high and expensive scaffolds. However, this does not mean that these works of art are better preserved due to more frequent renovations; usually too frequent "cleaning" is more harmful than useful to the frescoes. In the cathedral such a space is certainly the presbytery with four larger, easily reachable paintings, where in places only an inkling of Quaglio's brushstrokes remains underneath numerous overpaints (figure 248). Here much work awaits restorers.

Figure 248: A detail of Quaglio's wall painting in the presbytery of Ljubljana cathedral.
