THE RESTORATION OF QUAGLIO'S WALL PAINTINGS
IN LJUBLJANA CATHEDRAL

The Restoration of Quaglio's Wall Paintings in Ljubljana Cathedral

A conservation-restoration project involving the wall paintings created by Giulio Quaglio (1668–1751)

on the nave vault and the western wall of the Cathedral of St Nicholas in Ljubljana, IPCHS Restoration Centre (2002–2006)

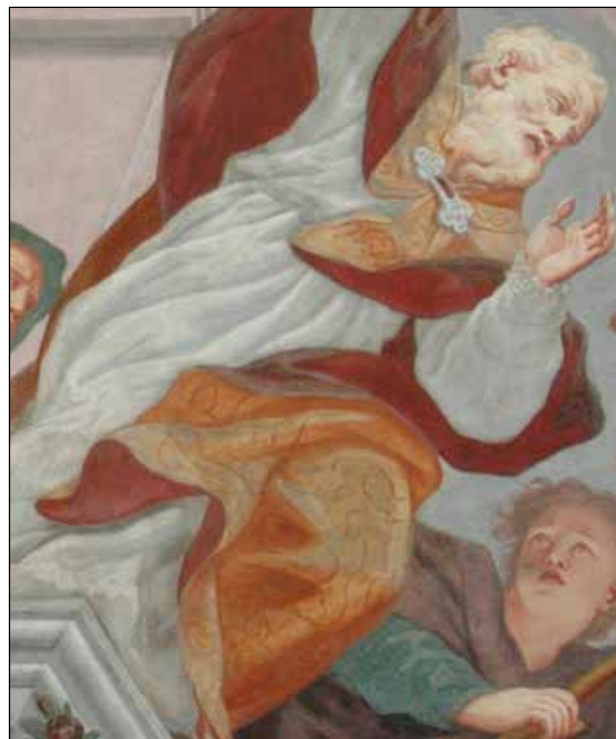
Figure 250: St Nicholas, a detail of the vault painting in Ljubljana Cathedral.

The comparison of three draperies with a similar pattern by artist Giulio Quaglio depicted in 1697/1698 in Udine (Palazzo Antonini, figure 249), 1705/1706 in Ljubljana (cathedral vault, figure 250), and 1706 at Puštal near Škofja Loka (Chapel of the Holy Cross, figure 251) reveal an obviously darkened, smudged grey lining in the regions that had originally been painted using a lighter shade (most obvious in figure 250). On the younger mural (figure 249) no changes or damage can be noted at first. However, the incredibly well preserved wall painting in the Chapel of the Holy Cross at Puštal that was produced straight after the completion of work on Ljubljana Cathedral, upon closer examination, reveals darkened highlights also on this mural, and not only on the drapery, but also on the hair of the female figure (figure 251). Obviously these two paintings received less attention by restorers, whereas it can be said for the one at Puštal that it had not yet been subject to any

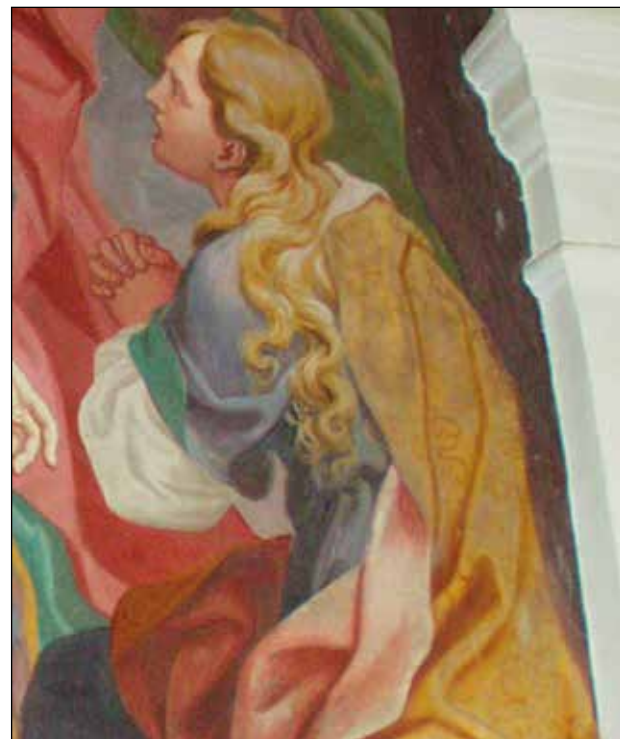
Figure 251: A detail of the wall painting *Descent from the Cross* at Puštal.

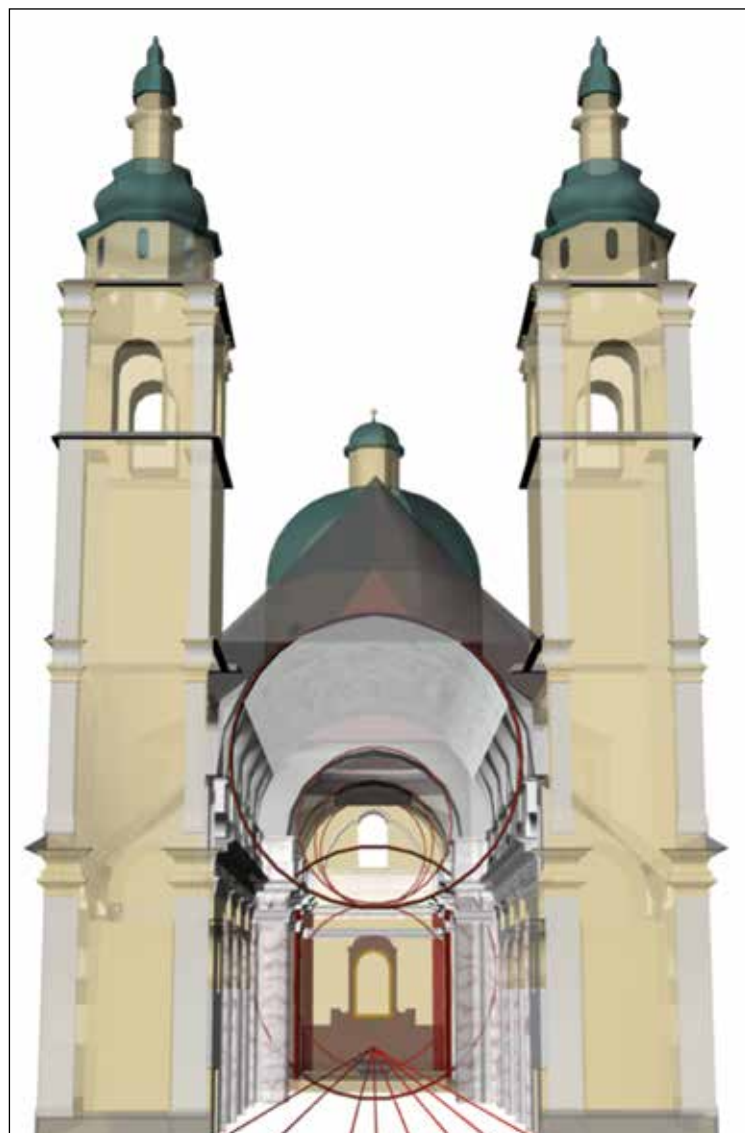
Figure 1: Geometrical analysis of the vertical architectural composition of the presbytery.

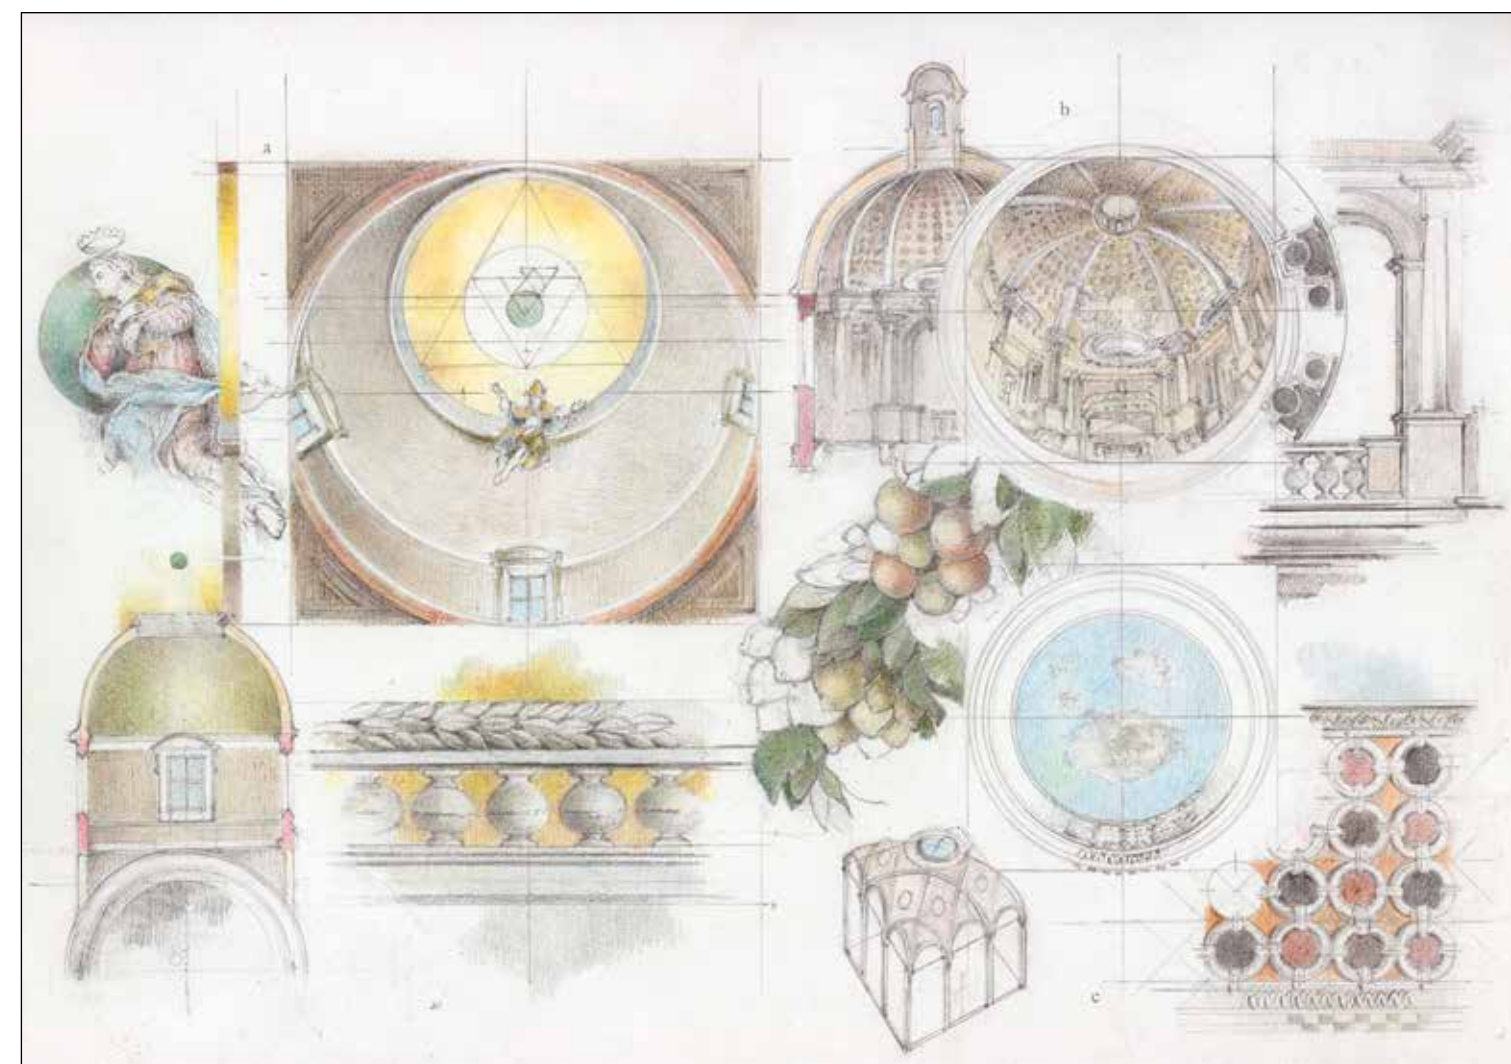
Figure 2: Compositional characteristics of the false cupola; a) G. Quaglio, an analysis of the former painting in Ljubljana Cathedral; b) A. Pozzo, an analysis of the painting San Ignazio in Rome; c) A. Mantegna, an analysis of the ceiling in the *Camera degli sposi* in Mantova.

in 1643.¹⁵ The two examples differ not only in colour and content, but also in the location of the oculus. Mantegna painted his exactly in the middle of the square vault¹⁶ as an independent composition; in Quaglio's painting, on the other hand, as with Pozzo's, the lantern is moved to the very edge of the painting circle in the direction of the nave. Both give the illusion of a light window; however, the one in Ljubljana is coloured and with regard to content tied to the highest, central part of the nave vault, just as the lower bands are present in both. The false dome in Rome is just an illusionist illustration of the inside of the yet unbuilt part of the architectural form, while the Ljubljana example gives the impression of being two parts of the same motif. Thus, it not only elevates the space but also provides one of the key scenes, the conical composition which has its summit in the centre of the oculus. It is emphasised by a sphere as a symbolic presentation of the Creator's acts and the crowning of Mary takes place in relation to this. In terms

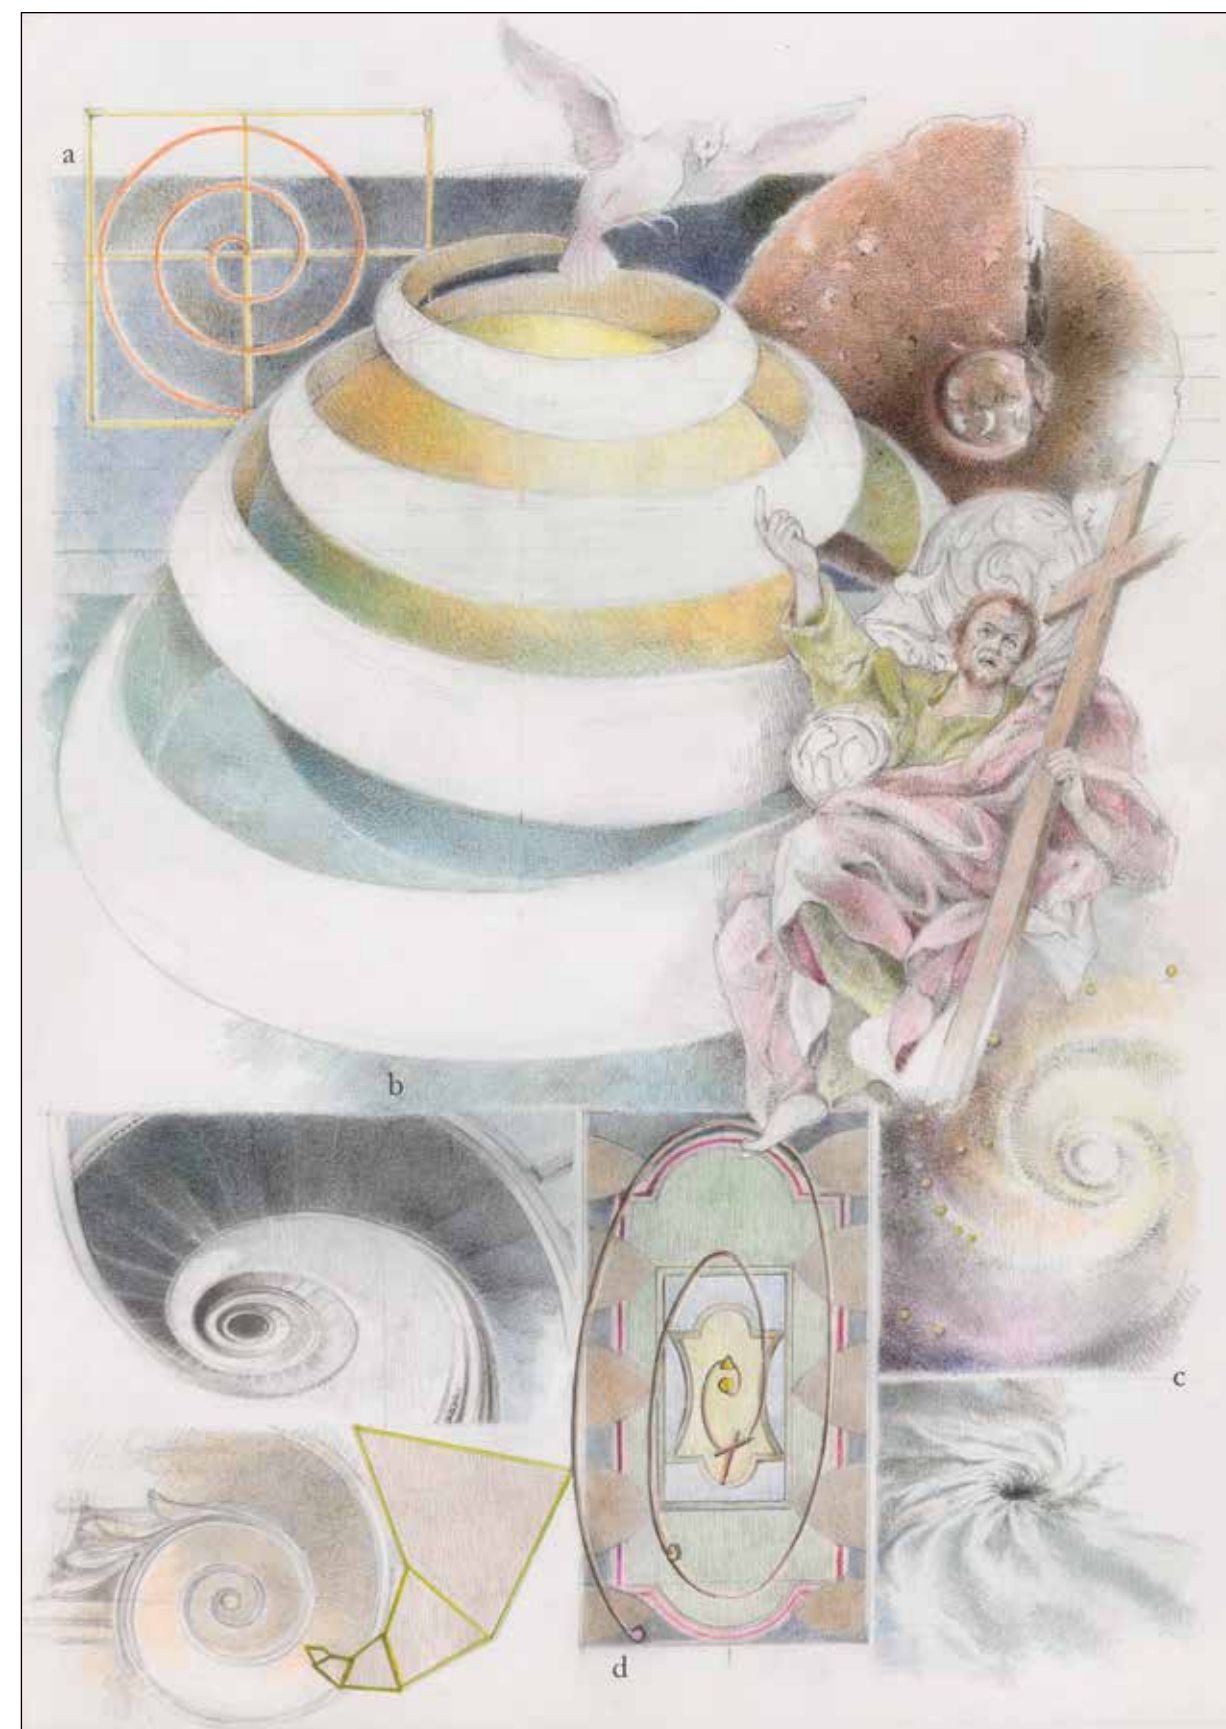
Figure 12: A spiral, a natural and artificial form as an element connecting motifs and combining themes: a) in mathematics; b) in architecture; c) in nature; d) in the composition of the painting on the nave vault.

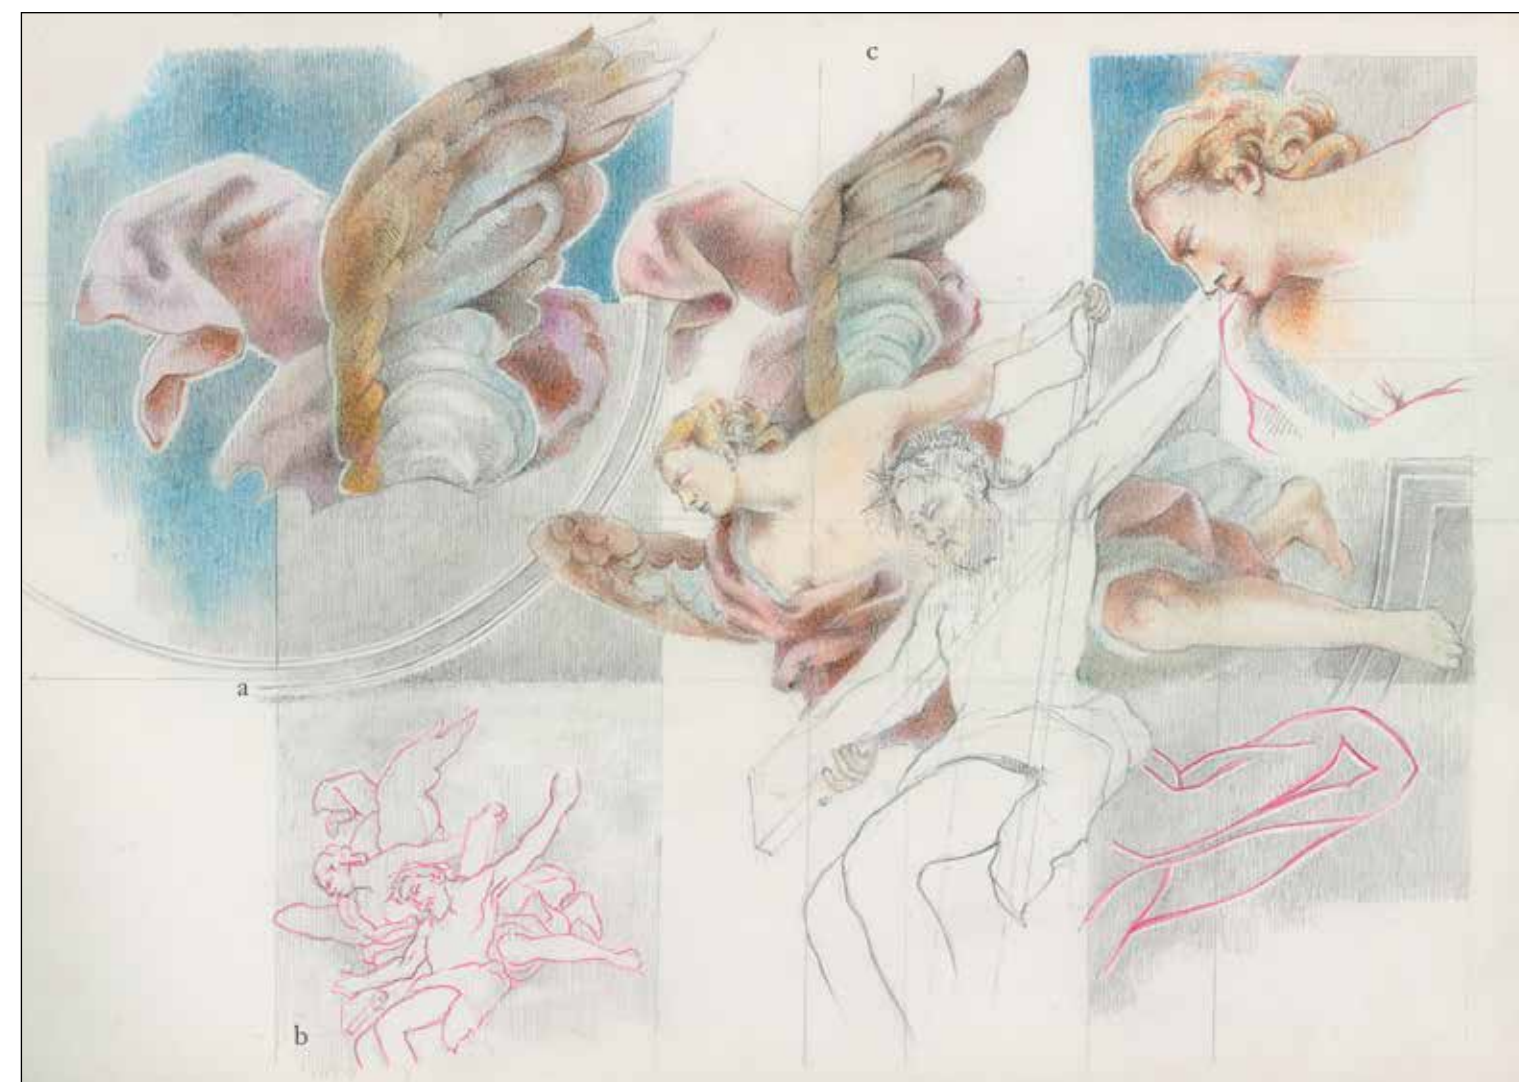
Figure 14: The relation between line and colour – from the planning stage to the final colour image: a) *intonaco*; b) *arriccio*; c) painted surface.
